FIELD INSPECTION

Project Name:	Mountain Valley Pipeline	Inspector:	Marshall Willis
Inspection Date:	Monday, May 6, 2019	Project Contact:	Brian Clauto
Spread I: Franklin County	STA 13784+35 – 13826+95 MVP-FR-300/302	Weather (Wet/Dry/Rain):	Wet

FIELD INSPECTION PHOTO LOG

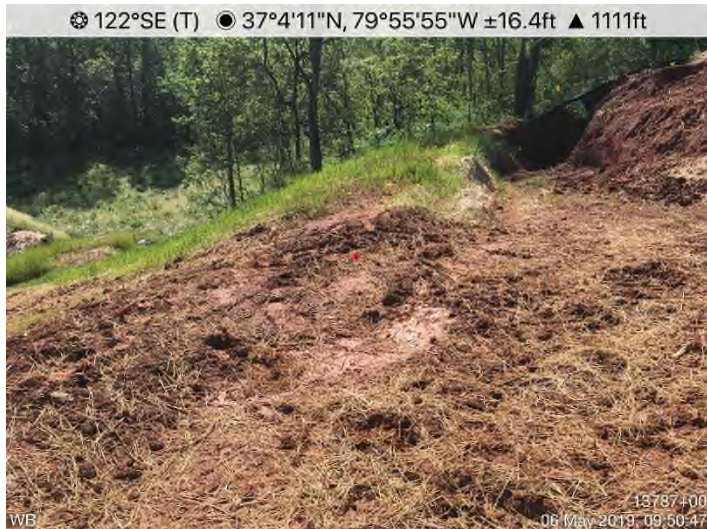
Fig. 1: **STA 13787+00** – Waterbar requires maintenance.

Recommended Corrective Action: Maintain and install all controls per the approved plan and specs.

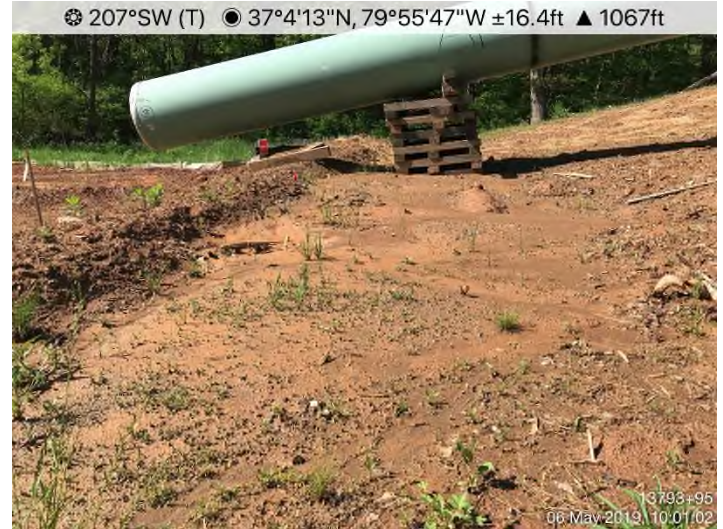
Fig. 2: **STA 13793+95** – Waterbar requires maintenance.

- STA 13797+00: Repair/maintain waterbar.
- STA 13793+95: Repair/maintain waterbar, install per approved PSS&S and stabilize dormant area upslope of waterbar.

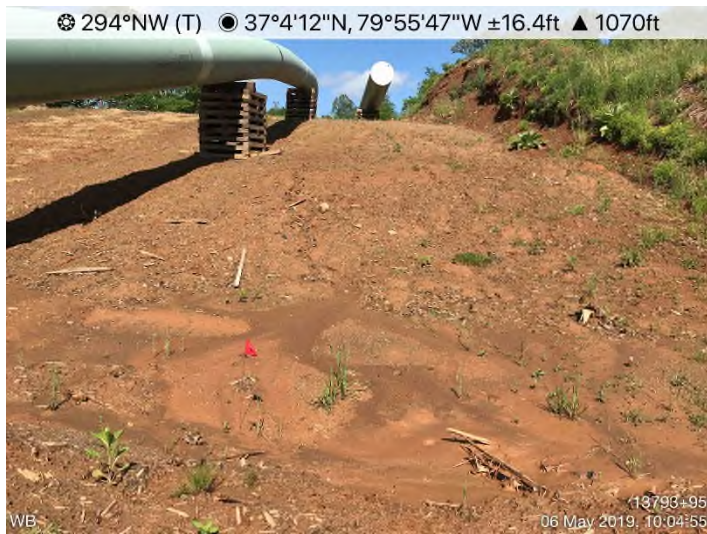
Fig. 3: **STA 13793+95** – Stabilize area upslope of waterbar.

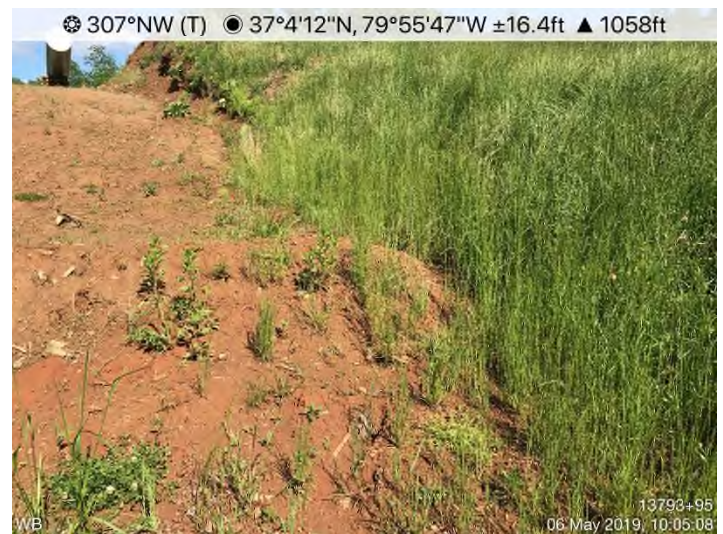
Fig. 4: **STA 13793+95** – Waterbar does not extend to perimeter controls/flow diverting around waterbar.
