## FIELD INSPECTION

| Project Name: | Mountain Valley Pipeline | Inspector: | Marshall Willis |
| Inspection Date: | Monday, April 29, 2019 | Project Contact: | Brian Clauto |
| Spread H:<br>Montgomery County | STA 12153+28 – 12298+77<br>MVP-MN-276.03/273 | Weather (Wet/Dry/Rain): | Dry |

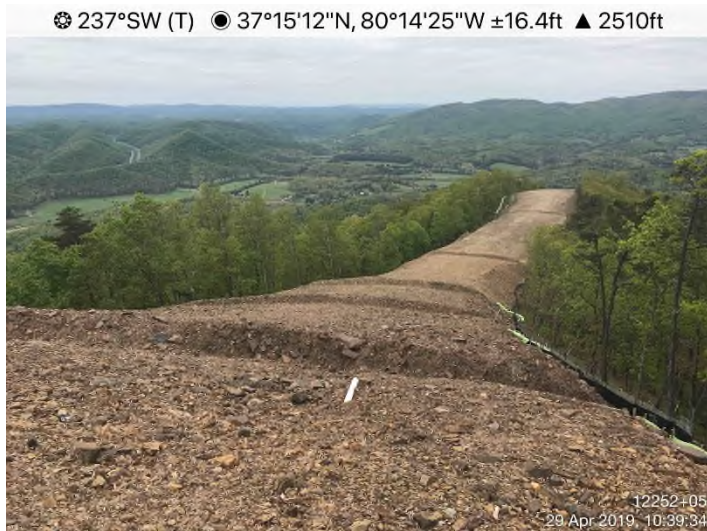
Fig. 1: **STA 12252+05** – Controls in place. Area stabilized with Earth Guard.

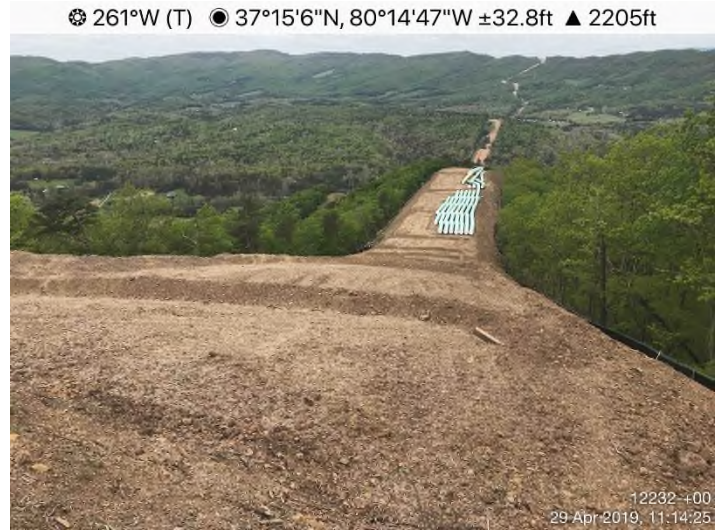
Fig. 2: **STA 12232+00** – Controls in place. Area stabilized with Earth Guard.

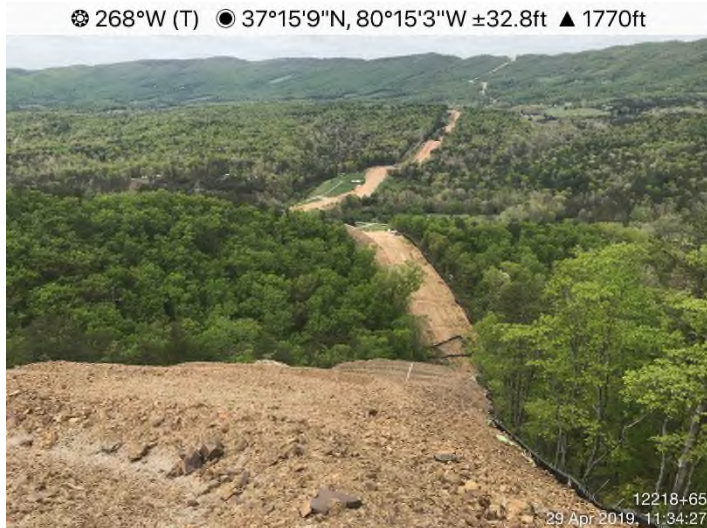
Fig. 3: **STA 12218+65** – Controls in place. Area stabilized with Earth Guard.

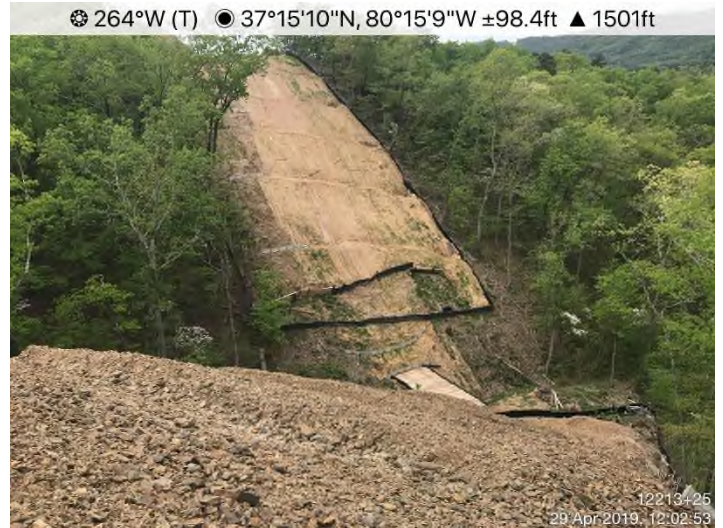
Fig. 4: **STA 12213+25** – Controls in place. Area stabilized with curlex fabric and Earth Guard.

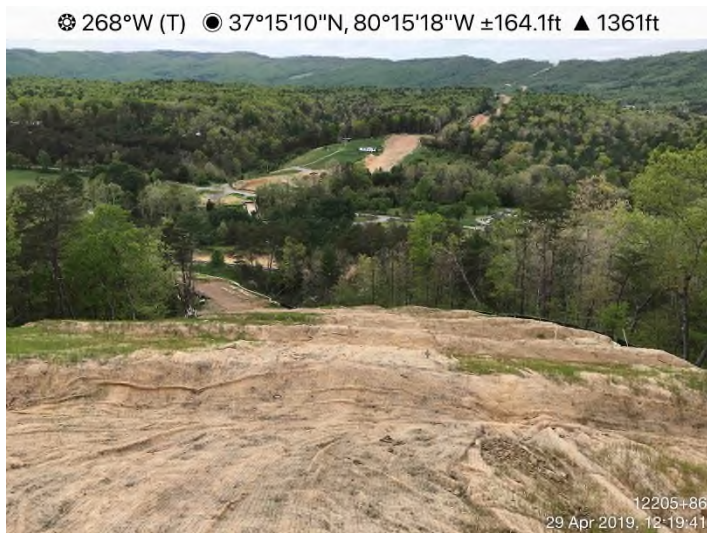
Fig. 5: **STA 12205+86** – Controls in place. Area stabilized with curlex fabric.

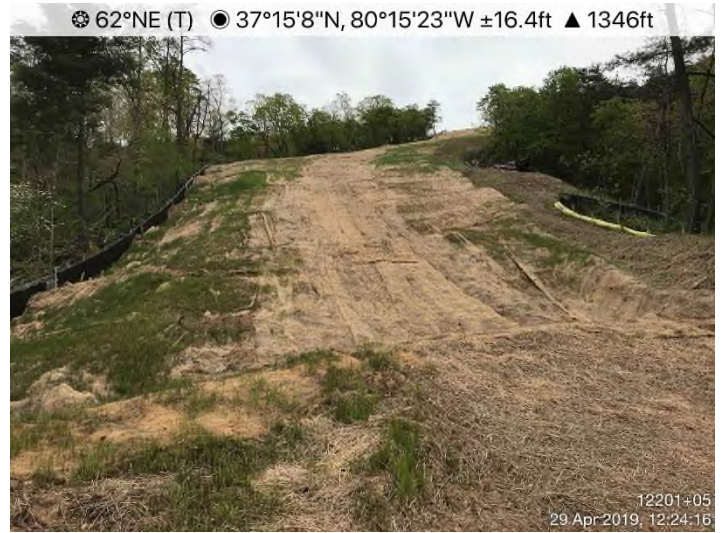
Fig. 6: **STA 12201+05** – Controls in place. Area stabilized with curlex fabric.

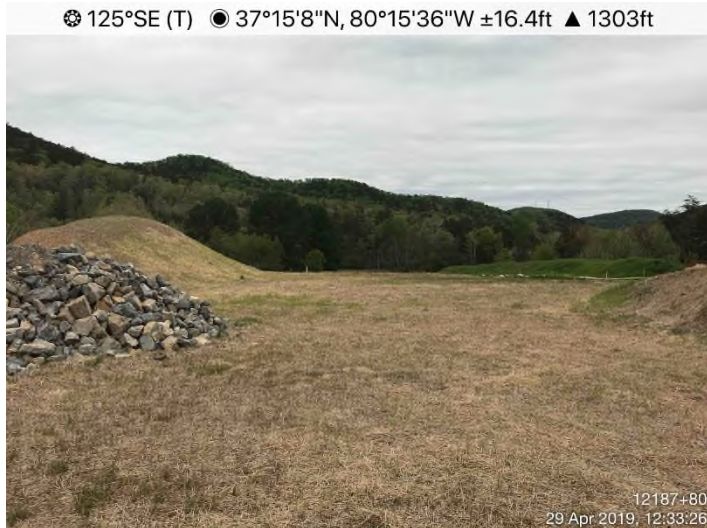
Fig. 7: **STA 12187+80** – Controls in place. Area stabilized with straw.

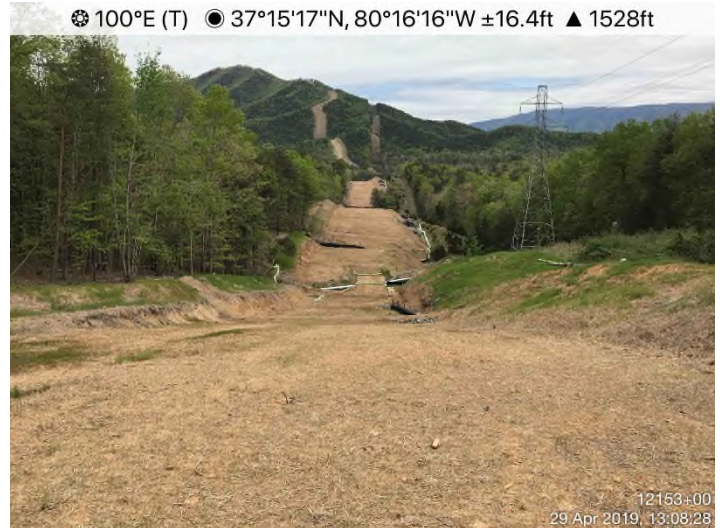
Fig. 8: **12153+00** – Controls in place. Area stabilized with straw.
