## FIELD INSPECTION

| Project Name: | Mountain Valley Pipeline | Inspector: | Marshall Willis |
| Inspection Date: | Friday, April 26, 2019 | Project Contact: | Brian Clauto |
| Spread I:<br>Franklin County | STA 13690+91 – 13713+56 | Weather (Wet/Dry/Rain): | Rainy |

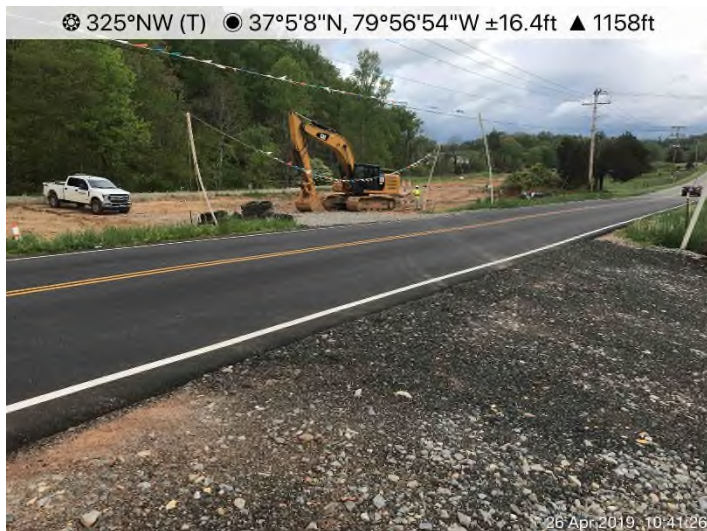
Fig. 1: **STA 13690+91** – Controls in place.

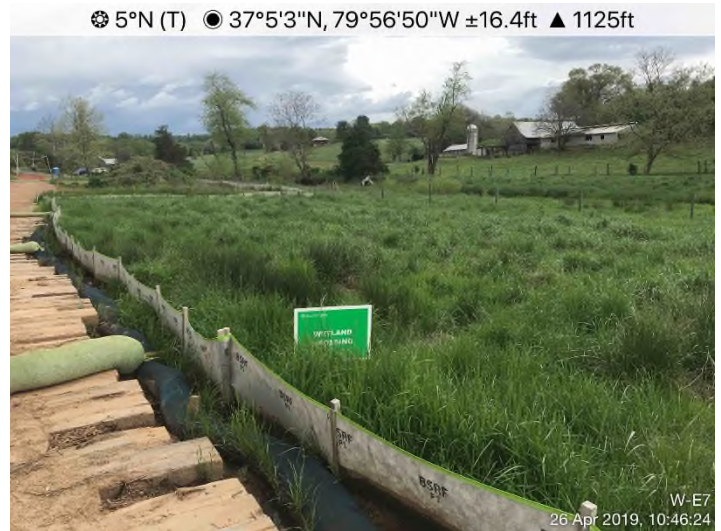
Fig. 2: **Wetland W-E7** – Controls in place.

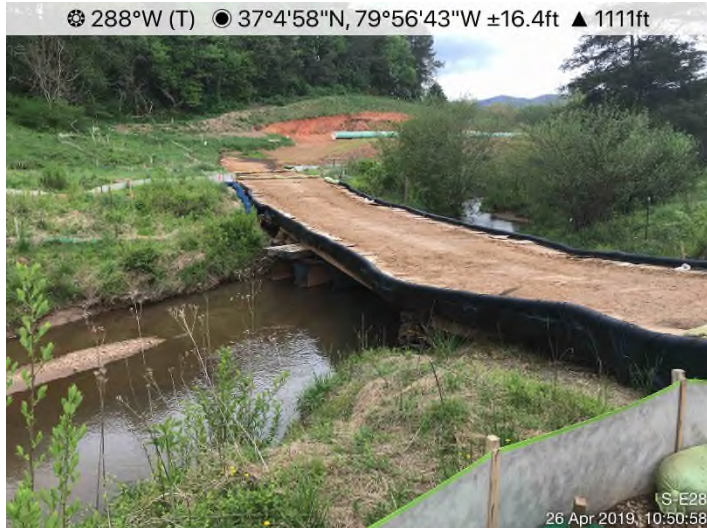
Fig. 3: **Stream S-E28** – Controls in place.

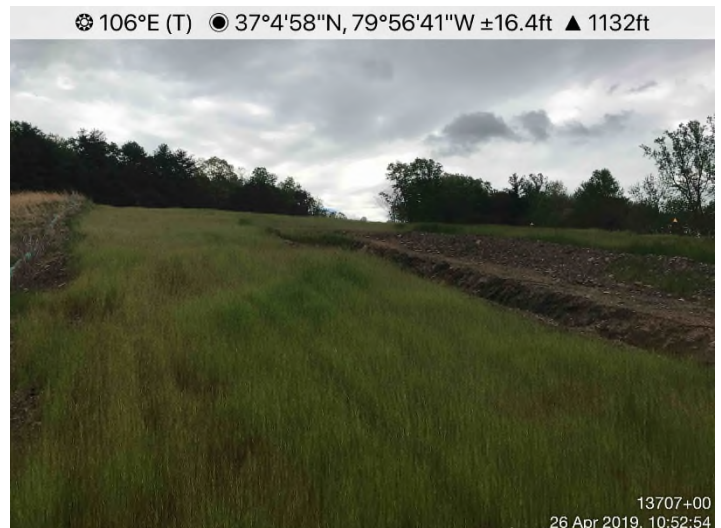
Fig. 4: **STA 13707+00** – Area stabilized. Controls in place.

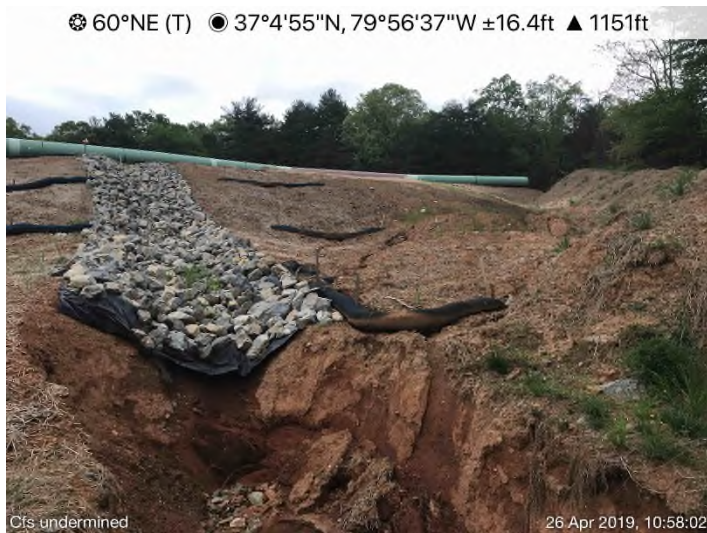
STA 13712+50: CFS undermined in ATWS 1362.  
 STA 13712+50: Maintain CFS, stabilize erosion in ATWS 1362.  
 STA 13712+50: Maintain CFS, stabilize erosion in ATWS 1362.

Fig. 5: **STA 13712+50** – CFS undermined.

**Recommended Corrective Action:** Maintain and install all controls per the approved plan and specs.

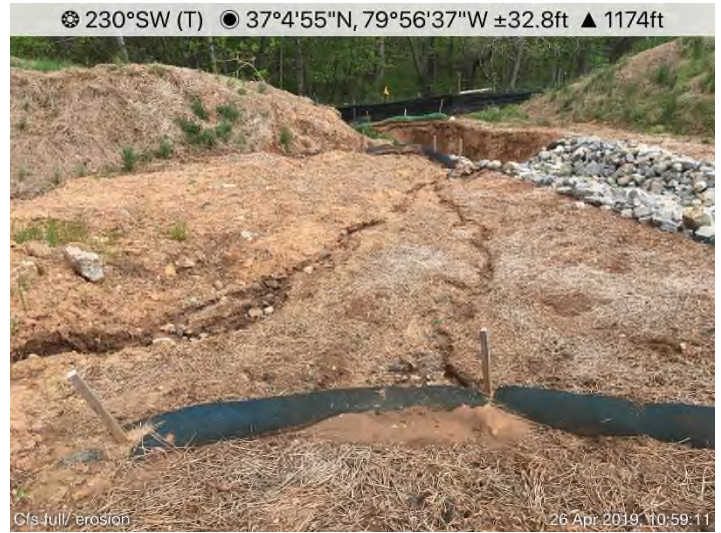
Fig. 6: **STA 13712+50** – CFS full, inadequate stabilization.

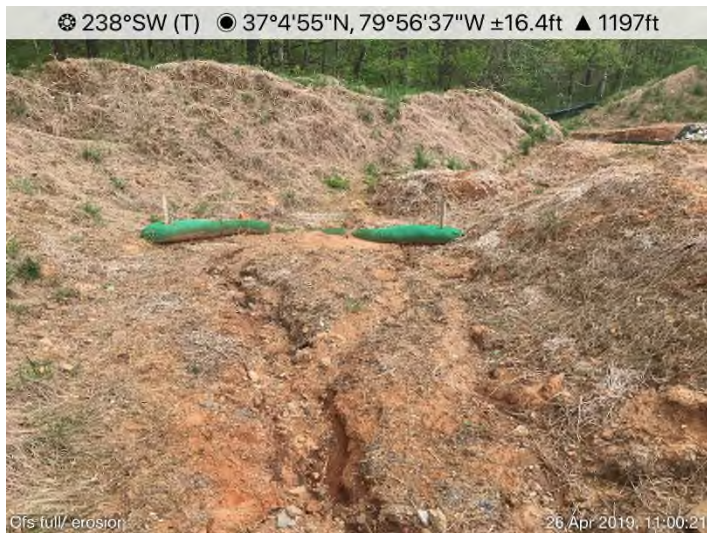
Fig. 7: **STA 13712+50** – CFS full, inadequate stabilization.

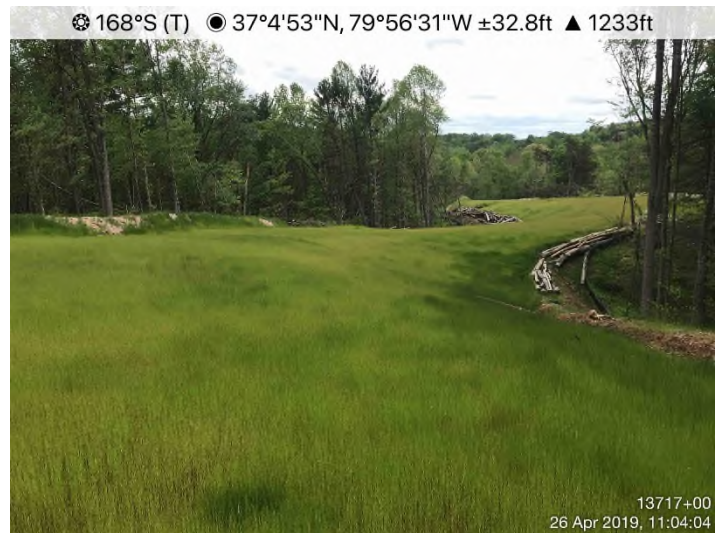
Fig. 8: **STA 13717+00** – Area stabilized. Controls in place.
