## FIELD INSPECTION

| Project Name: | Mountain Valley Pipeline | Inspector: | Marshall Willis |
| Inspection Date: | Thursday, April 25, 2019 | Project Contact: | Brian Clauto |
| Spread I:<br>Pittsylvania County | STA 15826+88 – STA 15947+64 | Weather (Wet/Dry/Rain): | Dry |

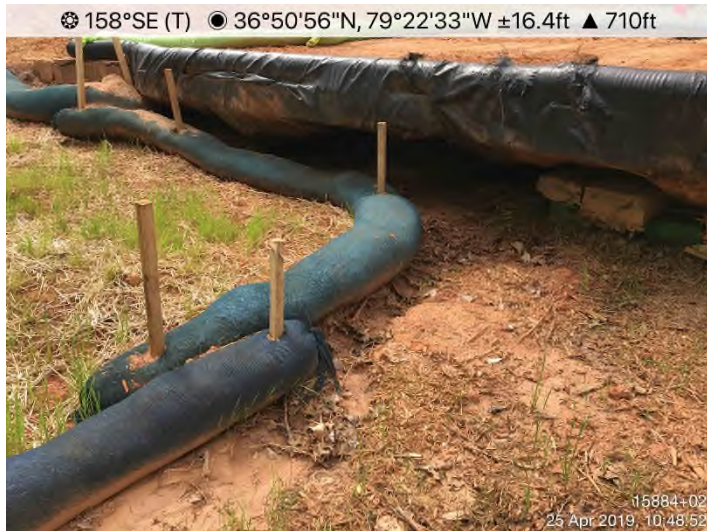
Fig. 1: **STA 15884+02** – Bridge underlayment damaged.

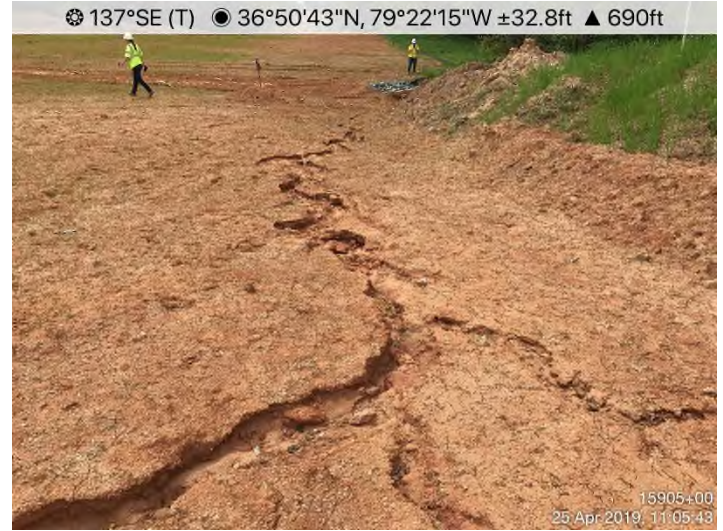
Fig. 2: **STA 15905+00** – Stabilize erosion.

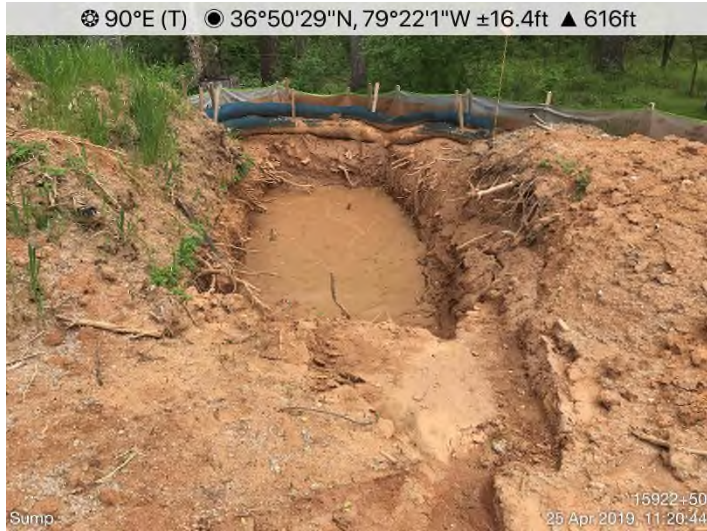
Fig. 3: **STA 15922+50** – Sump needs maintenance.

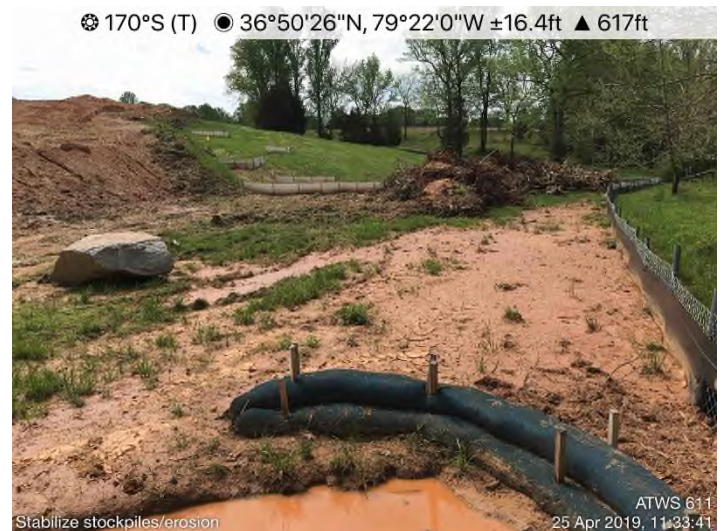
Fig. 4: **STA 15924+60** – Stabilize.

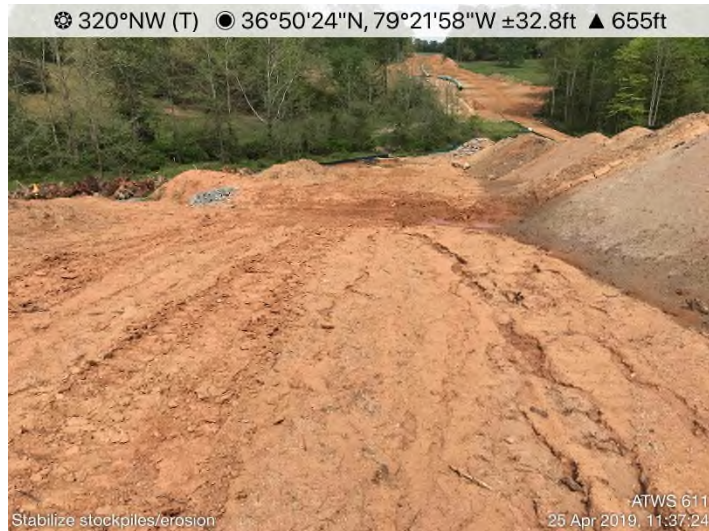
Fig. 5: **STA 15924+70 – STA 15929+00** – Stabilize stockpiles and areas outside travel lane in ATWS 611.

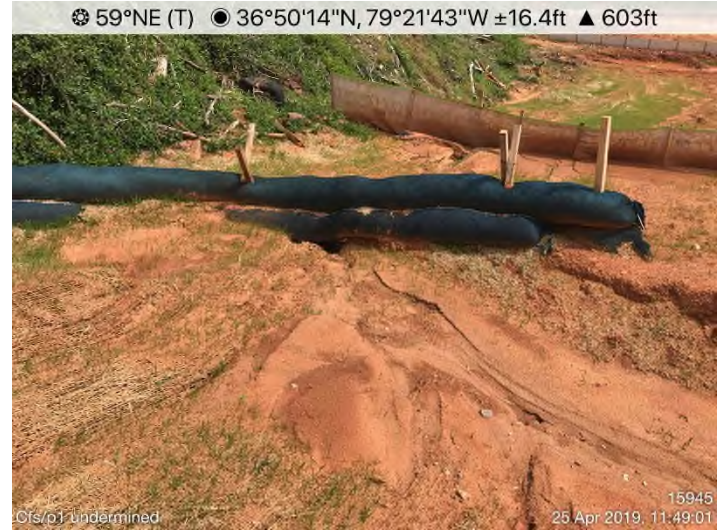
Fig. 6: **STA 15945+00** – CFS and P1 undermined.

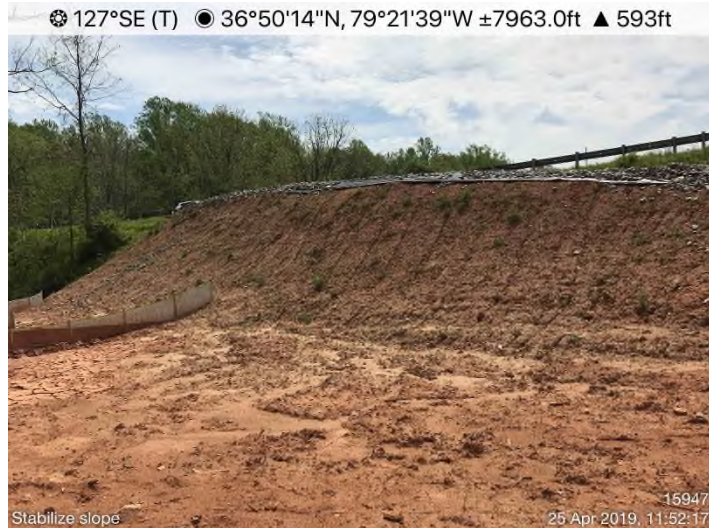
Fig. 7: **STA 15947+00** – Stabilize slope.

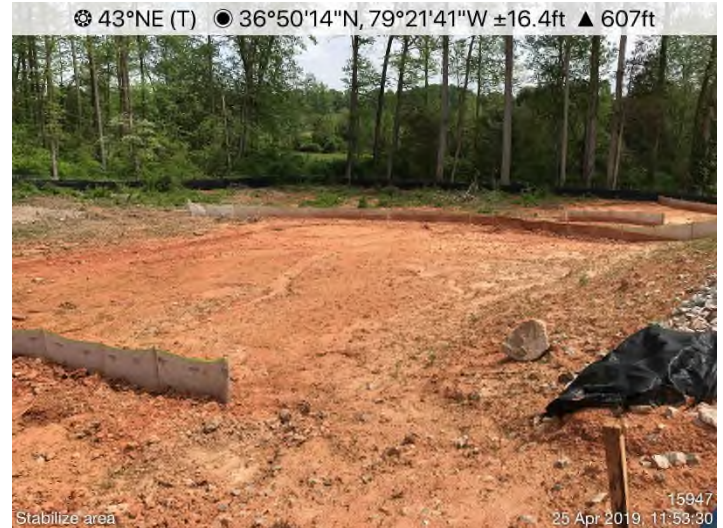
Fig. 8: **STA 15947+00** – Stabilize area.
