## FIELD INSPECTION

| Project Name: | Mountain Valley Pipeline | Inspector: | Marshall Willis |
| Inspection Date: | Monday, April 22, 2019 | Project Contact: | Brian Clauto |
| Spread I:<br>Franklin County | STA 13626+10 – 13644+52 | Weather (Wet/Dry/Rain): | Wet |

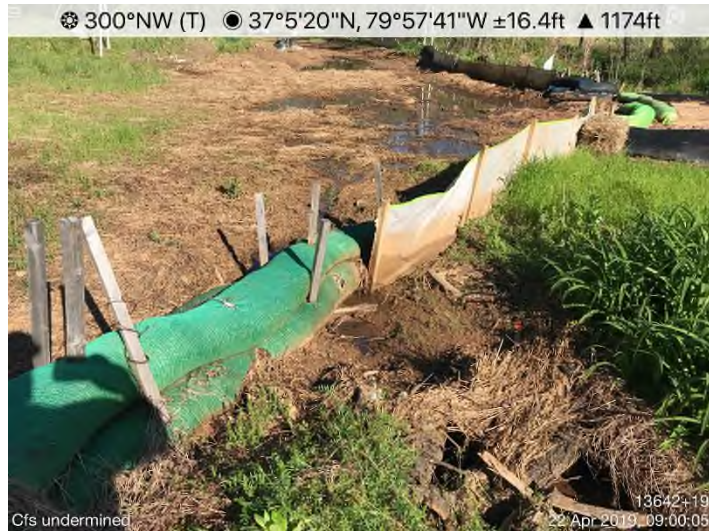
STA 13642+19: CFS undermined on CIS of S-E28.

Fig. 1: **STA 13642+19** – CFS undermined CIS S-E28.

**Recommended Corrective Action:** Maintain and install all controls per the approved plan and specs.

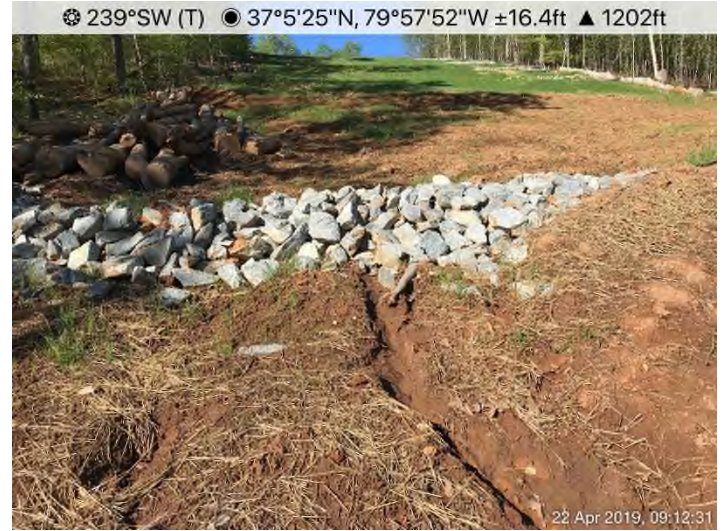
STA 13630+00 – STA 13631+50: Erosion on downslope side of permanent waterbar end treatments.

Fig. 2: **STA 13630+00 – 13631+50** – Erosion below permanent waterbars.

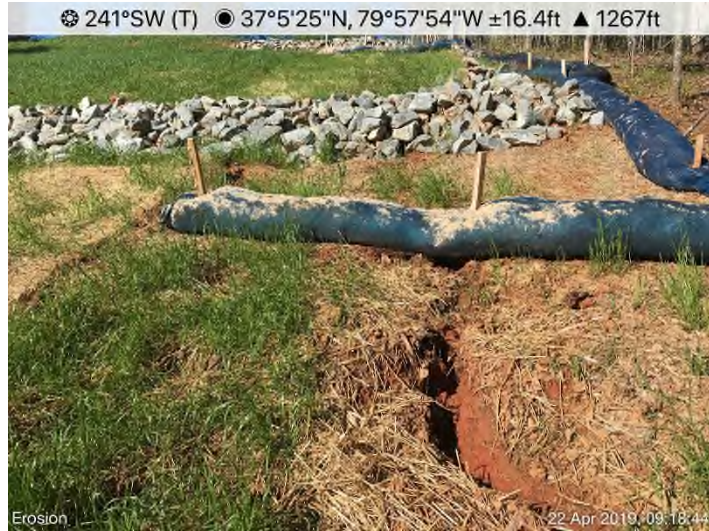
Fig. 3: **STA 13630+00 – 13631+50** – Erosion below permanent waterbars.

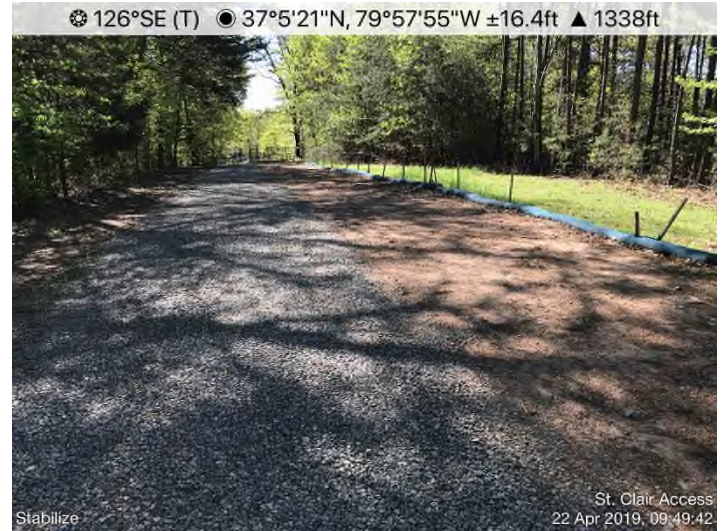
St. Clair Access Road: Stabilize shoulders of access road.

Fig. 4: **St. Clair Access Road** – Stabilize shoulder of access road.
