## FIELD INSPECTION

| Project Name: | Mountain Valley Pipeline | Inspector: | Marshall Willis |

## FIELD INSPECTION PHOTO LOG

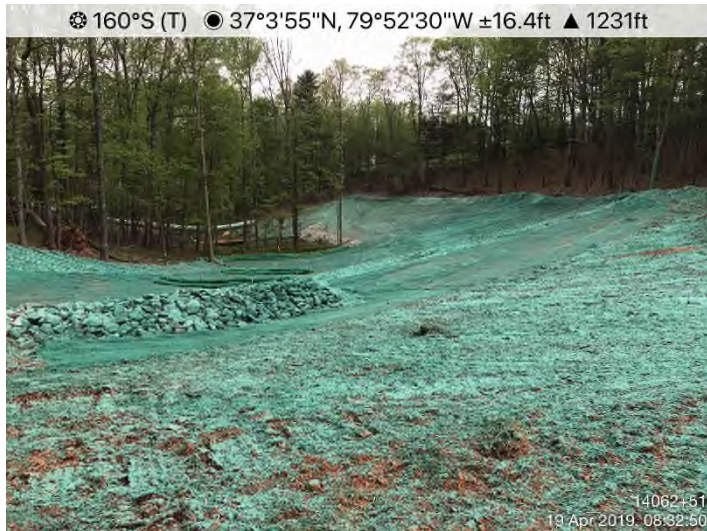
Fig. 1: **STA 14062+51** – Controls in place.

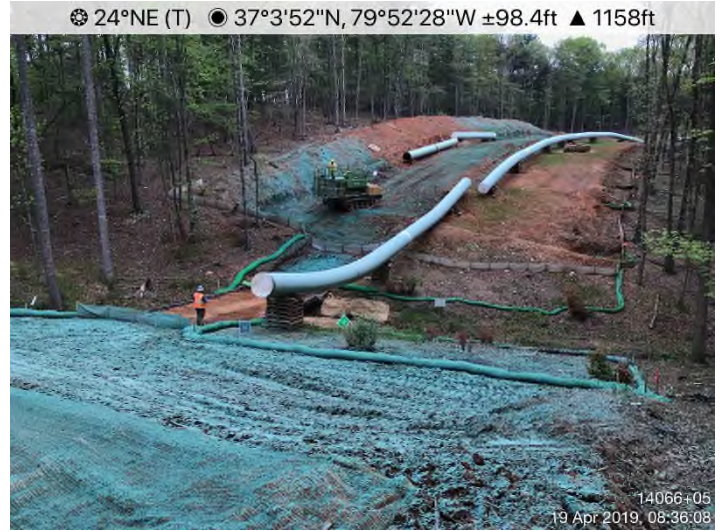
Fig. 2: **14066+05** – Controls in place. Hydro-seeding in progress.

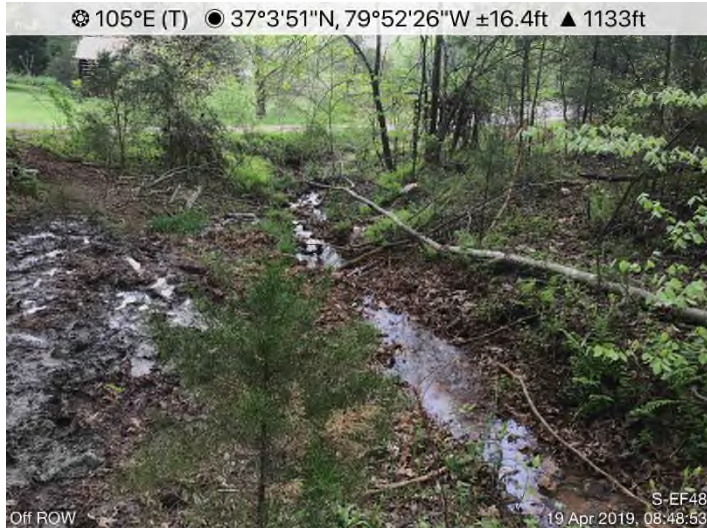
Fig. 3: **S-EF48** – Downstream following clean up.

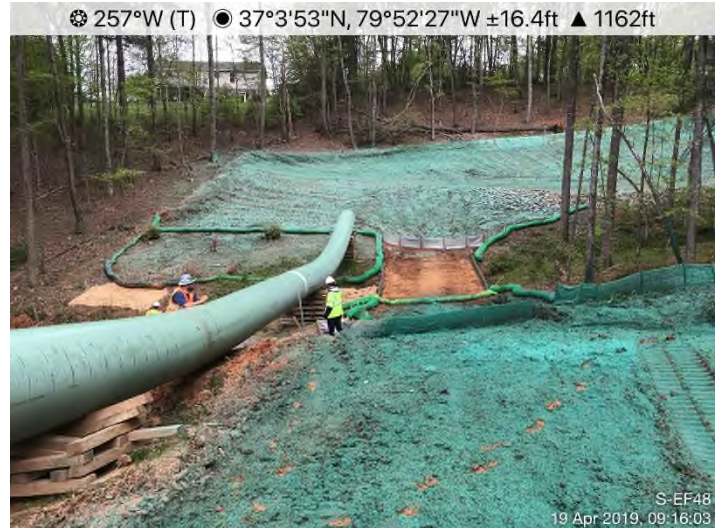
Fig. 4: **S-EF48** – Controls in place.
