## FIELD INSPECTION

| <b>Project Name:</b> | Mountain Valley Pipeline | <b>Inspector:</b> | Matthew Grant |
| <b>Inspection Date:</b> | Tuesday, April 16, 2019 | <b>Project Contact:</b> | Brian Clauto |

## FIELD INSPECTION PHOTO LOG

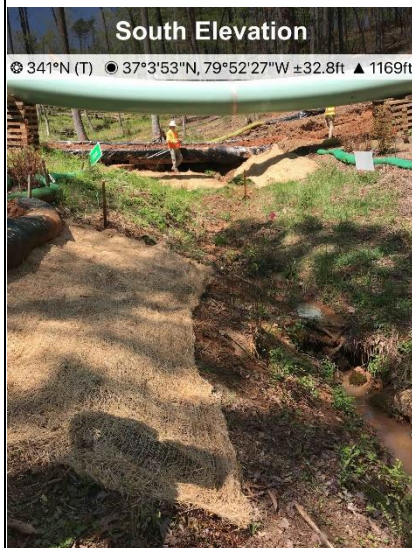
- Fig. 1 Designated stream S-EF46 has been impacted with sediment, remove sediment

**Recommended Corrective Action:** Maintain all controls per the approved plan and specs, remove sediment per DEQ approval.

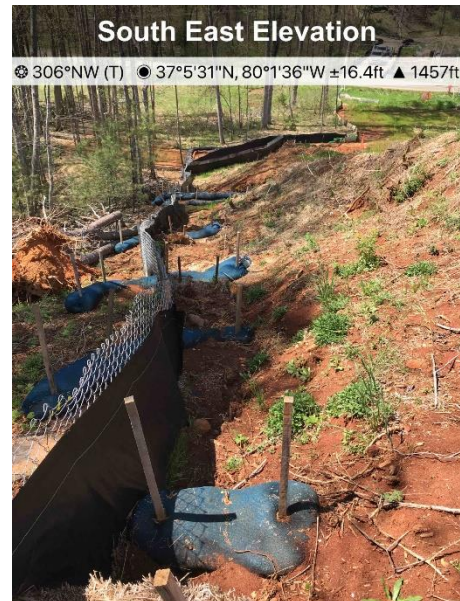
- Fig. 2 St#13416+54 through 13418+00 check dams require maintenance and stabilization of conveyance channel

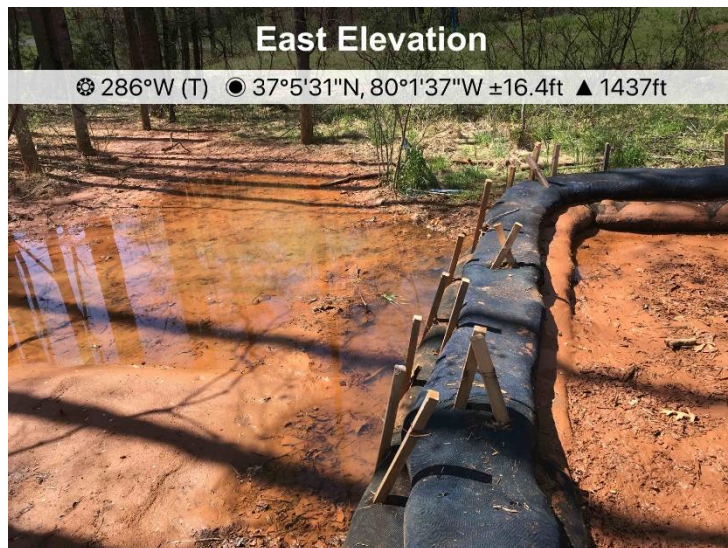
- Fig. 3 St#13416+23 sediment is off of ROW, remove sediment

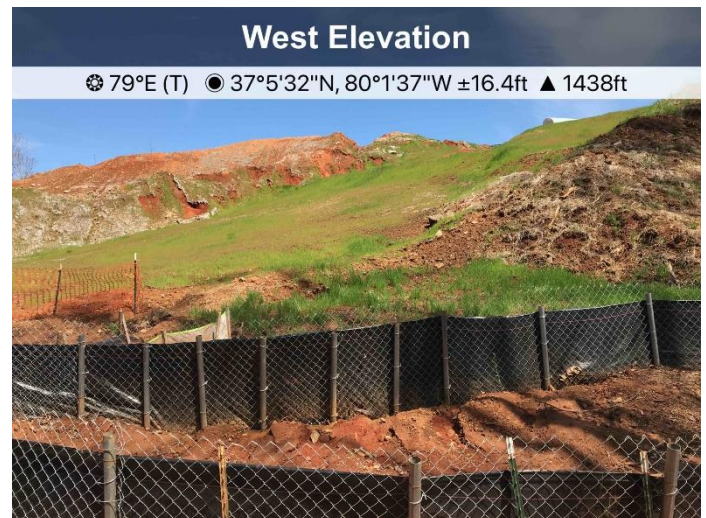
- Fig. 4 St#13418+99 stockpiles require re stabilization

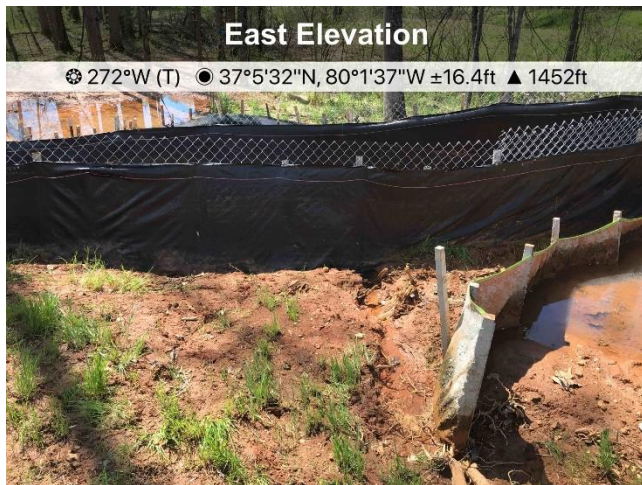
- Fig. 5 St#13416+23 end treatment SSF is undermined and bare areas require stabilization
