## FIELD INSPECTION

| Project Name: | Mountain Valley Pipeline | Inspector: | Marshall Willis |
| Spread I:<br>Franklin County | STA 14524+76 – 14549+84<br>STA 14616+62 – 14649+47 | Weather (Wet/Dry/Rain): | Rainy |

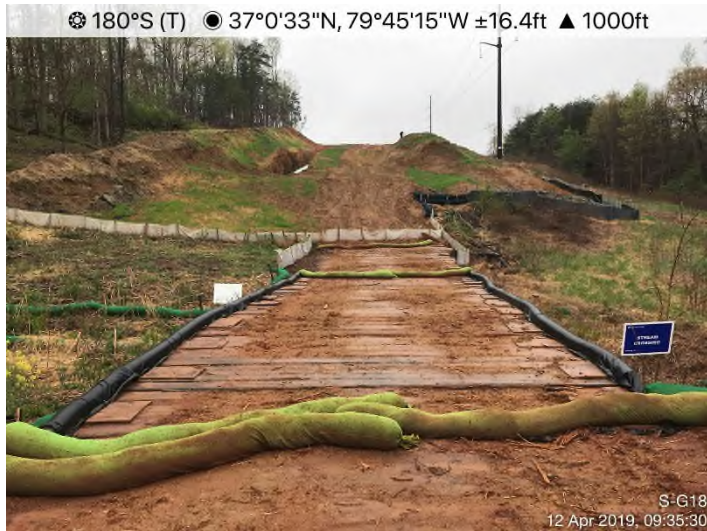
Comments: Inspected the following resources: S-G18.

Fig. 1: **S-G18** – Controls in place.

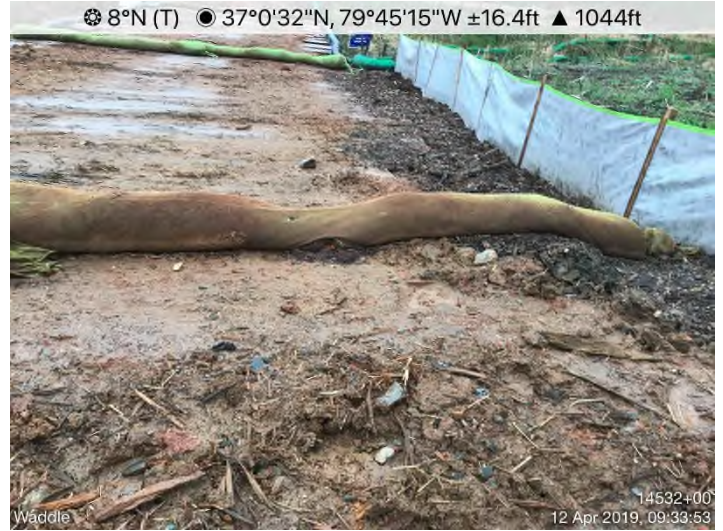
STA 14532+00: Replace waddle.

Fig. 2: **STA 14532+00** – Repair/replace waddle.

**Recommended Corrective Action:** Maintain and install all controls per the approved plan and specs.

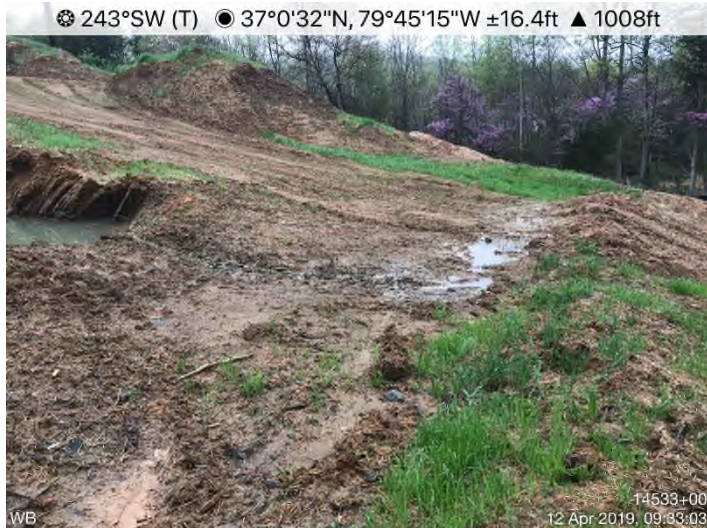
STA 14533+00: Waterbar not per spec.

Fig. 3: **STA 14533+00** – Waterbar not per spec.

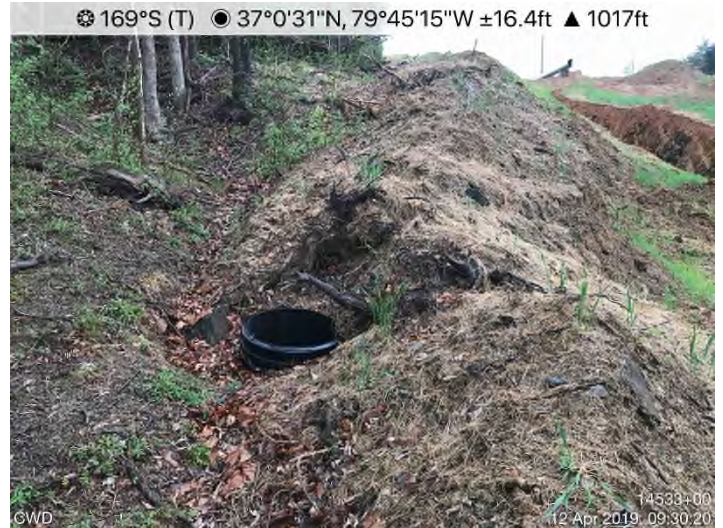
STA 14533+00: CWD does not have inlet protection. Inlet elevation too high.

Fig. 4: **STA 14533+00** – No inlet protection. Inlet too high.

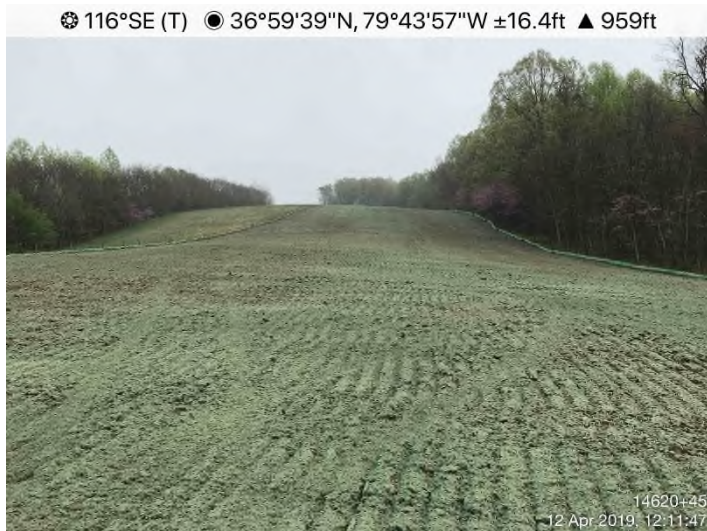
Fig. 5: **STA 14620+45** – Area at final stabilization.

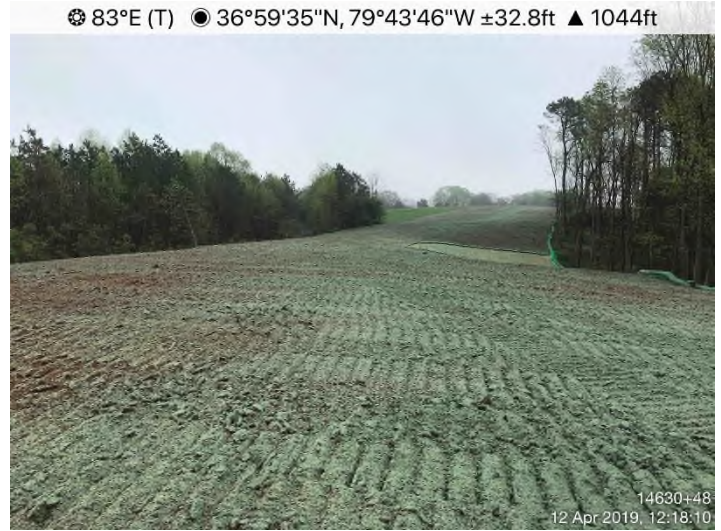
Fig. 6: **STA 14630+48** – Area at final stabilization..

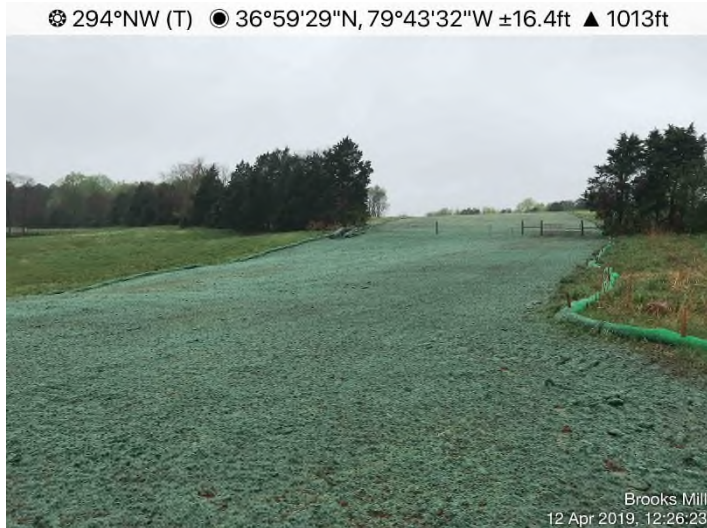
Fig. 7: **STA 14644+45** - Area at final stabilization.

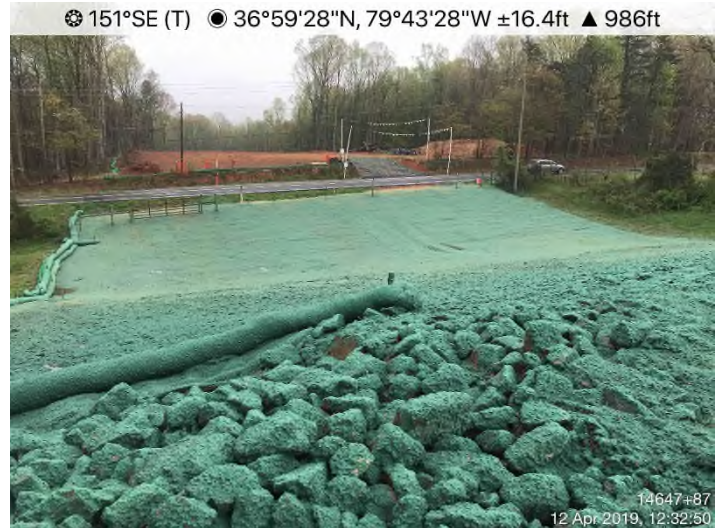
Fig. 8: **STA 14647+87** – Area at final stabilization.
