## FIELD INSPECTION

| <b>Project Name:</b> | Mountain Valley Pipeline | <b>Inspector:</b> | Matthew Grant |
| <b>Inspection Date:</b> | Wednesday, April 10, 2019 | <b>Project Contact:</b> | Brian Clauto |

## FIELD INSPECTION PHOTO LOG

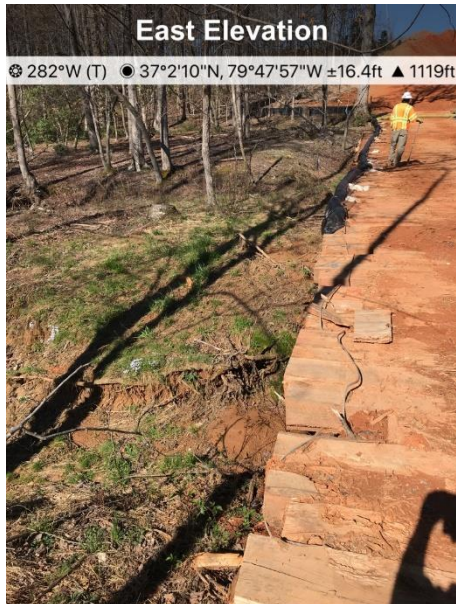
- Fig. 1 Designated stream SA-40 has been impacted this area was inspected and noted for corrective action on 4-9-19.

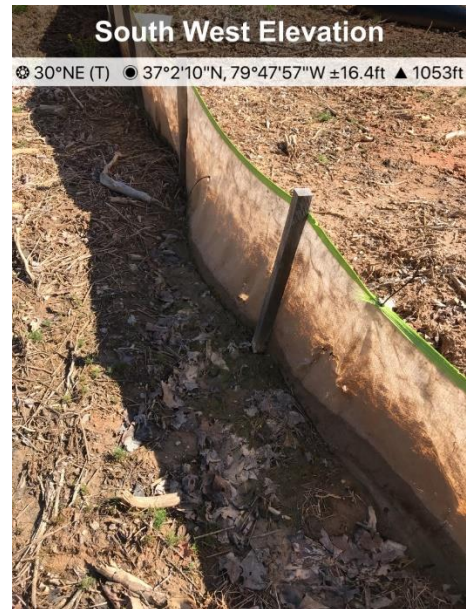
- Fig. 2 St#14354+10 hole in P1 fence

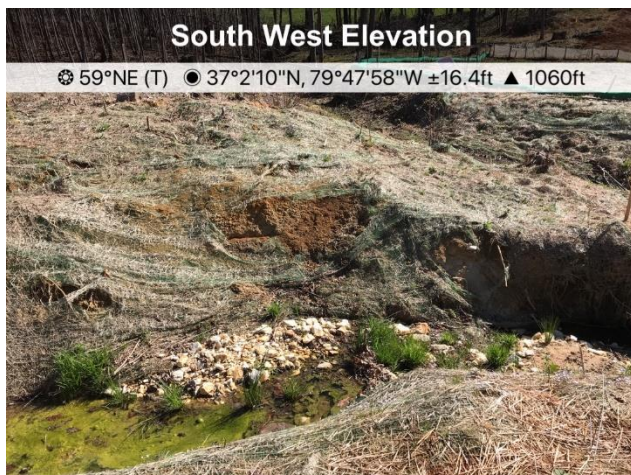
- Fig. 3 St#14353+17 bank stabilization matting has fallen off slope

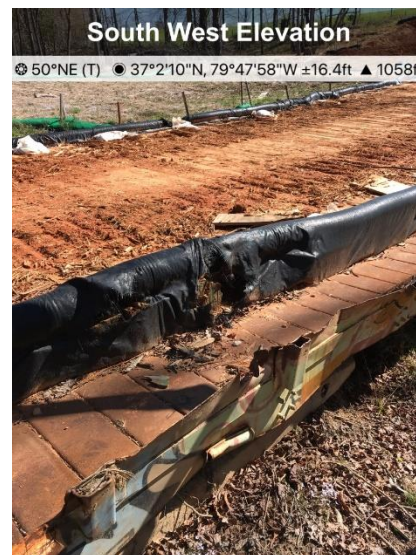
- Fig. 4 St#14354+20 hole in sidewall protection of bridge

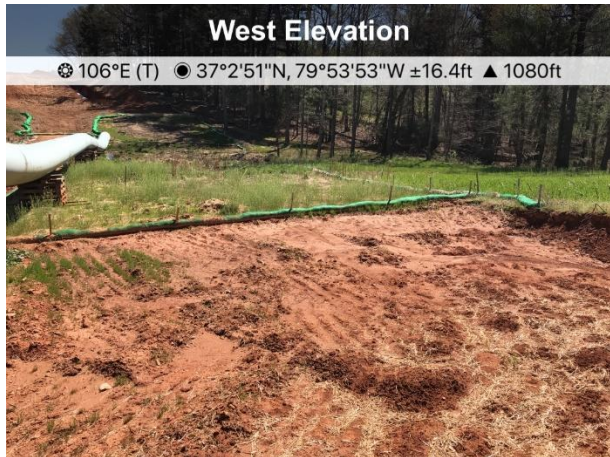
- Fig. 5 St#13948+80 re-stabilization required before aquatic resource

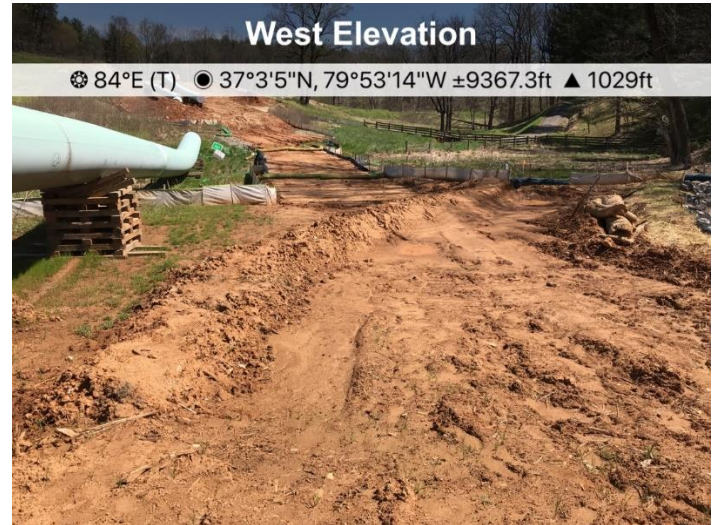
- Fig. 6 St#13990+31 re-stabilization required before aquatic resource
