## FIELD INSPECTION

<b>Project Name:</b>	Mountain Valley Pipeline	<b>Inspector:</b>	Marshall Willis
<b>Inspection Date:</b>	Friday, April 5, 2019	<b>Project Contact:</b>	Brian Clauto
<b>Spread I: Pittsylvania County</b>	H-603 STA 8+12 – STA 14+00 Transco Interconnect SWP H-602 STA 11+98 STA 16020+97 – STA 16006+05	<b>Weather (Wet/Dry/Rain):</b>	Rainy

## FIELD INSPECTION PHOTO LOG

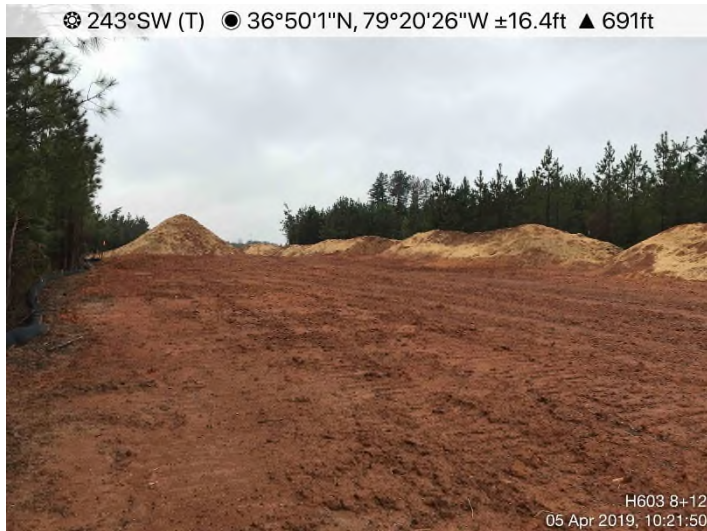
Fig. 1: **H-603 STA 8+12** – Area adequately stabilized with Earth Guard. Controls in place.

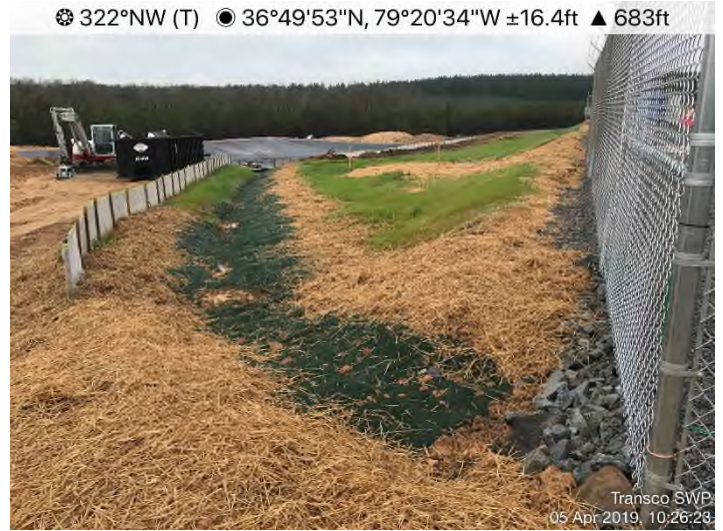
Fig. 2: **Transco Stormwater Pond** – Inlet channel K (CH-K).

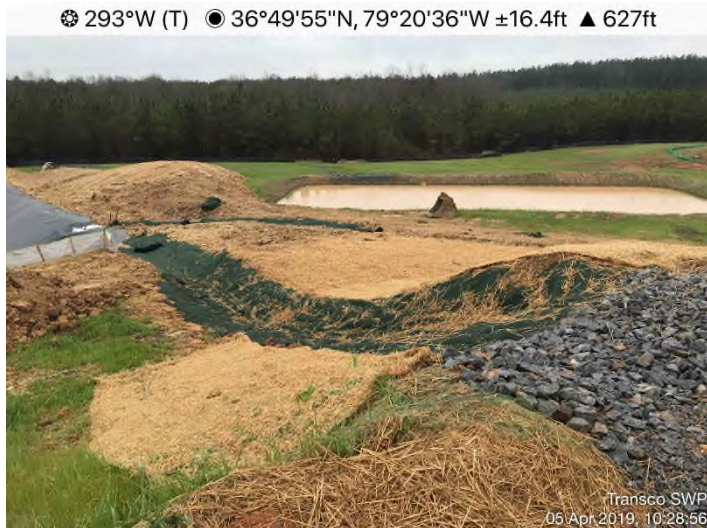
Fig. 3: **Transco Stormwater Pond** – Inlet channel J (CH-J).

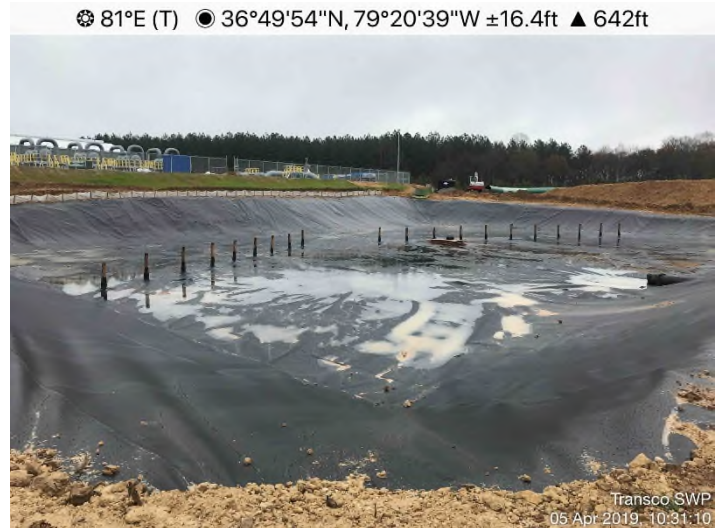
Fig. 4: **Transco Stormwater Pond** – Liner and baffle installation.

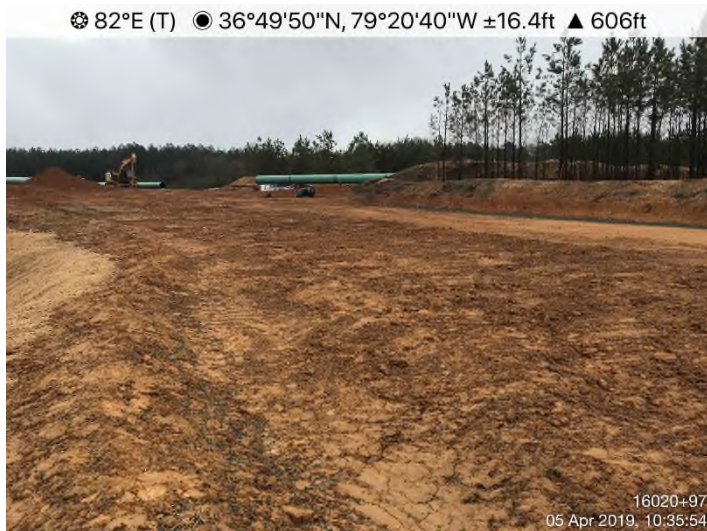
Fig. 5: **STA 16020+97** – Area adequately stabilized with Earth Guard. Controls in place.

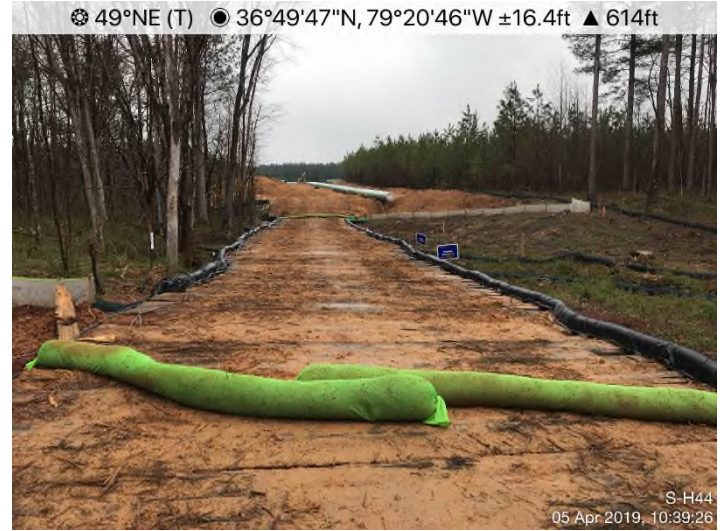
Fig. 6: **S-H44** – Area adequately stabilized. Controls in place.

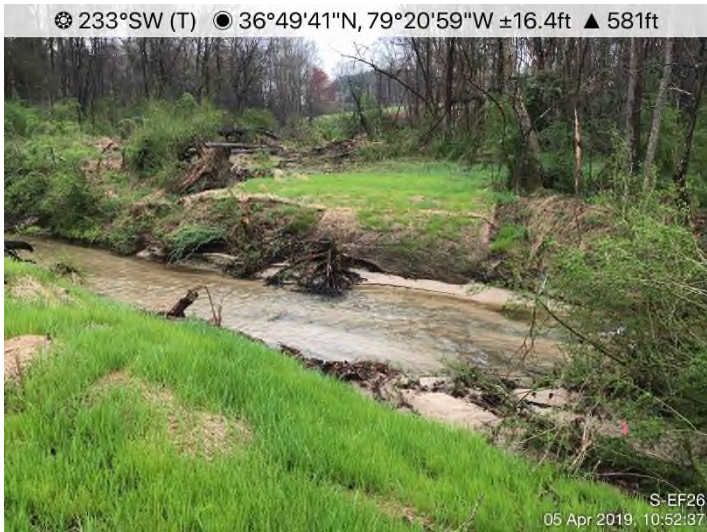
Fig. 7: **S-EF26** – Area adequately stabilized. Controls in place.

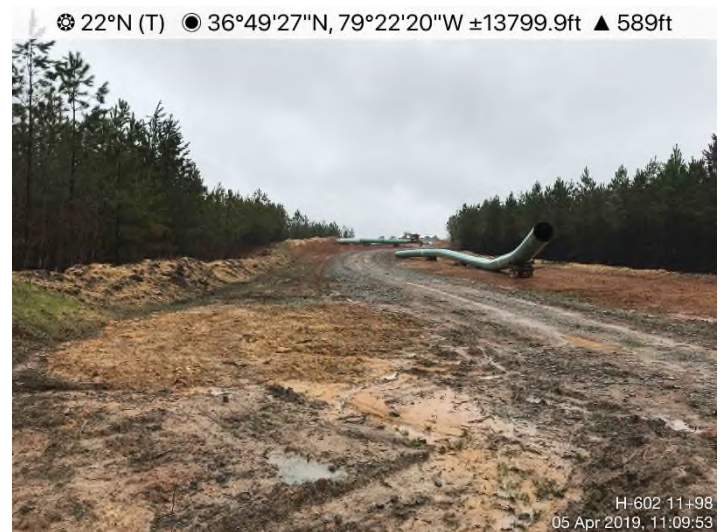
Fig. 8: **H-602 STA 11+96** – Area adequately stabilized with Earth Guard. Controls in place.
