## FIELD INSPECTION

| <b>Project Name:</b> | Mountain Valley Pipeline | <b>Inspector:</b> | Matthew Grant |
| <b>Inspection Date:</b> | Thursday, April 4, 2019 | <b>Project Contact:</b> | Brian Clauto |

## FIELD INSPECTION PHOTO LOG

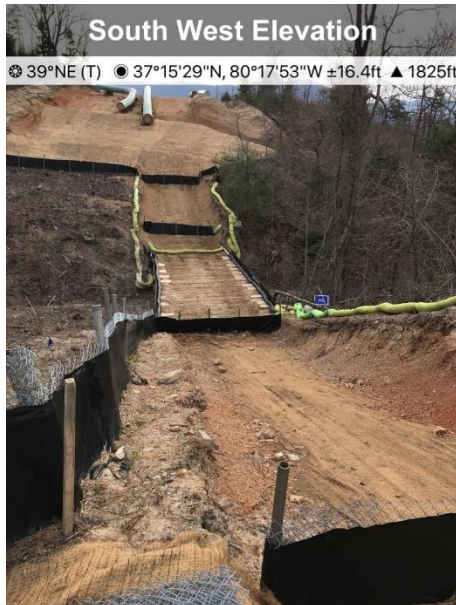
- Fig. 1 Near S-MM 15, area has been stabilized and ECD's are in place

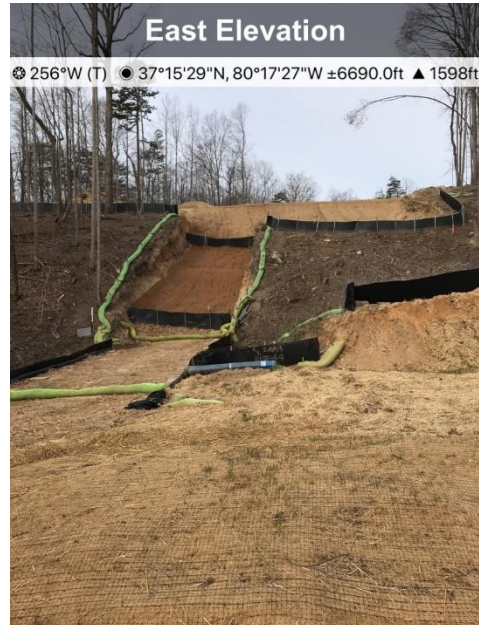
- Fig. 2 Near S-MM13, area has been stabilized and ECD's are in place

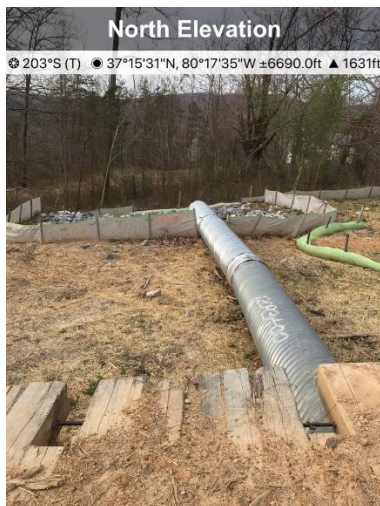
- Fig. 3 CWD in place and functioning at St#12003+00

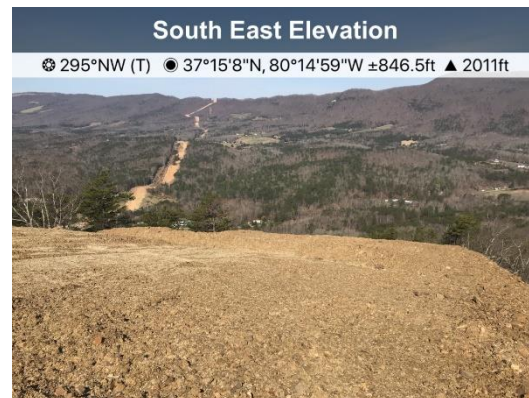
- Fig. 4 Near St#12233+77 area has been stabilized
