## FIELD INSPECTION

| Project Name: | Mountain Valley Pipeline | Inspector: | Marshall Willis |
| Spread I:<br>Franklin County | STA 14546+85 – 14599+24 | Weather (Wet/Dry/Rain): | Dry |

## FIELD INSPECTION PHOTO LOG

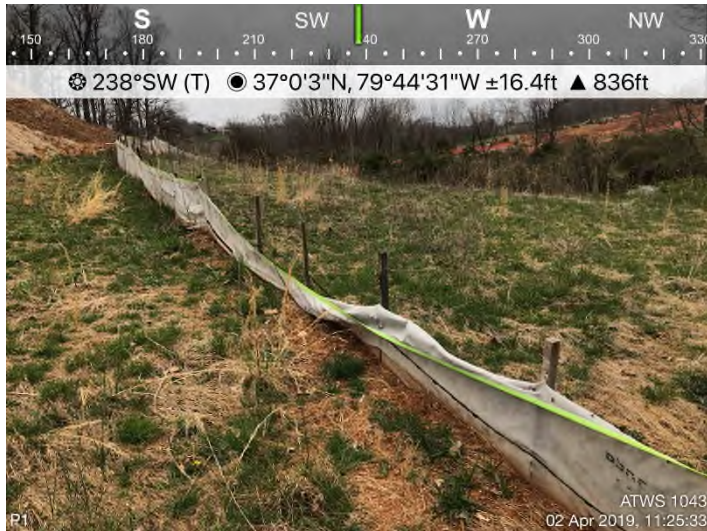
STA 14583+56: Repair P1.  
STA 14549+84: No inlet protection on CWD.

Fig. 1: **STA 14583+56** – ATWS 1043: Repair P1.

**Recommended Corrective Action:** Maintain and install all controls per the approved plan and specs.

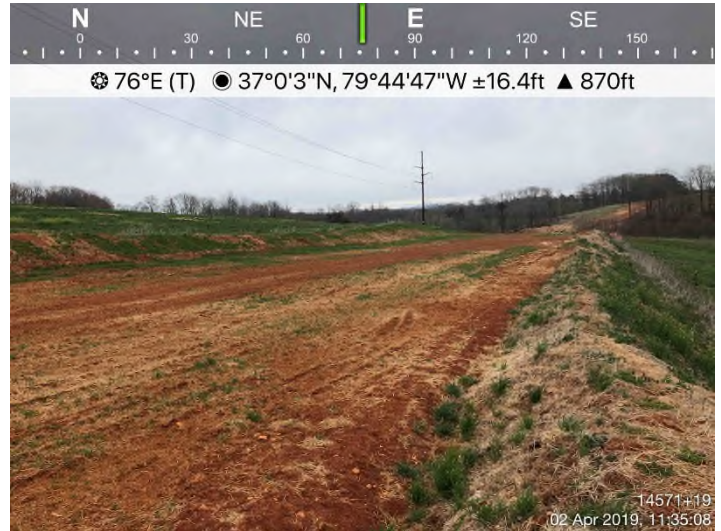
Fig. 2: **STA 14571+19** – Area adequately stabilized. Controls in place.

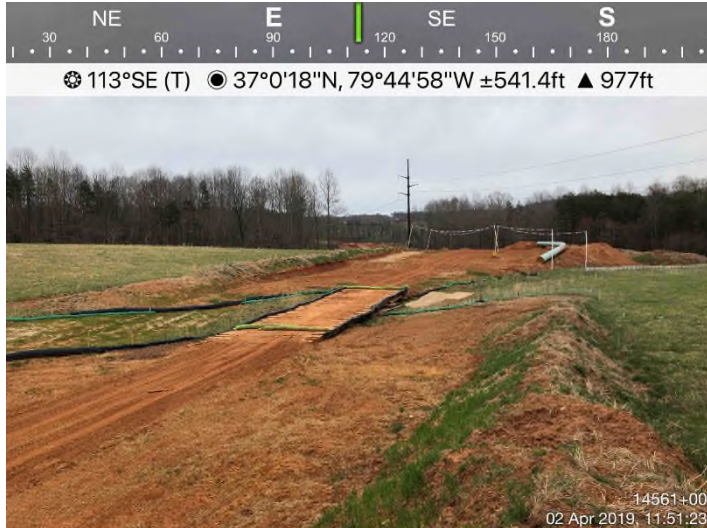
Fig. 3: **STA 14561+00** – Area adequately stabilized. Controls in place.

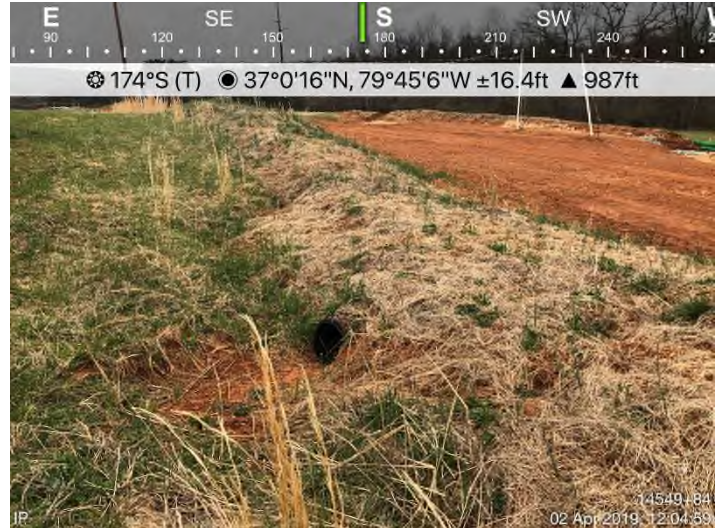
Fig. 4: **STA 14549+84** – CWD does not have inlet protection.
