## FIELD INSPECTION

| <b>Project Name:</b> | Mountain Valley Pipeline | <b>Inspector:</b> | Matthew Grant |
| <b>Inspection Date:</b> | Wednesday, March 27, 2019 | <b>Project Contact:</b> | Brian Clauto |

## FIELD INSPECTION PHOTO LOG

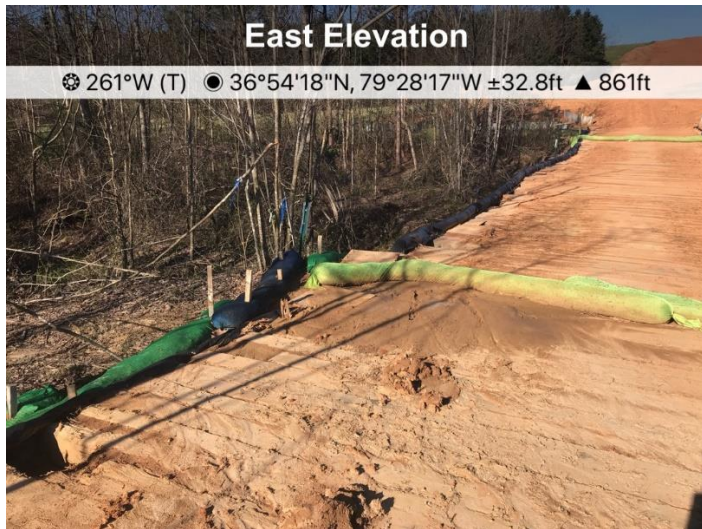
- Fig. 1 St#15508+15 CFS on bridge and to the side of bridge requires clean out.

**Recommended Corrective Action:** Maintain all controls per the approved plan and specs, remove sediment per DEQ approval.

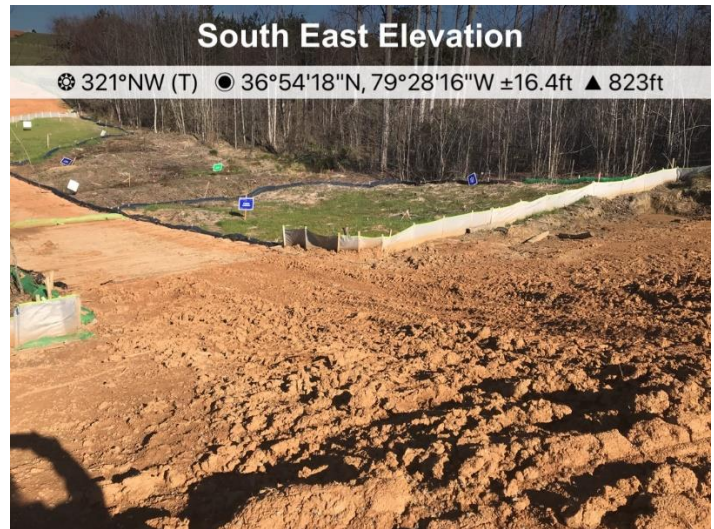
- Fig. 2 St#15508+55 stabilization from waterbar to the stream crossing bridge requires stabilization

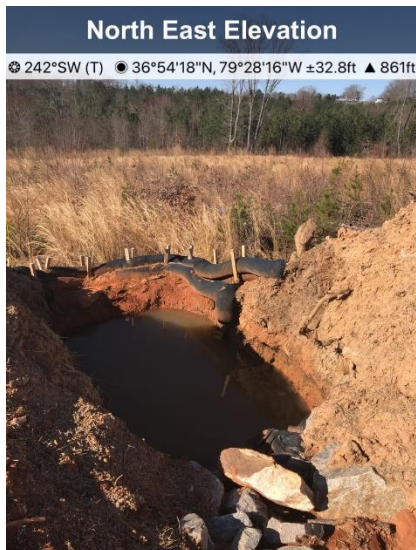
- Fig. 3 St# 15514+00 sump end treatment is falling into sump

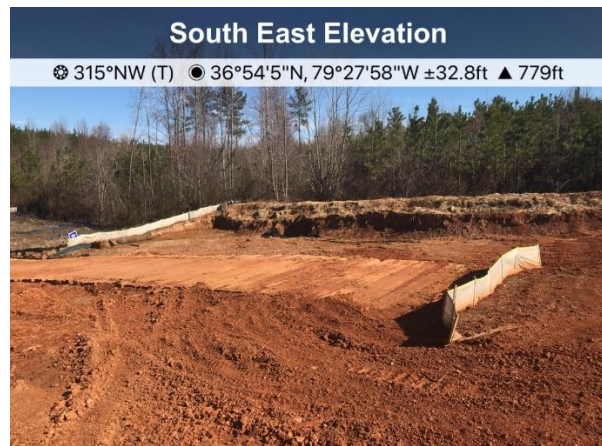
- Fig. 4 St# St#15529+00 stabilization from waterbar to the stream crossing bridge requires stabilization

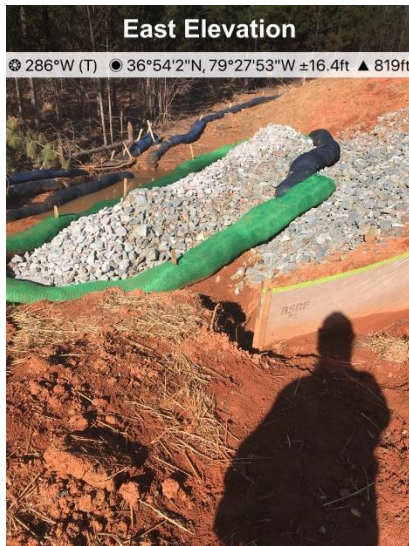
- Fig. 5 St#15534+00 P1 fence near CWD has eroded on side

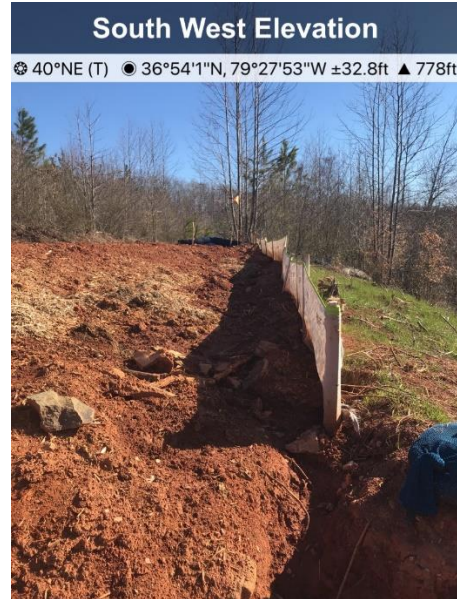
- Fig. 6 St#15541+00 sump not allowing water off of the ROW

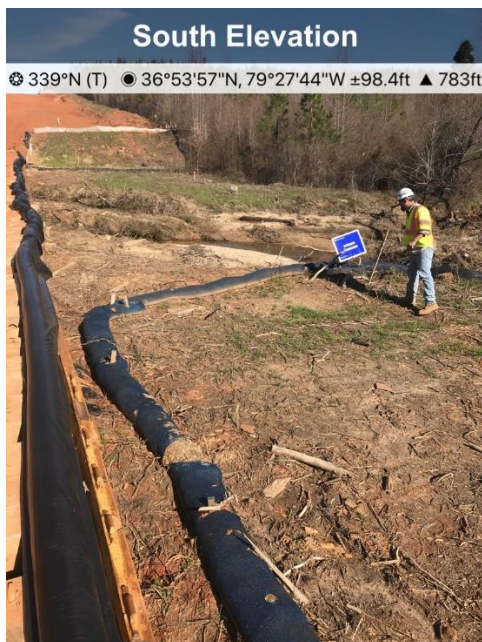
- Fig. 7 St#15543+00 at SCC5 buffer area CFS has a hole in it

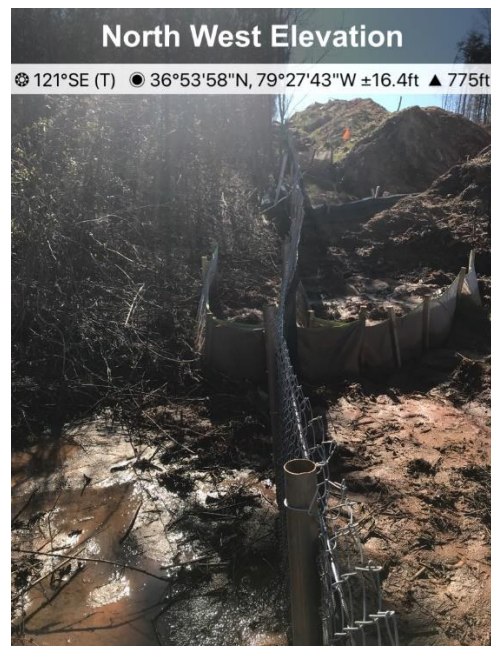
- Fig. 8 St#15543+20 sediment has escaped off of ROW

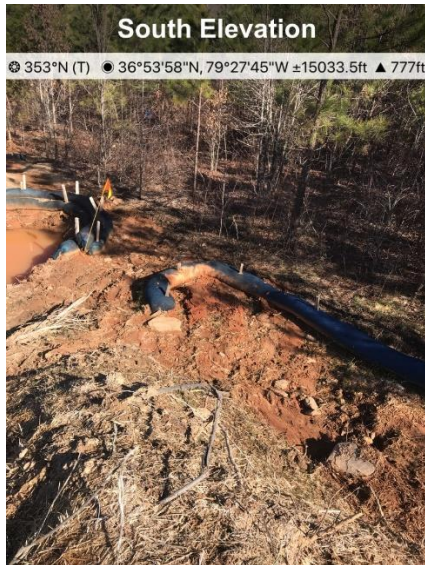
- Fig. 9 St#15546+00 CFS at j hook is full

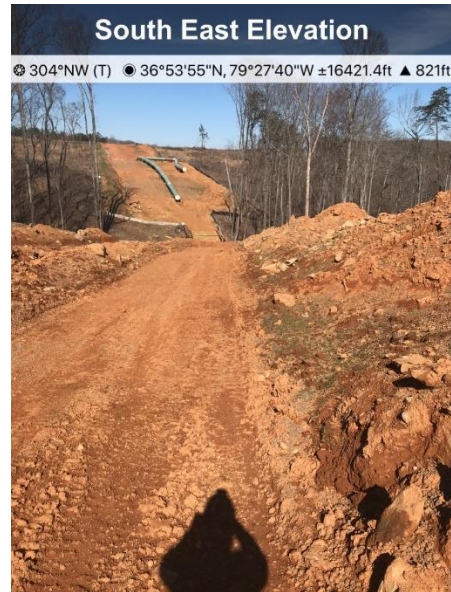
- Fig. 10 St#15564+70 waterbar does not go the full length

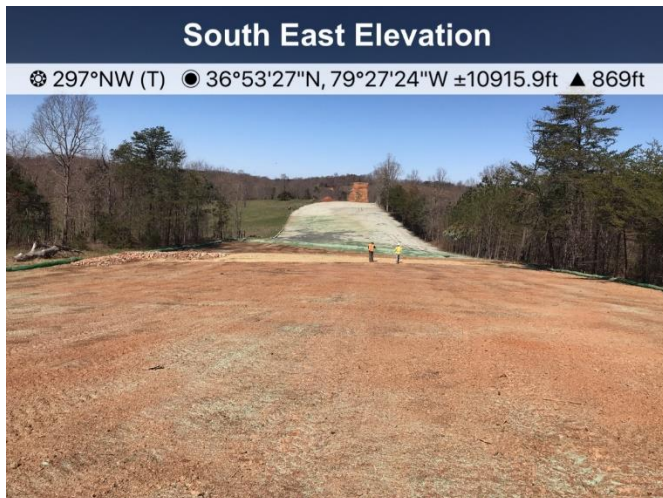
Fig. 11 Near MP287 final restoration in process
