## FIELD INSPECTION

| Project Name: | Mountain Valley Pipeline | Inspector: | Marshall Willis |
| Inspection Date: | Friday, March 22, 2019 | Project Contact: | Brian Clauto |
| Spread H:<br>Montgomery County | STA 12144+47 – 12188+34<br>STA 11993+00 – 12015+84 | Weather (Wet/Dry/Rain): | Dry |

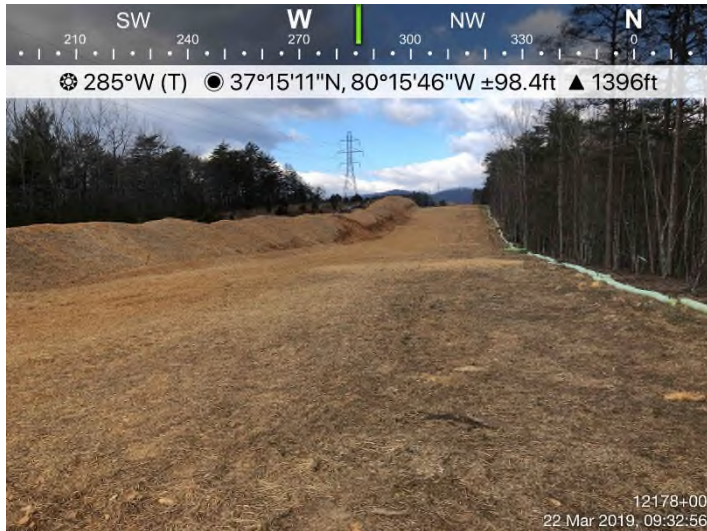
Fig. 1: **STA 12178+00** – Area adequately stabilized. Controls in place.

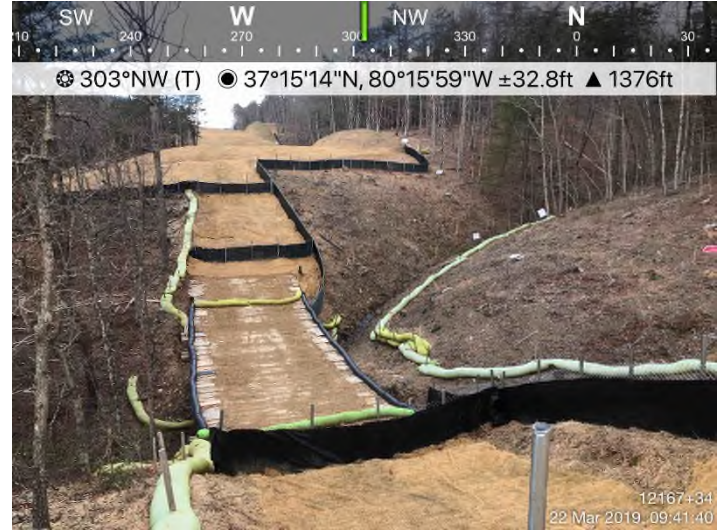
Fig. 2: **STA 12167+34** – Area adequately stabilized. Controls in place.

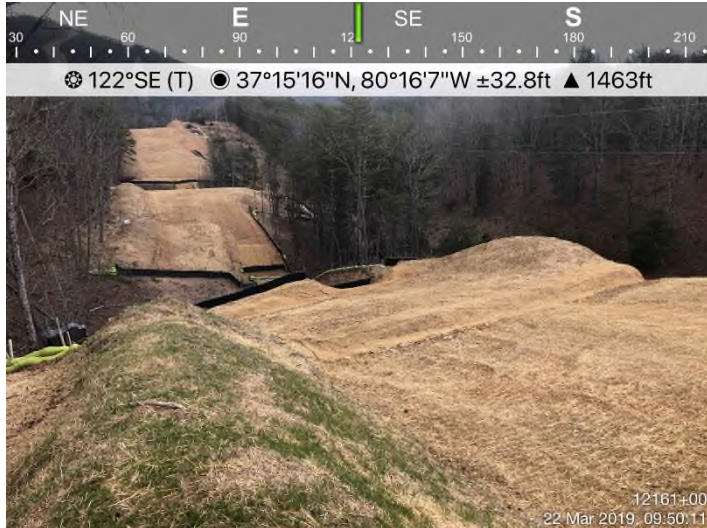
Fig. 3: **STA 12161+00** – Area adequately stabilized. Controls in place.

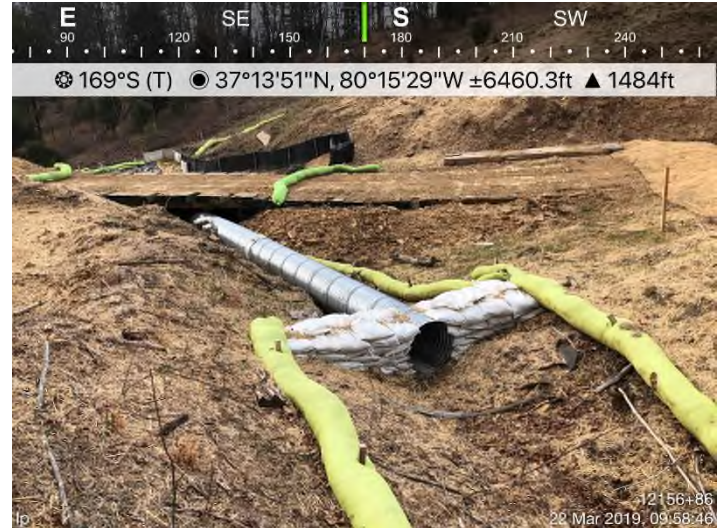
- STA 12156+86: CWD does not have inlet protection.
- STA 12168+75: Re-stake geo-fabric.

Fig. 4: **STA 12156+86** – CWD needs inlet protection.

**Recommended Corrective Action:** Maintain and install all controls per the approved plan and specs.

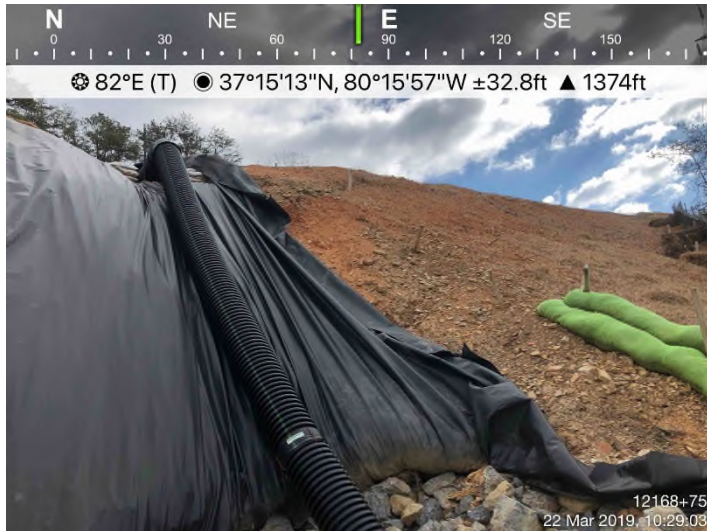
Fig. 5: **STA 12168+75** – Re-stake fabric.

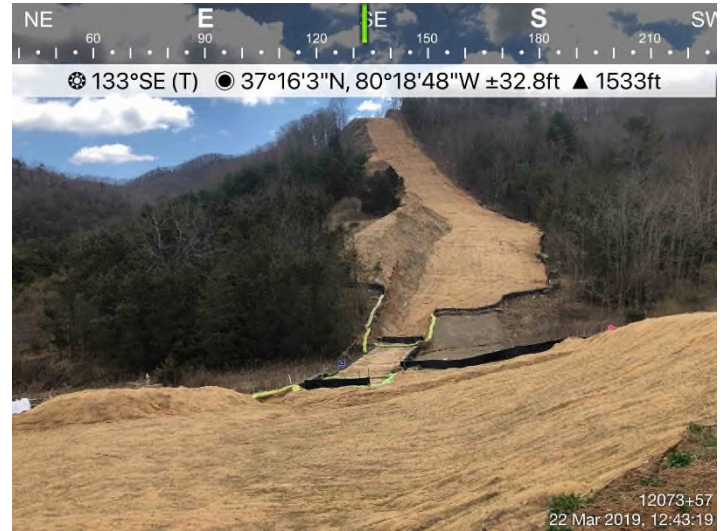
Fig. 6: **STA 12073+57** – Area adequately stabilized. Controls in place.

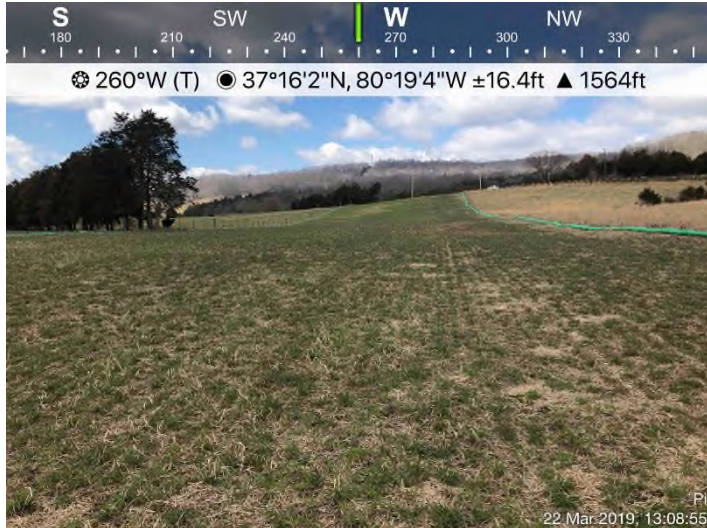
Fig. 7: **STA 12006+00** – Area adequately stabilized. Controls in place.

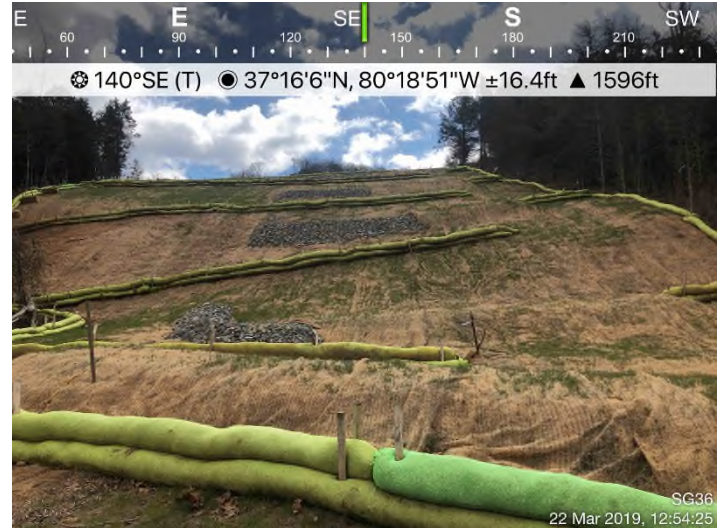
Fig. 8: **STA 12008+53** – Area adequately stabilized. Controls in place.
