## FIELD INSPECTION

<b>Project Name:</b>	<b>Mountain Valley Pipeline</b>	<b>Inspector:</b>	<b>Marshall Willis</b>
<b>Inspection Date:</b>	<b>Thursday, March 21, 2019</b>	<b>Project Contact:</b>	<b>Brian Clauto</b>
<b>Spread I:</b> <b>Pittsylvania County</b>	<b>STA 15596+70 – 15619+48</b>	<b>Weather (Wet/Dry/Rain):</b>	<b>Rainy</b>

# FIELD INSPECTION PHOTO LOG

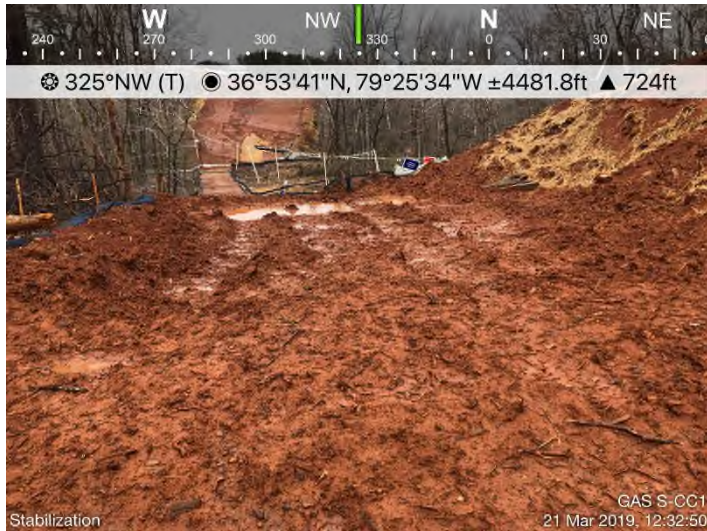
Fig. 1: **STA 15596+87 to STA 15600+12** - Stabilize travel lane, no Earth Guard present.

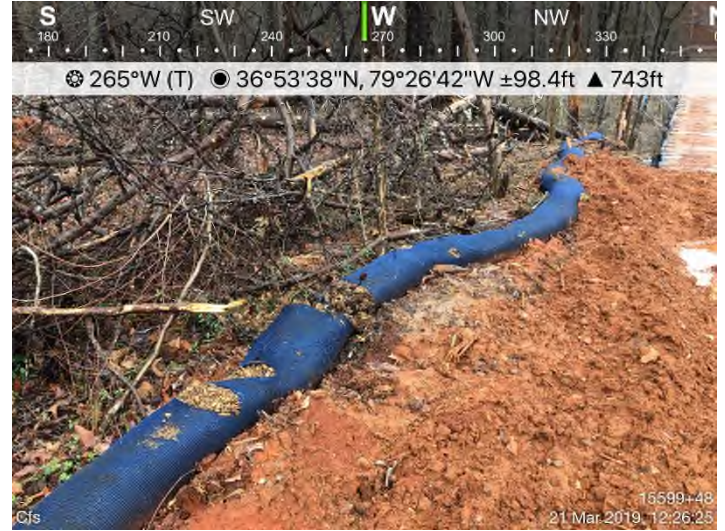
Fig. 2: **STA 15599+48** - Repair CFS.

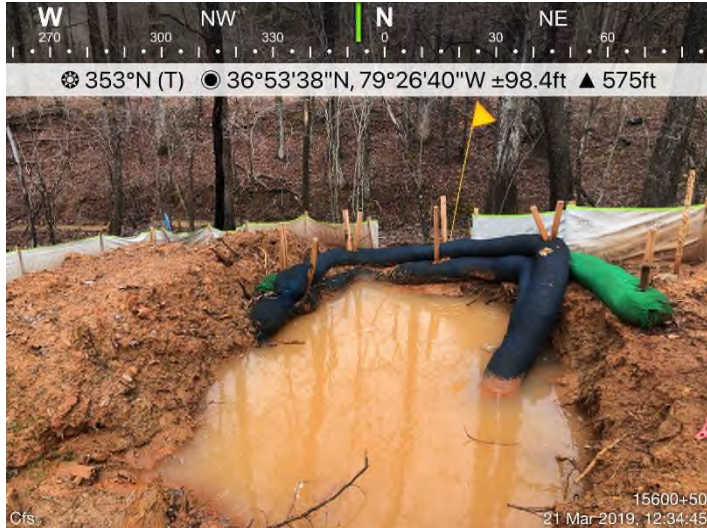
Fig. 3: **STA 15600+50** - Repair end treatment.

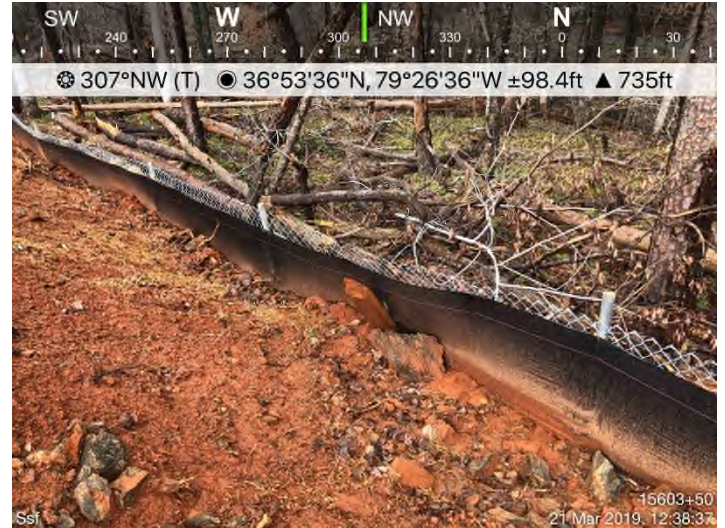
Fig. 4: **STA 15603+50** - Repair SSF.

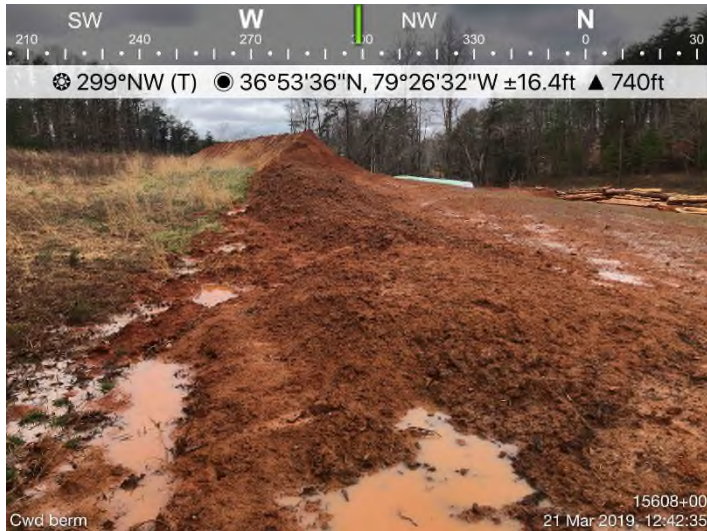
Fig. 5: **STA 15608+00** - Adequately stabilize perimeter CWD.

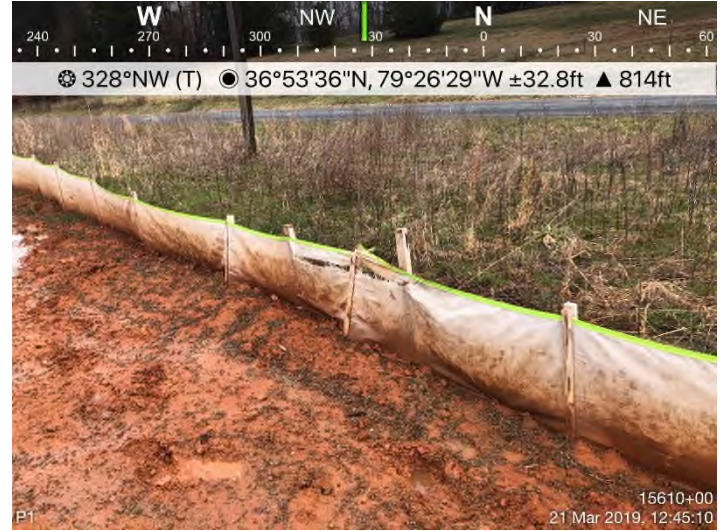
Fig. 6: **STA 15610+00** - Repair P1.

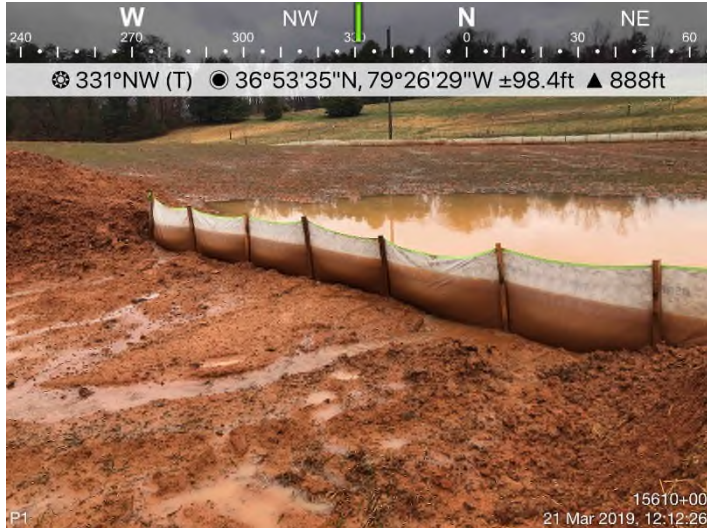
Fig. 7: **STA 15610+00** - P1 Undermined, clean out CFS.

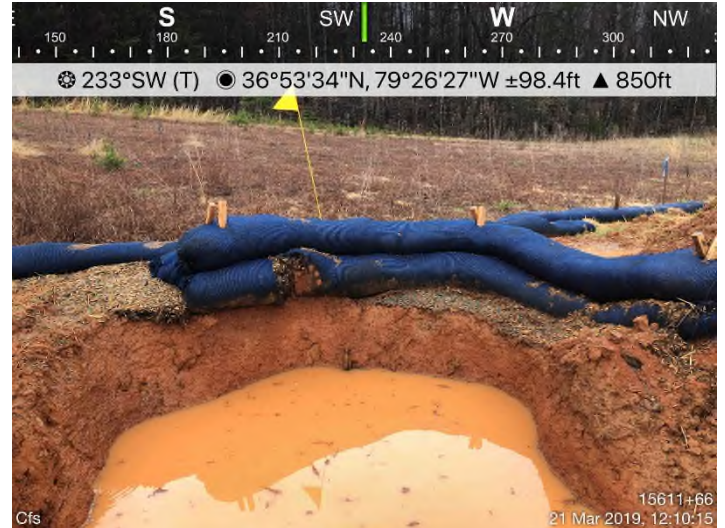
Fig. 8: **STA 15611+66** - Repair CFS.

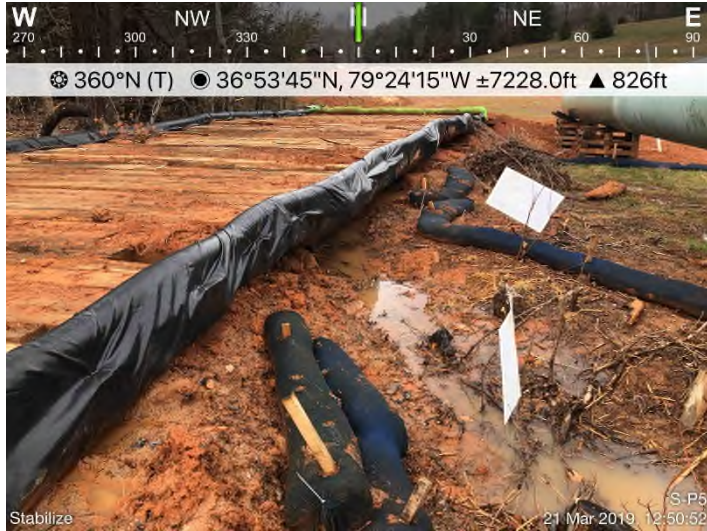
Fig. 9: **STA 15614+94** - (S-P5) Repair CFS, remove sediment, stabilize banks.

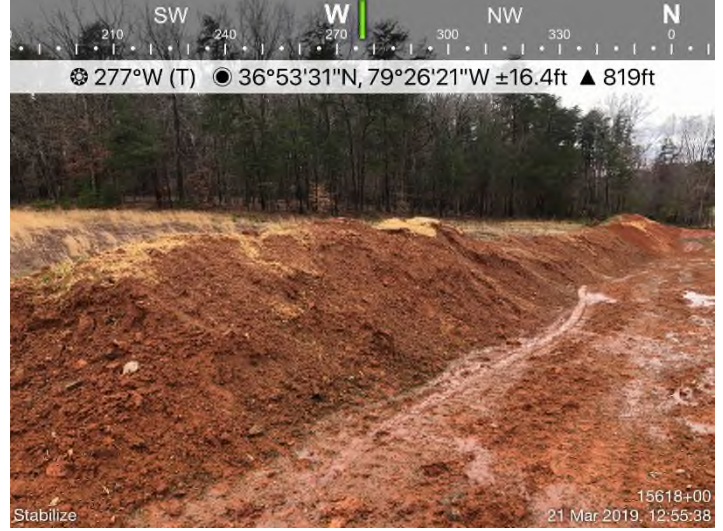
Fig. 10: **STA 15618+00** - Adequately stabilize perimeter CWD.
