## FIELD INSPECTION

Project Name:	Mountain Valley Pipeline	Inspector:	Marshall Willis
Inspection Date:	Wednesday, March 20, 2019	Project Contact:	Brian Clauto
Spread I: Franklin County	STA 13755+49 – 13784+95	Weather (Wet/Dry/Rain):	Dry

## FIELD INSPECTION PHOTO LOG

Project Name: Mountain Valley Pipeline Date: Wednesday, March 20, 2019

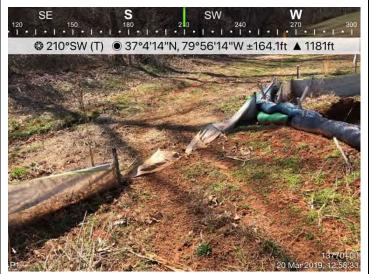
Fig. 1: **STA 13770+00** – Repair P1.

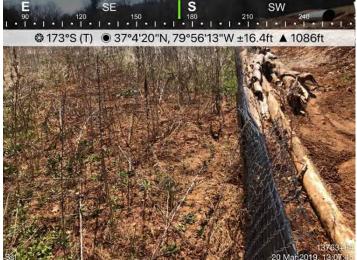
Fig. 2: **STA 13763+64** – SSF undermined. Sediment off ROW.

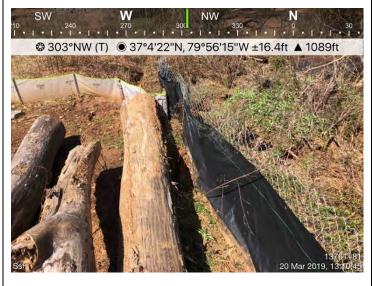
Fig. 3: **STA 13761+87** – SSF undermined.

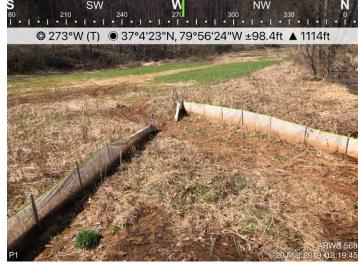
Fig. 4: **ATWS 568** – Repair P1.
