## FIELD INSPECTION

| <b>Project Name:</b> | Mountain Valley Pipeline | <b>Inspector:</b> | Matthew Grant |
| <b>Inspection Date:</b> | Wednesday, March 20, 2019 | <b>Project Contact:</b> | Brian Clauto |

## FIELD INSPECTION PHOTO LOG

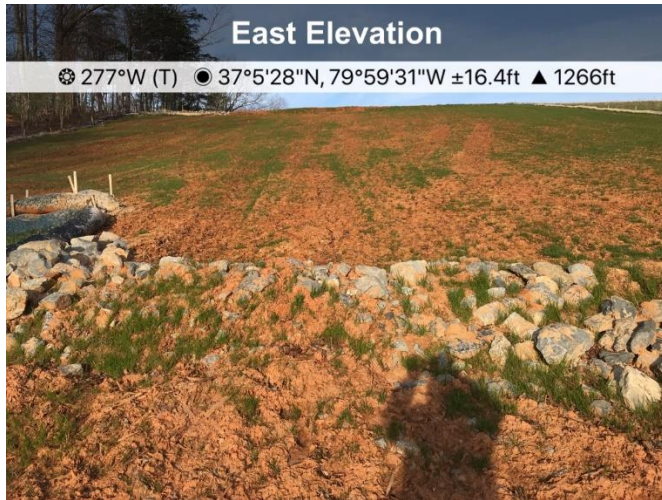
- Fig. 1 St#13539+14 Slope lacks adequate stabilization

**Recommended Corrective Action:** Maintain all controls per the approved plan and specs.

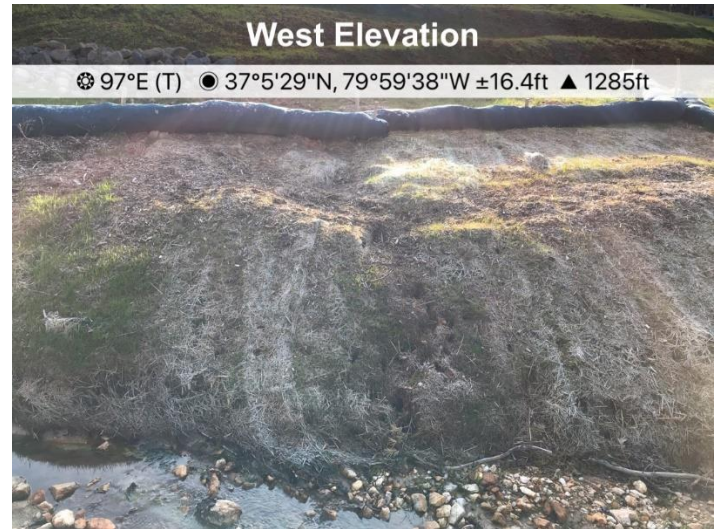
- Fig. 2 St#13533+52 Banks require repair and stabilization

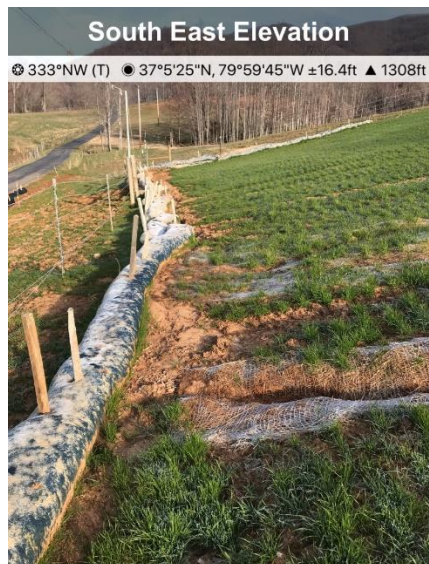
- Fig. 3 St#13528+00 Rills at farmer road crossing and CFS requires maintenance

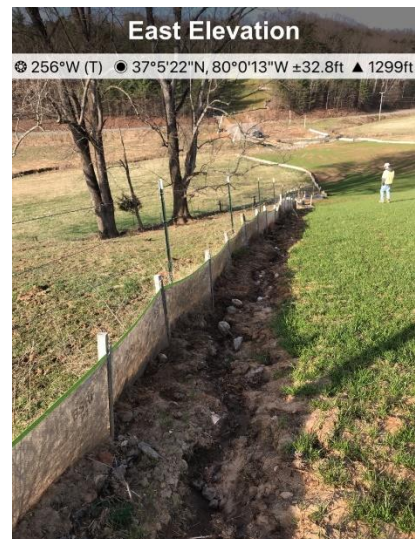
- Fig. 4 St#13500+00 Rill erosion along P1 SF and J-hook is overtopped

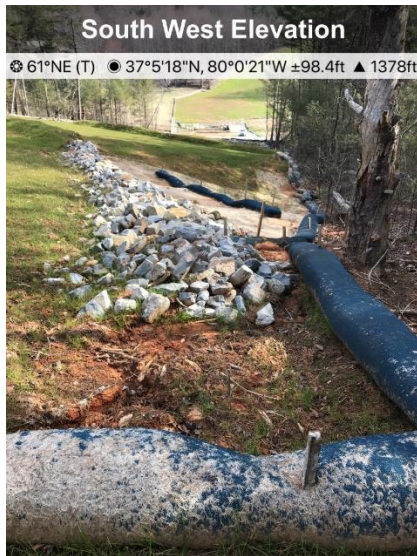
- Fig. 5 St#13494+00 Rill erosion above blanket matting

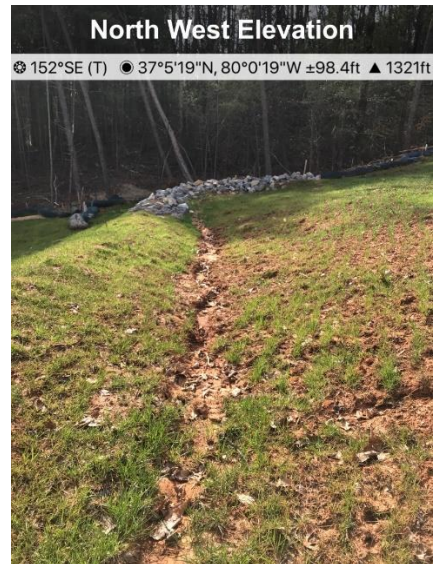
- Fig. 6 St#13496+00 Flow path of waterbar eroded

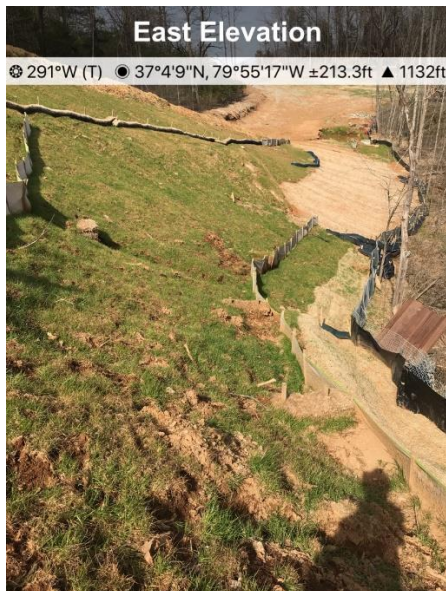
- Fig. 7 St#13818+60 P1 half the height with sediment/possible slip
