## FIELD INSPECTION

| <b>Project Name:</b> | Mountain Valley Pipeline | <b>Inspector:</b> | Marshall Willis |
| <b>Inspection Date:</b> | Tuesday, March 19, 2019 | <b>Project Contact:</b> | Brian Clauto |
| <b>Spread H:</b><br>Montgomery County<br>Roanoke County | STA 12054+00 – 12140+00<br>STA 12451+61 – 12460+00 | <b>Weather (Wet/Dry/Rain):</b> | Dry |

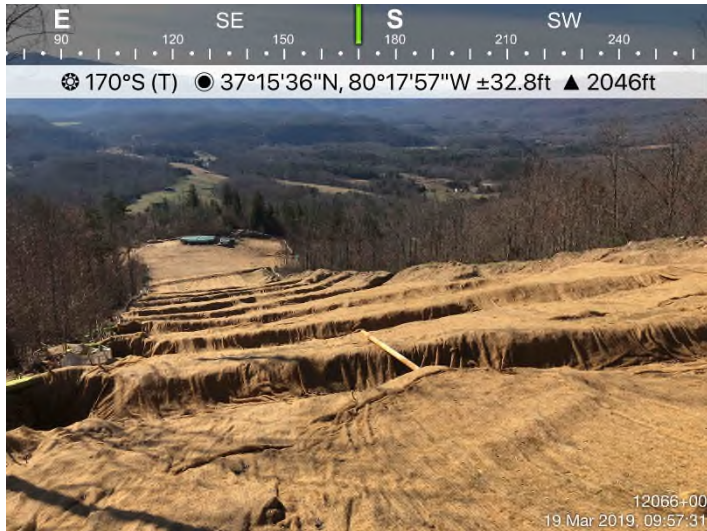
Fig. 1: **STA 12066+00**– Area adequately stabilized. Controls in place.

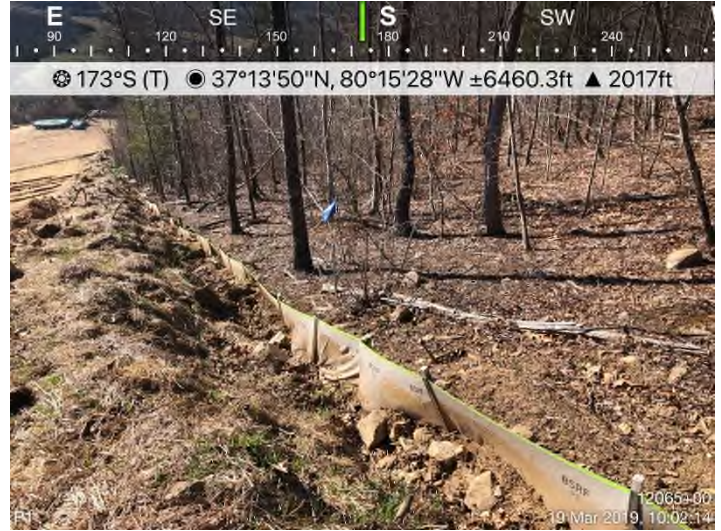
- STA 12065+00: P1 undermined at several locations along perimeter.
- STA 12092+80: CWD does not have inlet protection.
- STA 12098+44: Repair CFS at CIS S-MM13.
- STA 12100+00: Perimeter CWD berm failing.

Fig. 2: **STA 12065+00** – P1 undermined in several locations.

**Recommended Corrective Action:** Maintain and install all controls per the approved plan and specs.

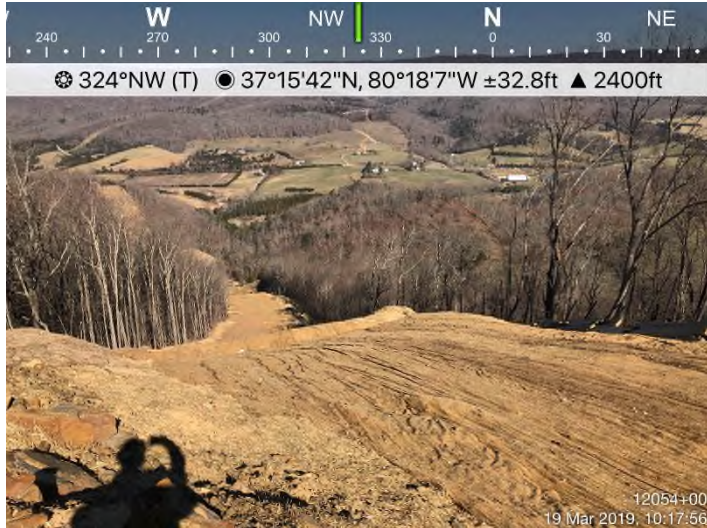
Fig. 3: **STA 12054+00** – Area adequately stabilized. Controls in place.

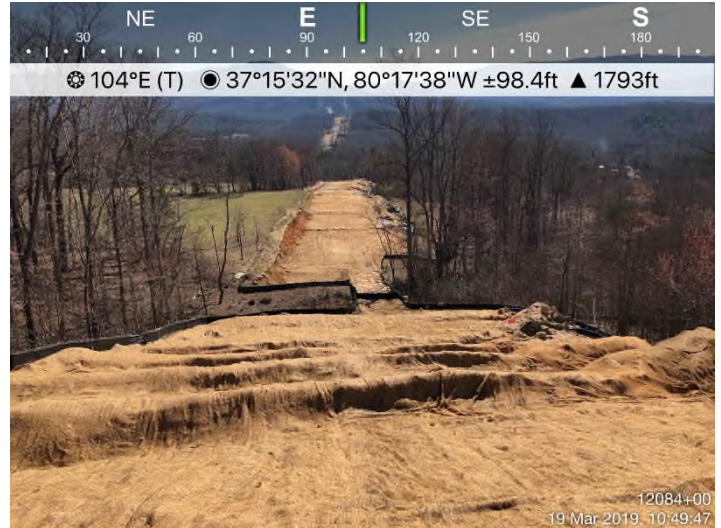
Fig. 4: **STA 12084+00** – Area adequately stabilized. Controls in place.

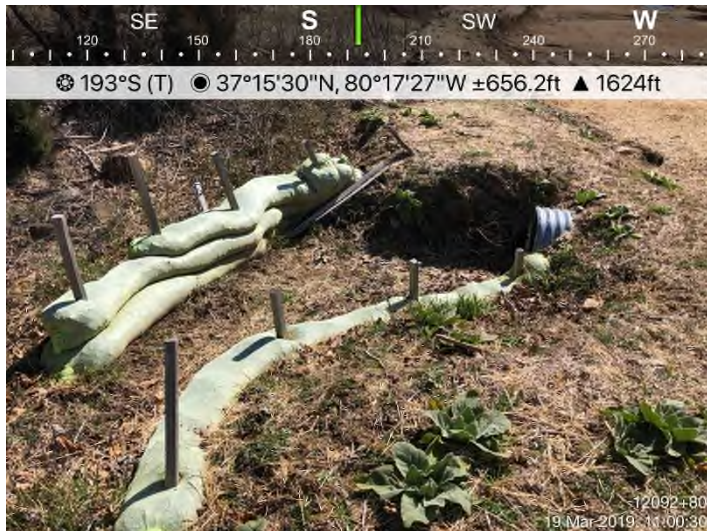
Fig. 5: **STA 12092+80** – Inlet protection needed at CWD.

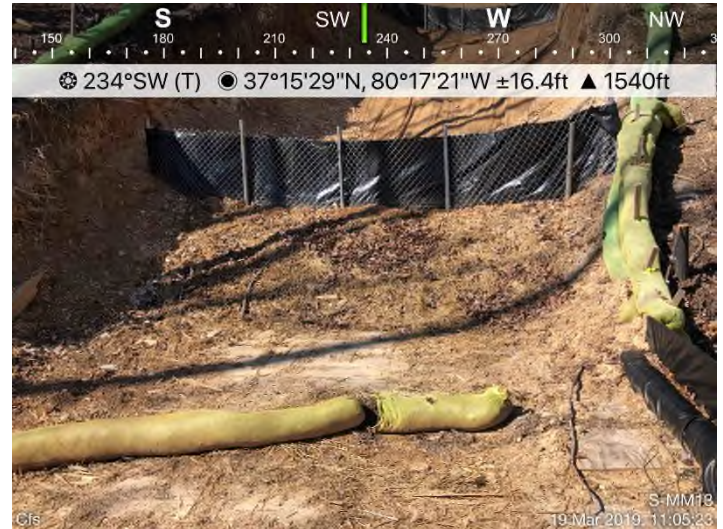
Fig. 6: **STA 12098+44** – Repair CFS at S-MM13.

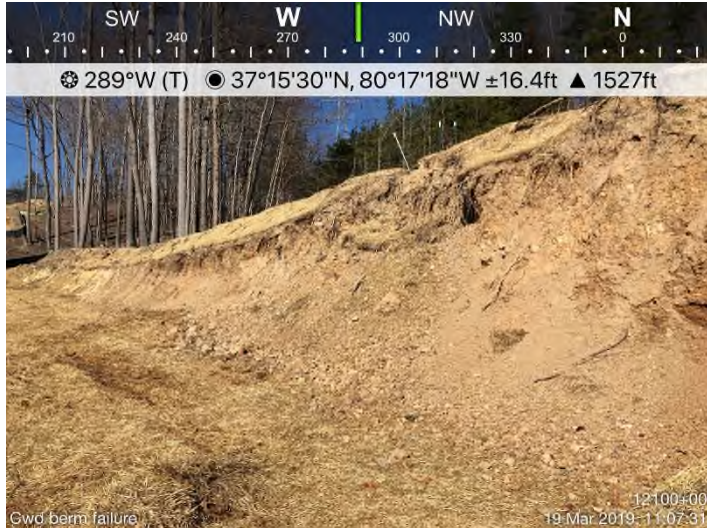
Fig. 7: **STA 12100+00** – Perimeter CWD berm failing.

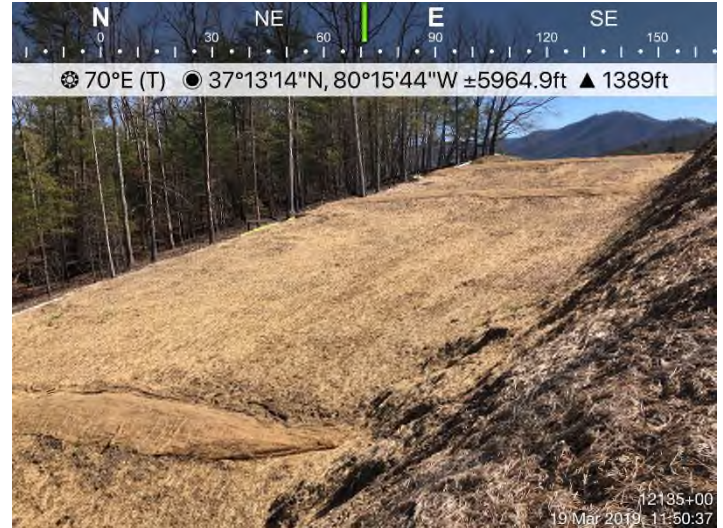
Fig. 8: **STA 12135+00** – Area adequately stabilized. Controls in place.
