## FIELD INSPECTION

| Project Name: | Mountain Valley Pipeline | Inspector: | Marshall Willis |
| Inspection Date: | Thursday, March 14, 2019 | Project Contact: | Brian Clauto |
| Spread I:<br>Franklin County | STA 14802+17 – 14881+54<br>LY 045/046 | Weather (Wet/Dry/Rain): | Dry |

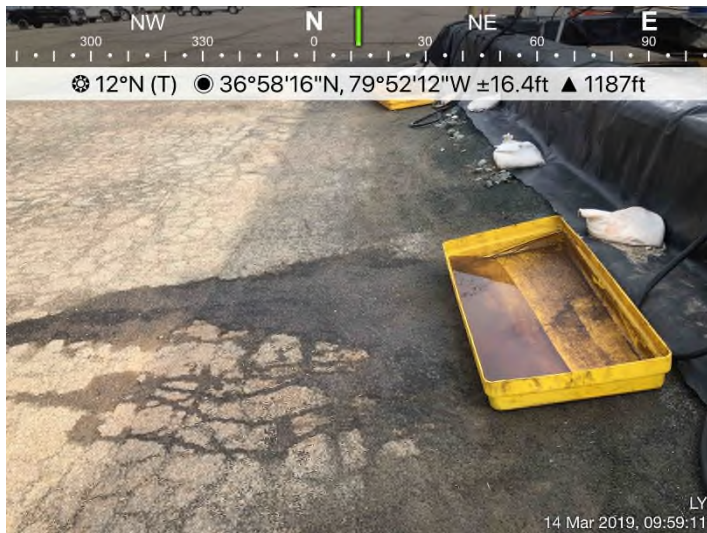
Fig. 1: **LY 045/046** – Clean out secondary containment. Clean up and properly document diesel spill immediately.

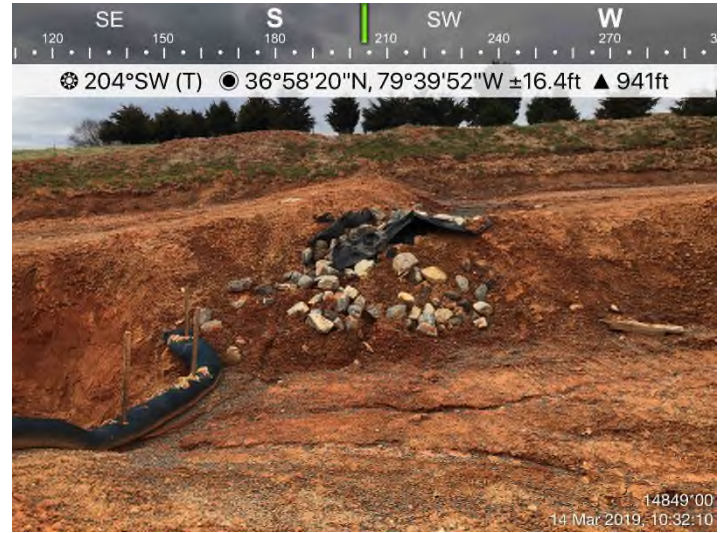
Fig. 2: **STA 14849+00** – Repair/maintain slope protection.

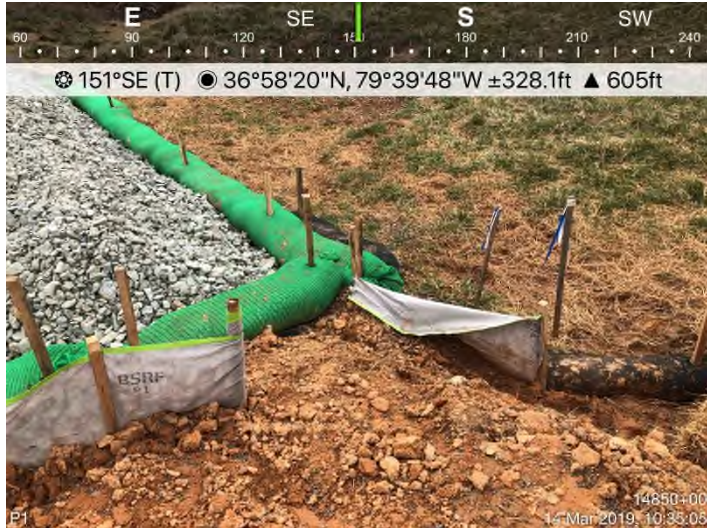
Fig. 3: **STA 14850+00** – Maintain P1.

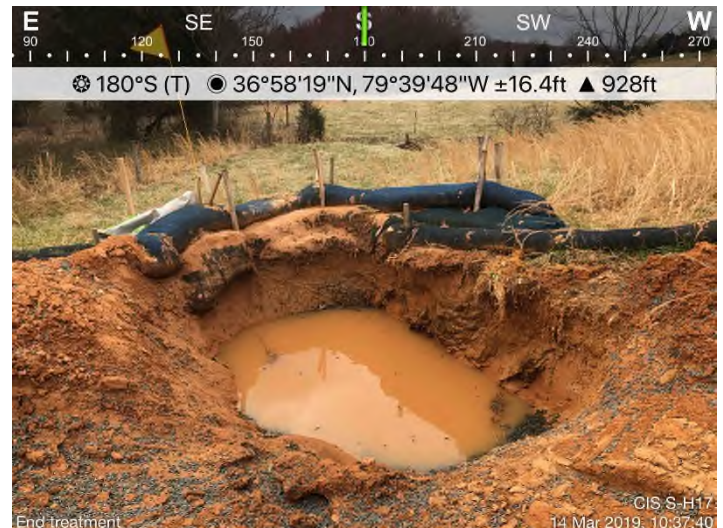
Fig. 4: **STA 14852+00** – Repair/maintain end treatment.

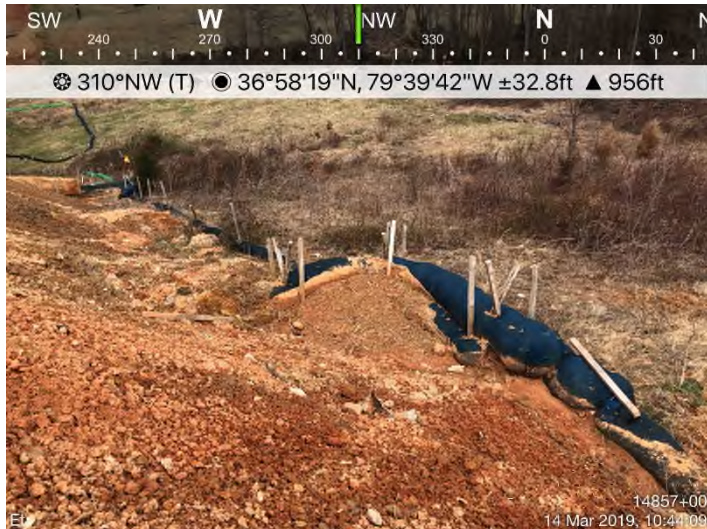
Fig. 5: STA 14857+00 – Maintain CFS.

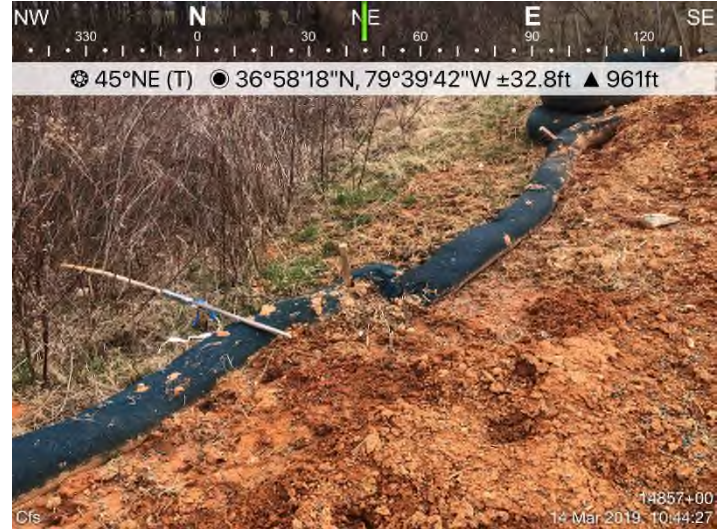
Fig. 6: STA 14857+00 – Repair/maintain CFS.

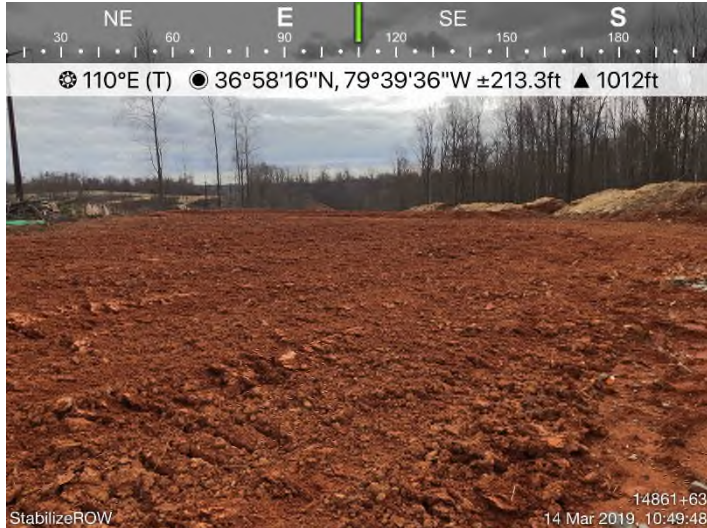
Fig. 7: STA 14861+63 – 14881+54 – Stabilize ROW.

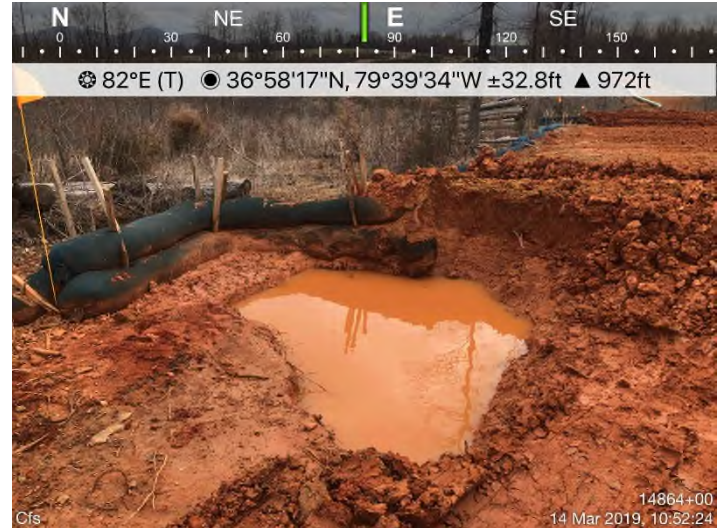
Fig. 8: STA 14864+00 – Repair/maintain end treatment.

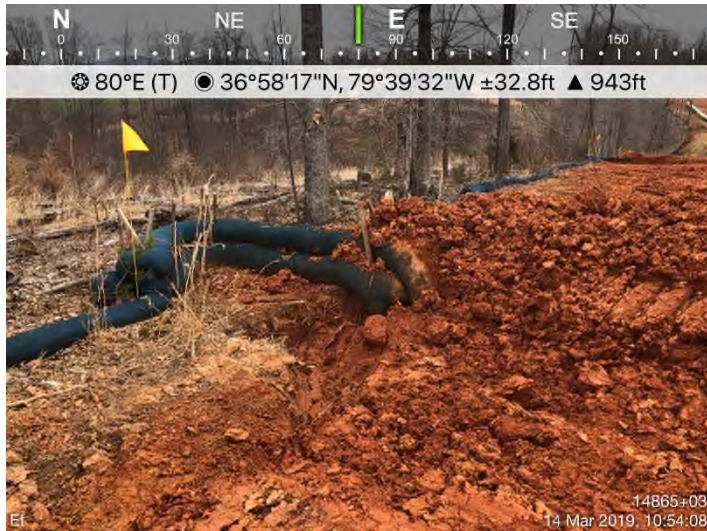
Fig. 9: **STA 14865+03** – Install sump per PSS&S.

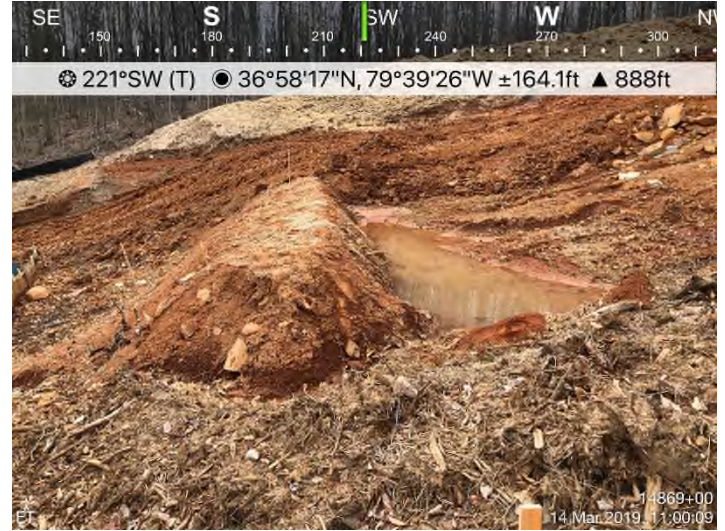
Fig. 10: **STA 14869+00** – Install waterbar and end treatment per PSS&S.

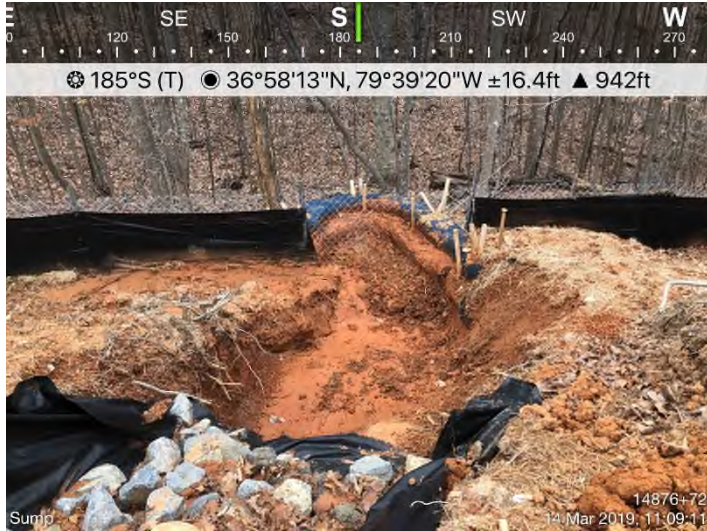
Fig. 11: **STA 14876+72** – Maintain/cleanout sump.

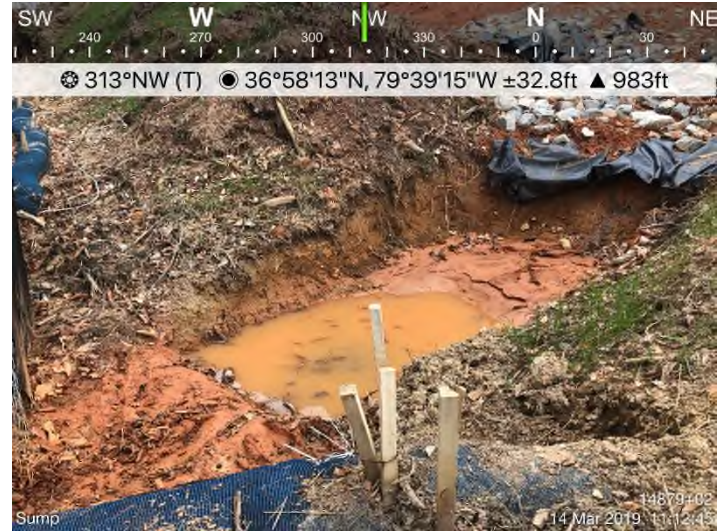
Fig. 12: **STA 14879+02** – Maintain/cleanout sump.

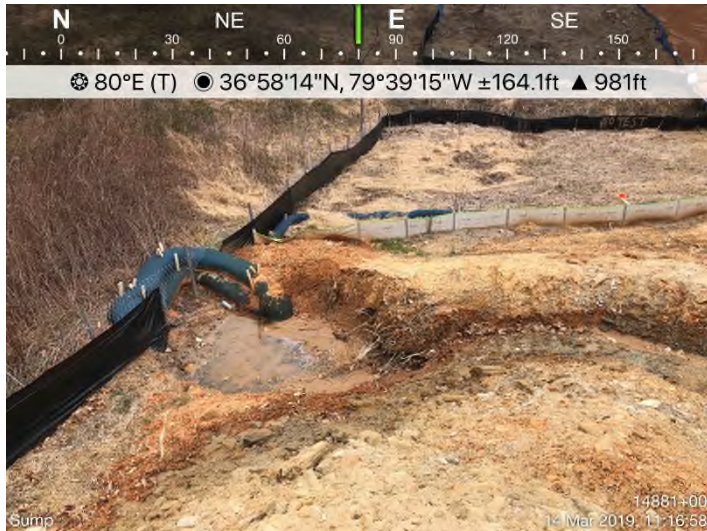
Fig. 13: **STA 14881+00** – Maintain/cleanout sump.

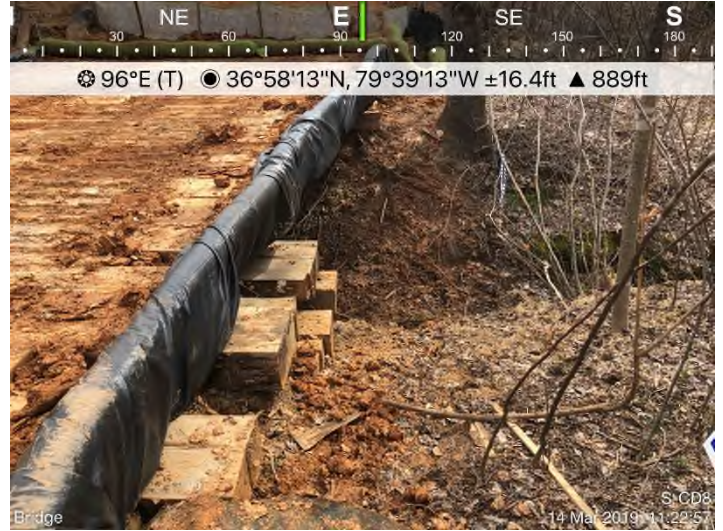
Fig. 14: **S-CD8** – Clean bridge, remove sediment overflow, stabilize bank.

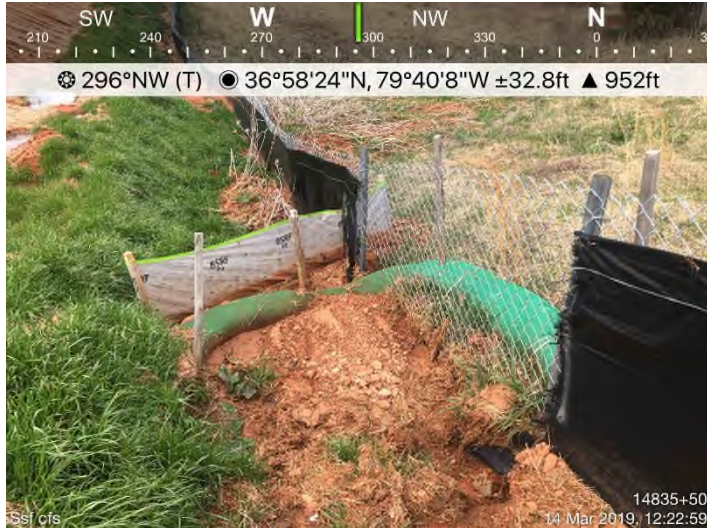
Fig. 15: **STA 14835+50** – Clean out/maintain CFS. Repair SSF.

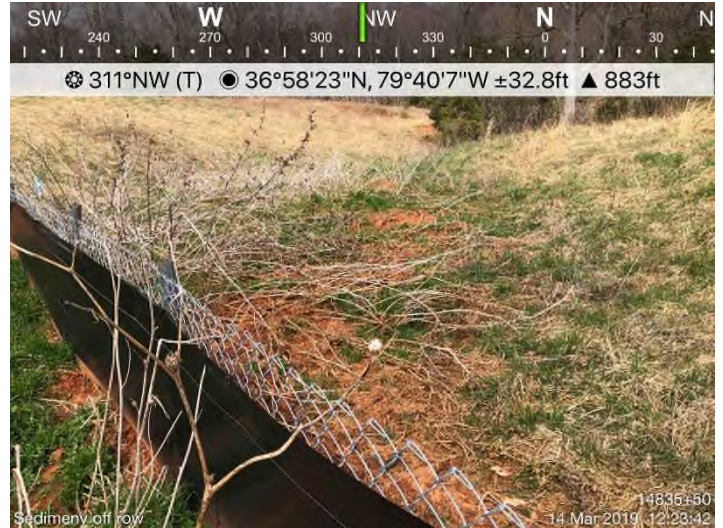
Fig. 16: **STA 14835+50** – Sediment off ROW.
