## FIELD INSPECTION

| <b>Project Name:</b> | Mountain Valley Pipeline | <b>Inspector:</b> | Matthew Grant |
| <b>Inspection Date:</b> | Wednesday, March 13, 2019 | <b>Project Contact:</b> | Brian Clauto |
| <b>Spread: Franklin County MP 251-252</b> | Spread H | <b>Weather (Wet/Dry/Rain):</b> | Dry |

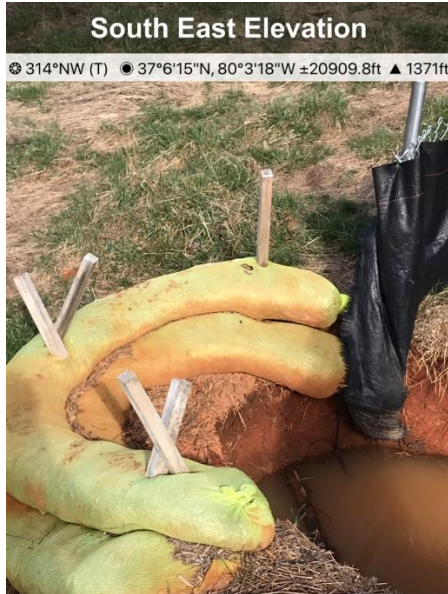
- Fig. 1 St#13299+30 sump end treatment falling into sump

**Recommended Corrective Action:** Maintain all controls per the annual standard and spec

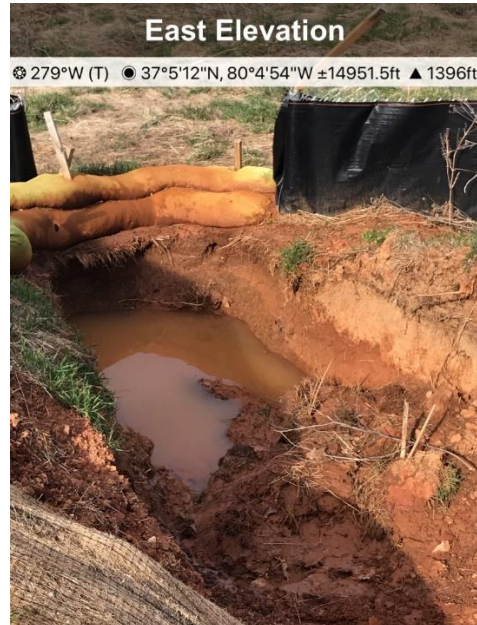
- Fig. 2 St#13033+30 sump has had soil collapse in to storage area

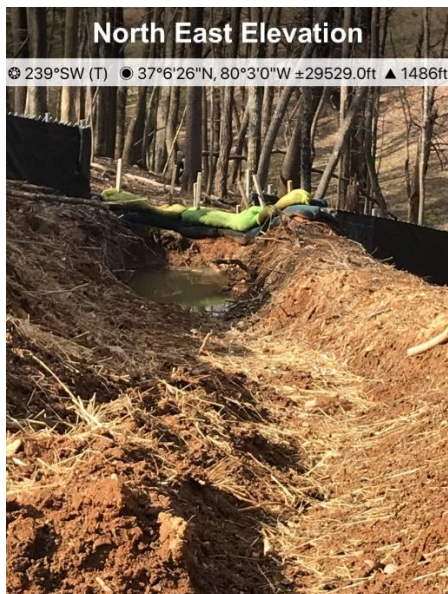
- Fig. 3 St#13326+35 water bar flow path requires repair and end treatment is undermined

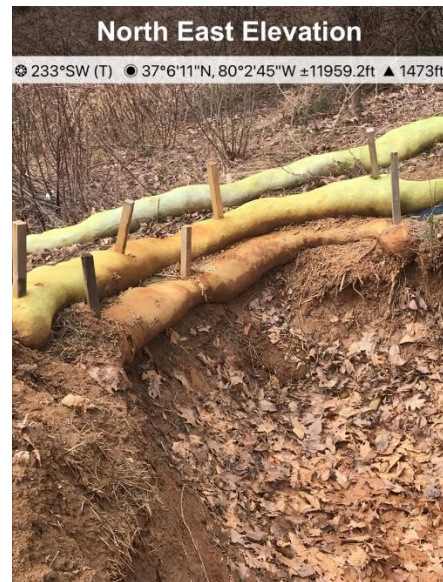
- Fig. 4 St#13331+75 triple stack is undermined
