## FIELD INSPECTION

| <b>Project Name:</b> | Mountain Valley Pipeline | <b>Inspector:</b> | Marshall Willis |
| <b>Inspection Date:</b> | Tuesday, March 12, 2019 | <b>Project Contact:</b> | Brian Clauto |
| <b>Spread H:<br/>Franklin County</b> | STA 13023+00 – 13072+23<br>MVP-FR-289/290<br>STA 13136+00 – 13145+00<br>MVP-FR-292 | <b>Weather (Wet/Dry/Rain):</b> | Dry |

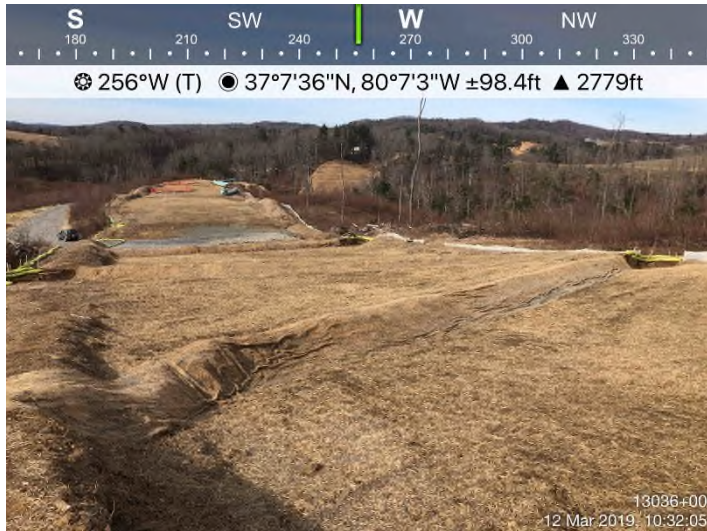
Fig. 1: **STA 13036+00** – Area adequately stabilized. Controls in place.

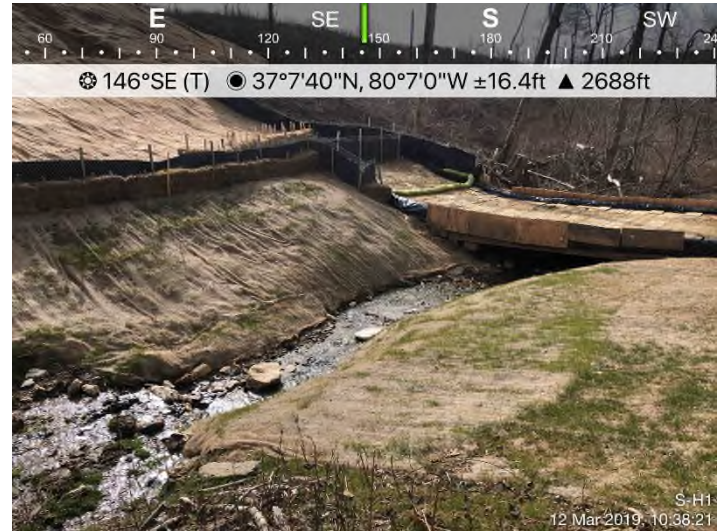
Fig. 2: **S-H1** – Controls in place.

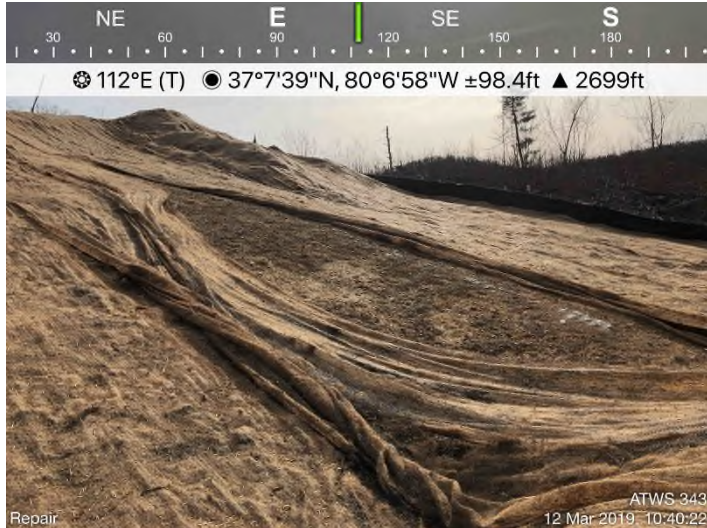
- ATWS 343: Repair fabric.
- STA 13058+00: Repair SSF.
- STA 13060+00: Repair SSF.
- STA 13066+48: CFS undermined.

Fig. 3: **ATWS 343** – Maintenance needed on fabric.

**Recommended Corrective Action:** Maintain and install all controls per the approved plan and specs.

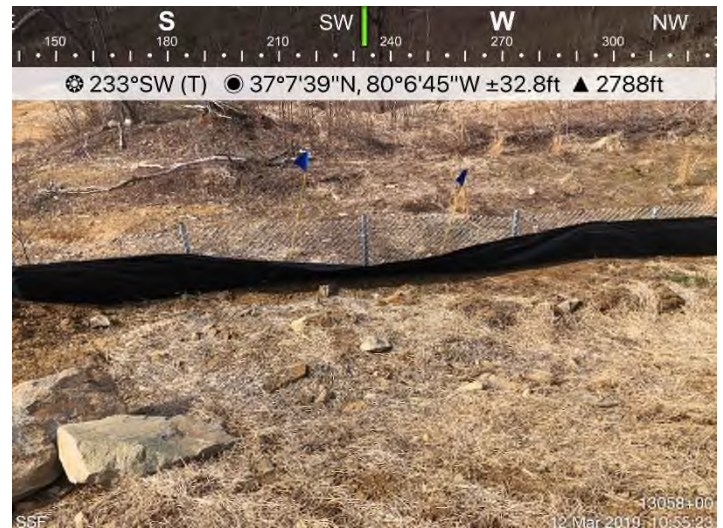
Fig. 4: **STA 13058+00** – Maintenance needed on SSF.

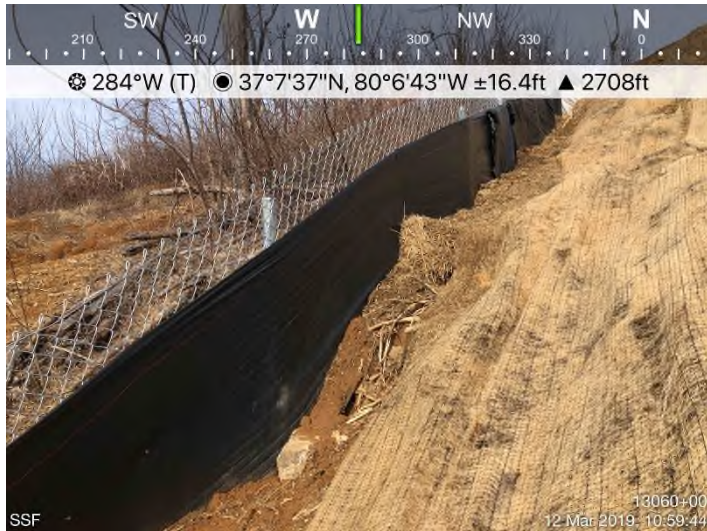
Fig. 5: **STA 13060+00** – Maintenance needed on SSF.

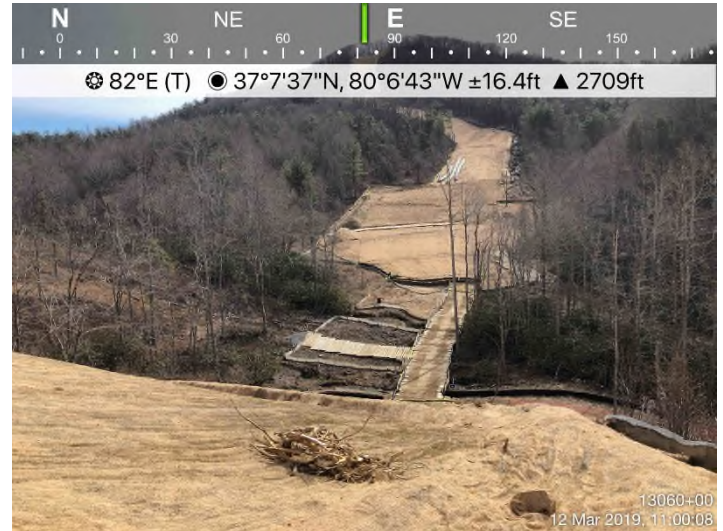
Fig. 6: **STA 13060+00** – Area adequately stabilized. Controls in place.

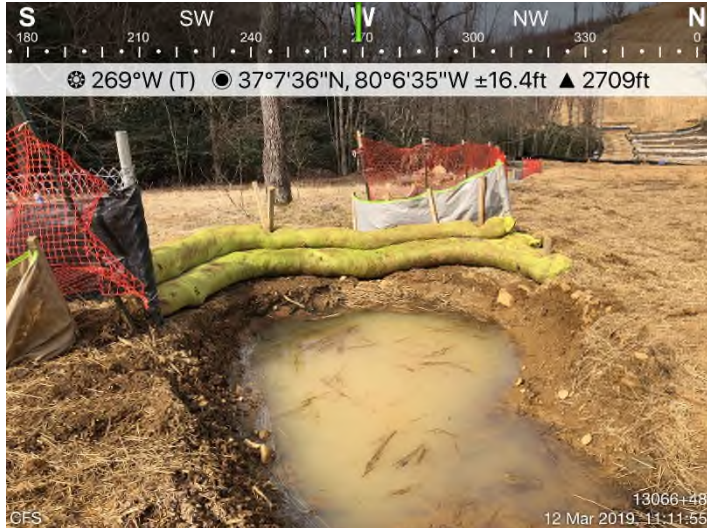
Fig. 7: **STA 13066+48** – CFS undermined. Maintenance needed.

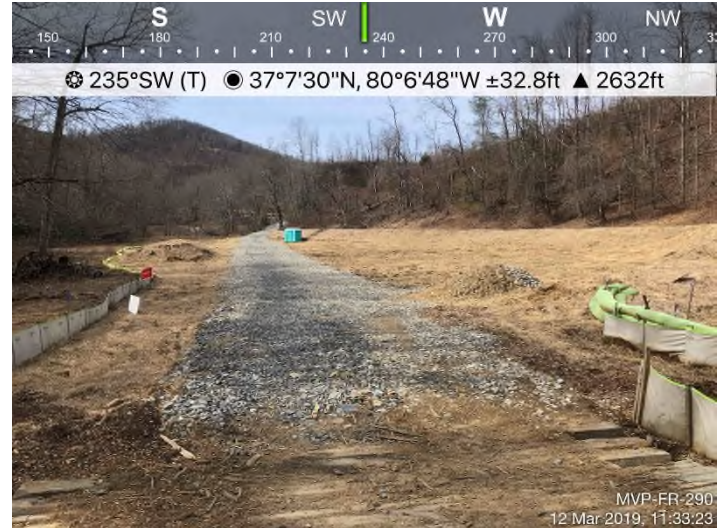
Fig. 8: **MVP-FR-290** – Area adequately stabilized. Controls in place.

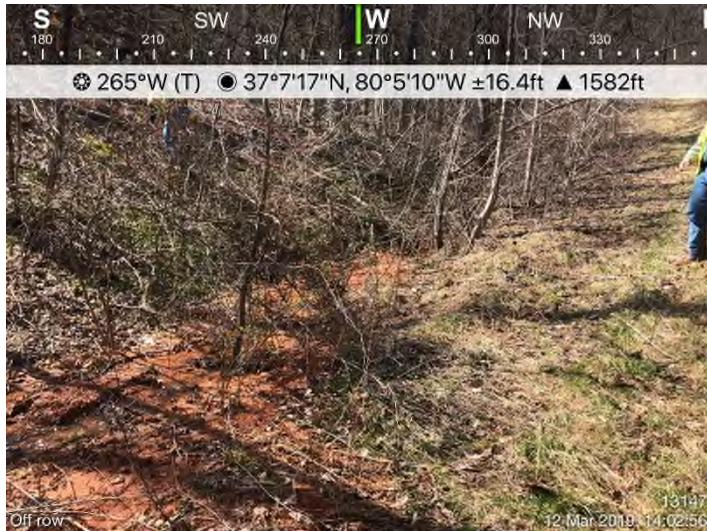
Attended a site meeting with Mr. Foley (landowner) and Ronald Wilson (Franklin County). Landowner was concerned that ROW activities at approx. STA 13143+00 may have diverted flow from a stream, causing a bank failure outside of the ROW and sediment deposition along Mr. Foley's property and subsequently clogging a downstream culvert. Site inspection concluded that only clearing had been conducted in this area, with no land disturbance to date. Onsite stream delineation flags for S-D14 and S-D17 showed that the stream (S-D17) has not been diverted since the start of the MVP project but may have been incidentally diverted prior to ROW activities or through past land use.

Fig. 9: **Mr. Foley's Property** – Sediment deposition/clogged culvert off ROW.

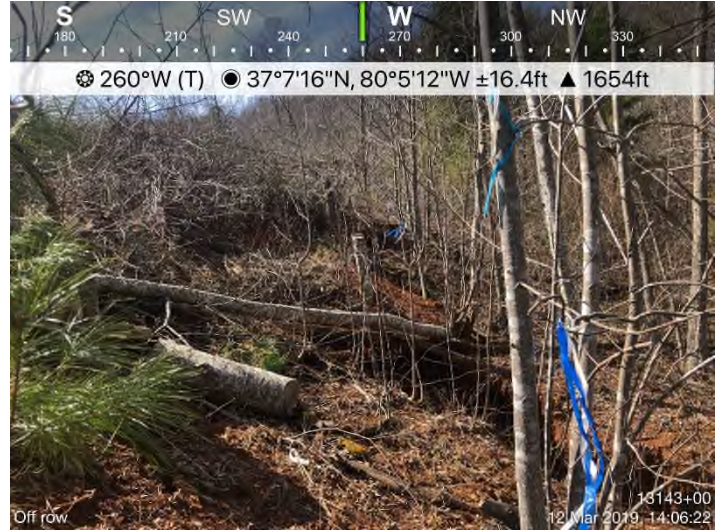
Fig. 10: **STA 13143+00** – ROW limit at bank failure at S-D17.

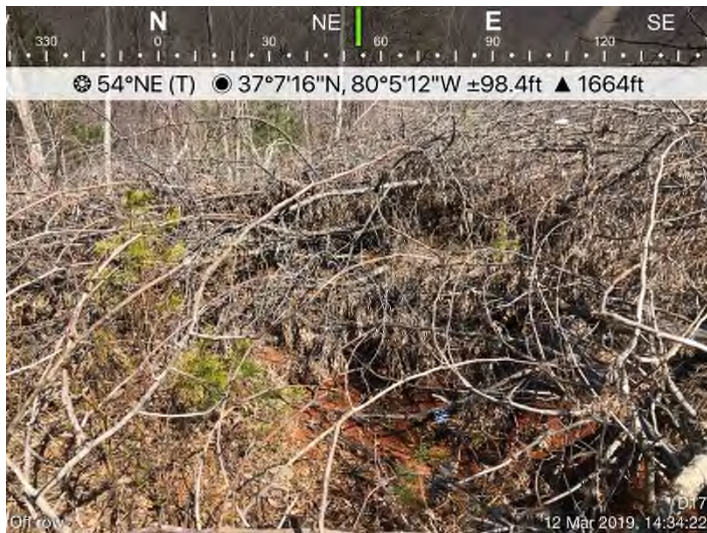
Fig. 11: **S-D17** – Inside ROW at S-D17 adjacent to bank failure.

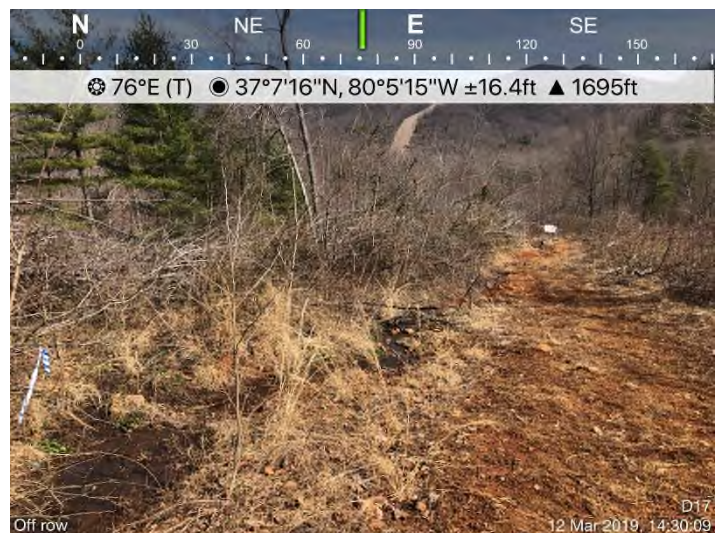
Fig. 12: **S-D17** – Stream running down old roadbed above bank failure.
