## FIELD INSPECTION

| <b>Project Name:</b> | Mountain Valley Pipeline | <b>Inspector:</b> | Matthew Grant |
| <b>Inspection Date:</b> | Tuesday, March 5, 2019 | <b>Project Contact:</b> | Brian Clauto |

## FIELD INSPECTION PHOTO LOG

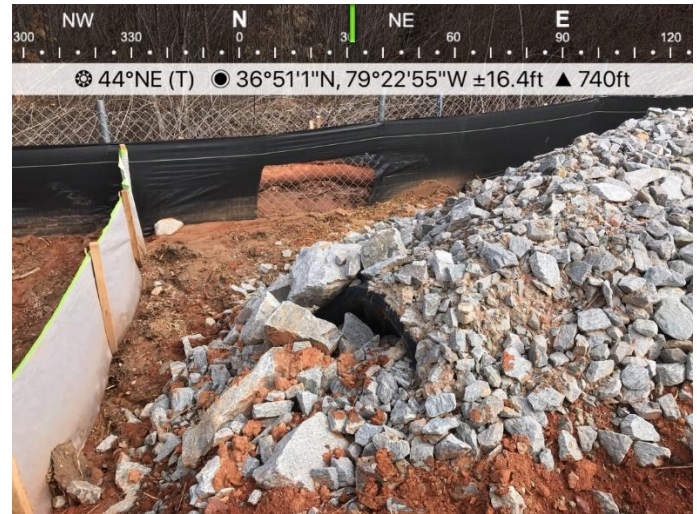
- Fig. 2 St#15865+00 level spreader lacks end cap

**Recommended Corrective Action:** Maintain all controls per the approved plan and specs, remove sediment and stabilize per DEQ approval.

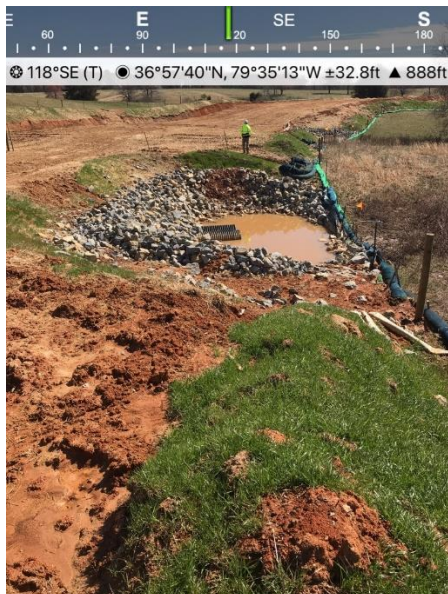
- Fig. 3 St#15084+00 CWD has been breached

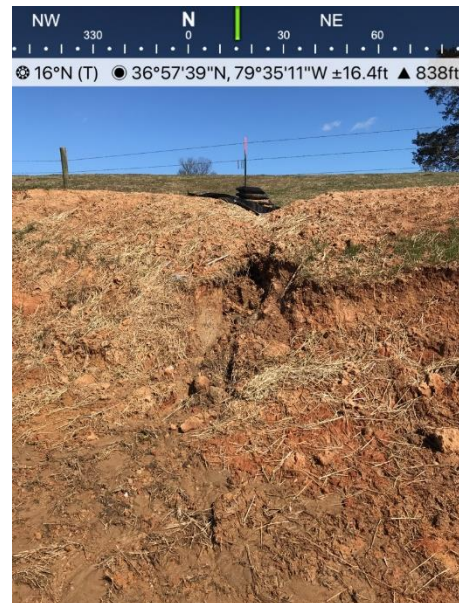
- Fig. 4 St#15086+00 CWD inlet has eroded
