## FIELD INSPECTION

| Project Name: | Mountain Valley Pipeline | Inspector: | Marshall Willis |
| Inspection Date: | Wednesday, February 27, 2019 | Project Contact: | Brian Clauto |
| Spread I:<br>Franklin County | STA 14209+75 – 14233+12 | Weather (Wet/Dry/Rain): | Dry |

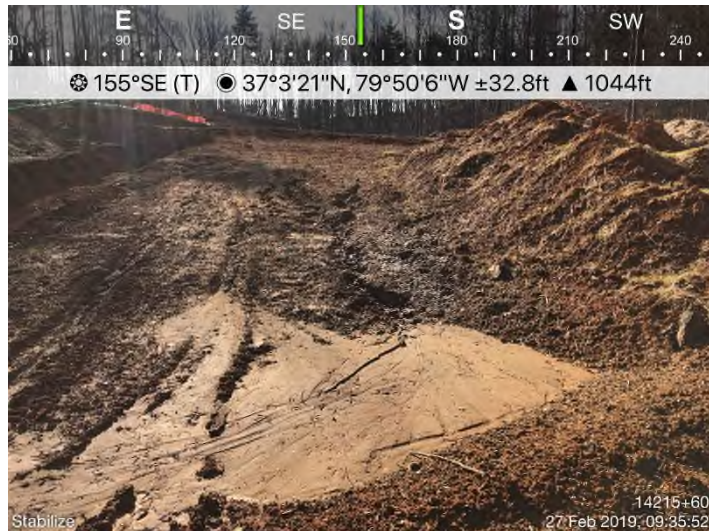
Fig. 1: STA 14215+60 – Inadequate stabilization.

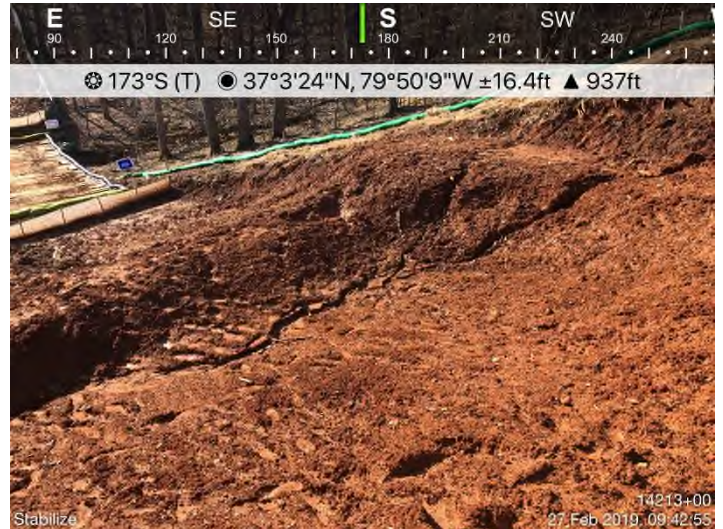
Fig. 2: STA 14213+00 – Inadequate stabilization.

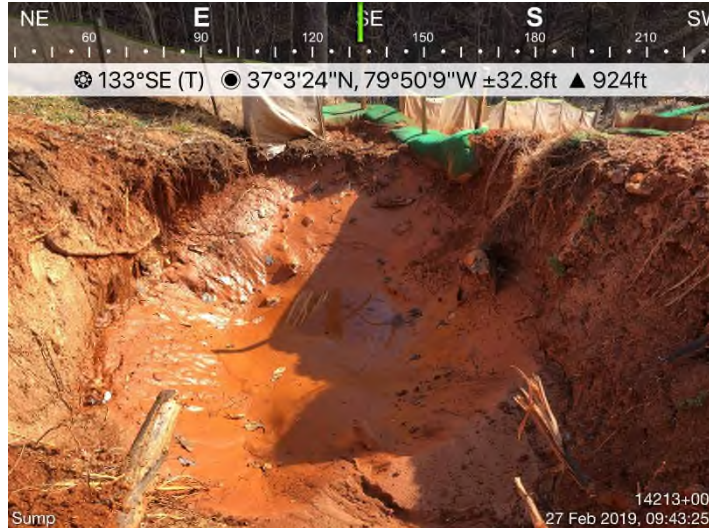
Fig. 3: STA 14213+00 – Maintain sump.

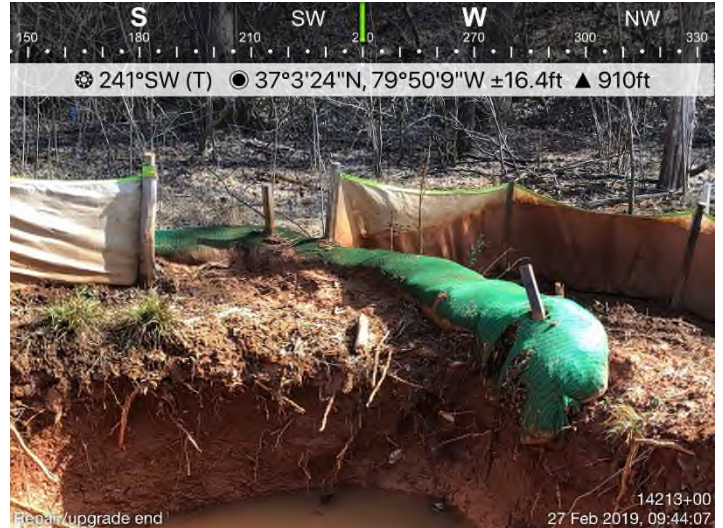
Fig. 4: STA 14213+00 – Maintain CFS/upgrade end-treatment.

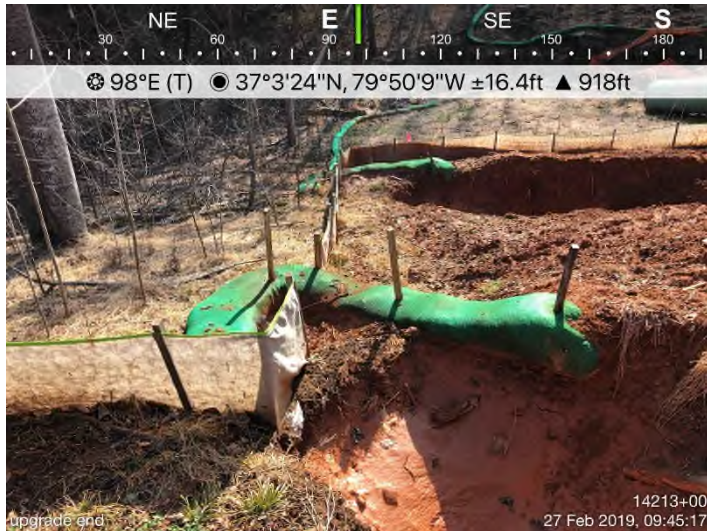
Fig. 5: **STA 14213+00** – Upgrade end-treatment. Discharge unable to exit ROW.

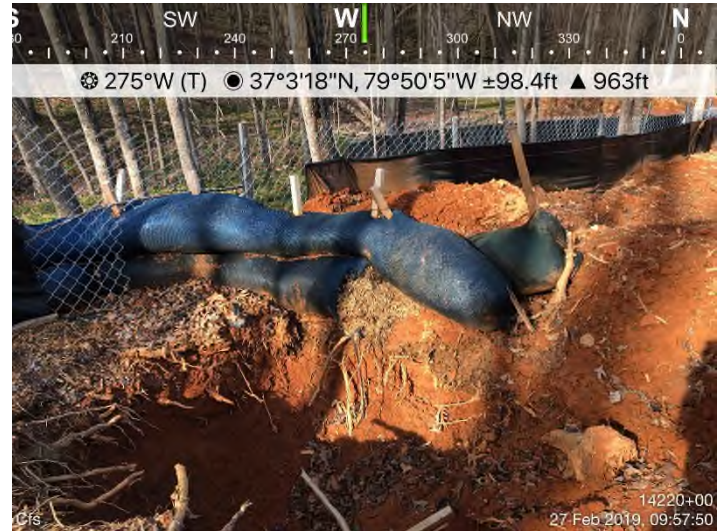
Fig. 6: **STA 14220+00** – Maintain CFS.

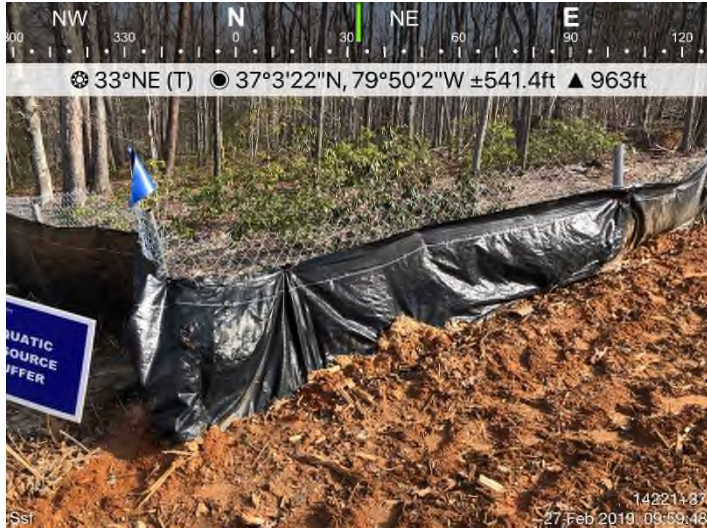
Fig. 7: **STA 14221+37** – Maintain SSF.

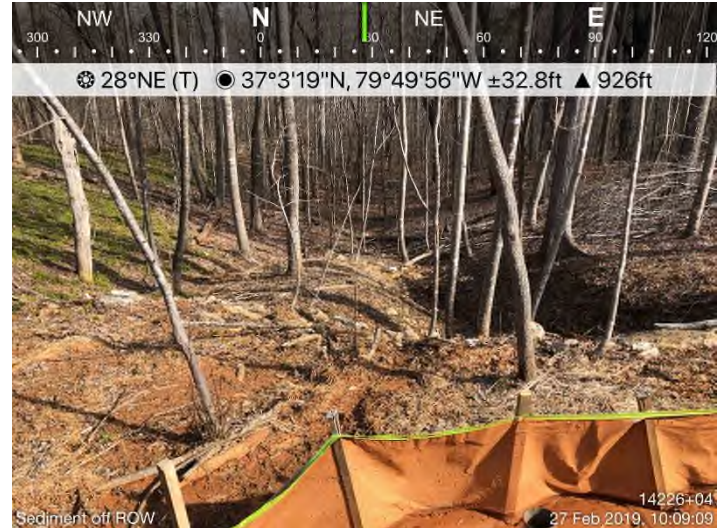
Fig. 8: **STA 14226+04** – Sediment off ROW.

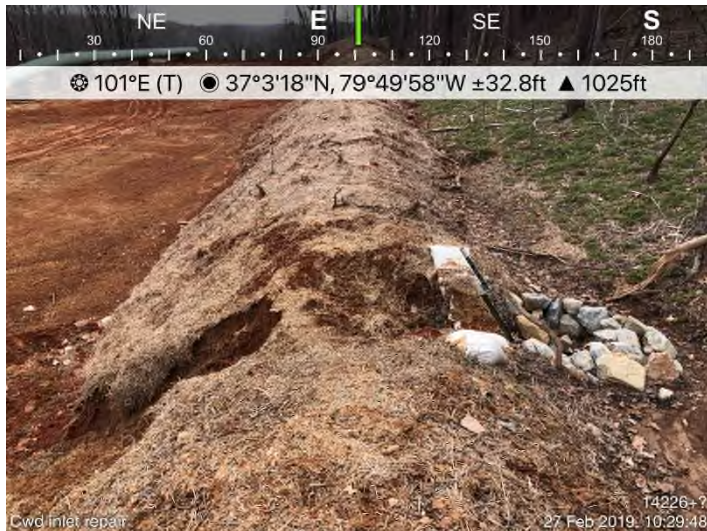
Fig. 9: STA 14226+25 – Repair CWD inlet.

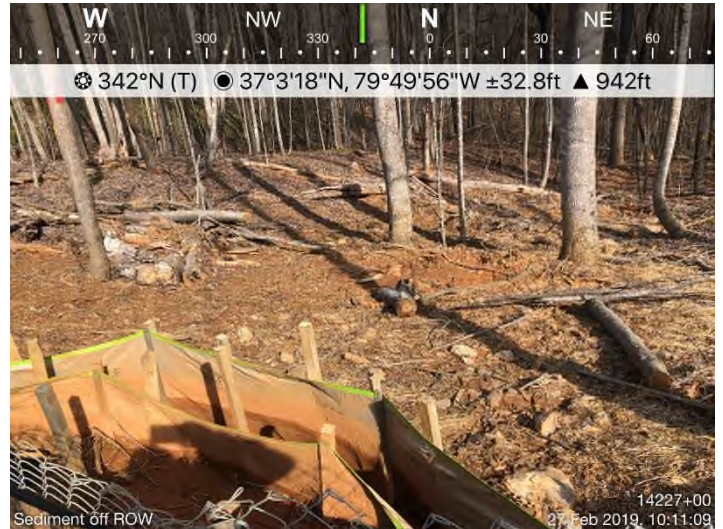
Fig. 10: STA 14227+00 – Sediment off ROW.

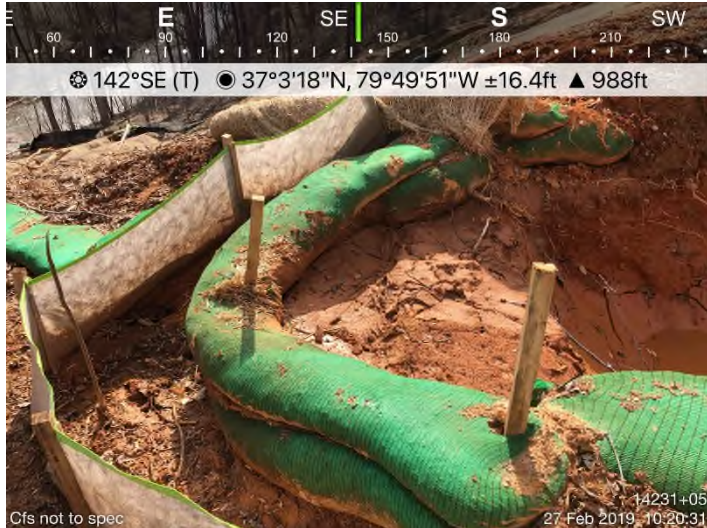
Fig. 11: STA 14331+05 – P1 undermined, CFS not installed per spec., sump full.

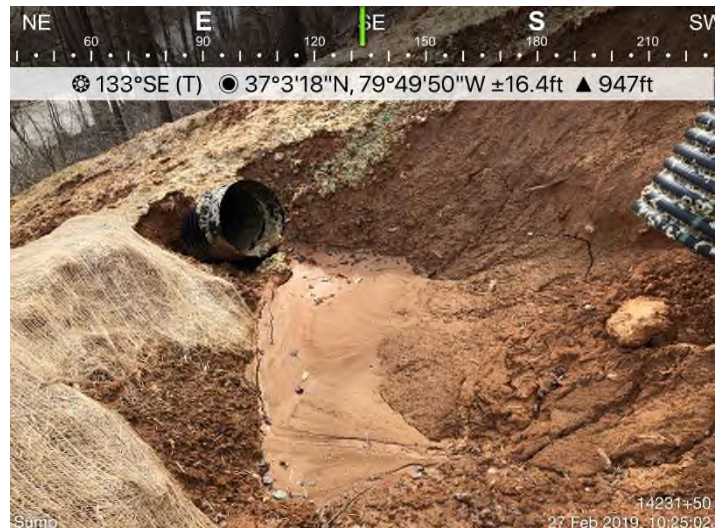
Fig. 12: STA 14231+50 – Sumps need maintenance.
