## FIELD INSPECTION

| <b>Project Name:</b> | Mountain Valley Pipeline | <b>Inspector:</b> | Matthew Grant |
| <b>Inspection Date:</b> | Wednesday, February 27, 2019 | <b>Project Contact:</b> | Brian Clauto |
| <b>Spread: Roanoke County AR 288</b> | Spread H | <b>Weather (Wet/Dry/Rain):</b> | Dry |

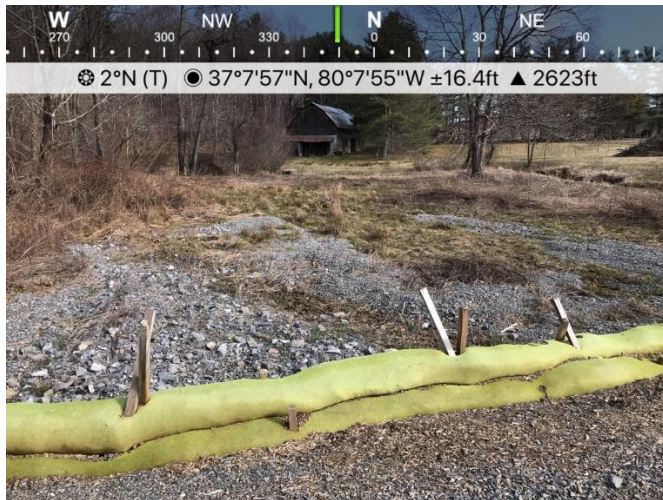
- Fig. 1. Wetland W-IJ10 controls were in place and functioning at the time of inspection. Roadside gravel has impacted wetland as noted in previous inspections.

**Recommended Corrective Action:** Remove roadside gravel in wetland if owner permission is obtained.

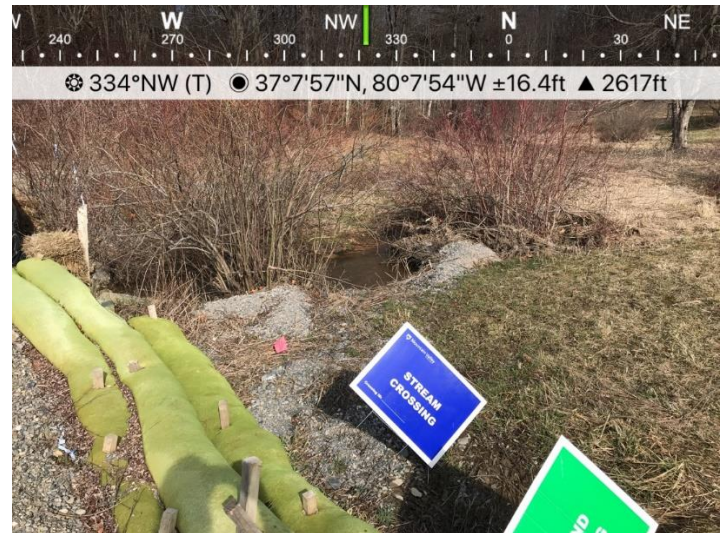
- Fig. 2 At designated stream S-Q20 at the time of the inspection no road side gravel was in stream.

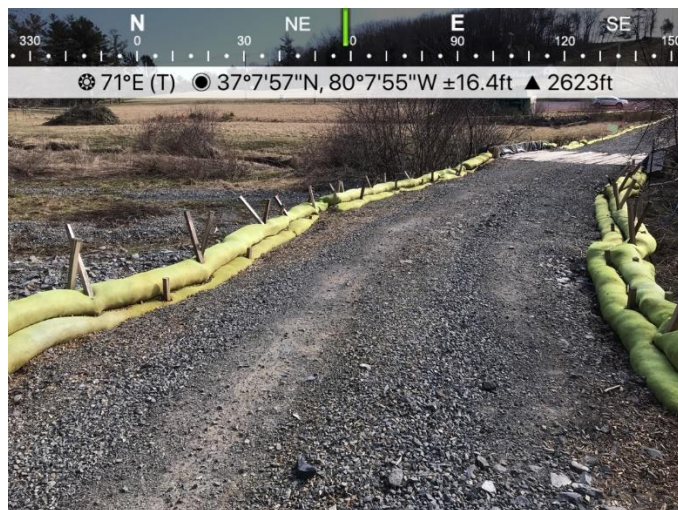
- Fig. 3 At AR 288 erosion controls were in place and functioning at the time of the inspection.
