## FIELD INSPECTION

| Project Name: | Mountain Valley Pipeline | Inspector: | Marshall Willis |
| Inspection Date: | Tuesday, February 26, 2019 | Project Contact: | Brian Clauto |
| Spread I:<br>Franklin County | STA 13848+50 – 13942+00 | Weather (Wet/Dry/Rain): | Dry |

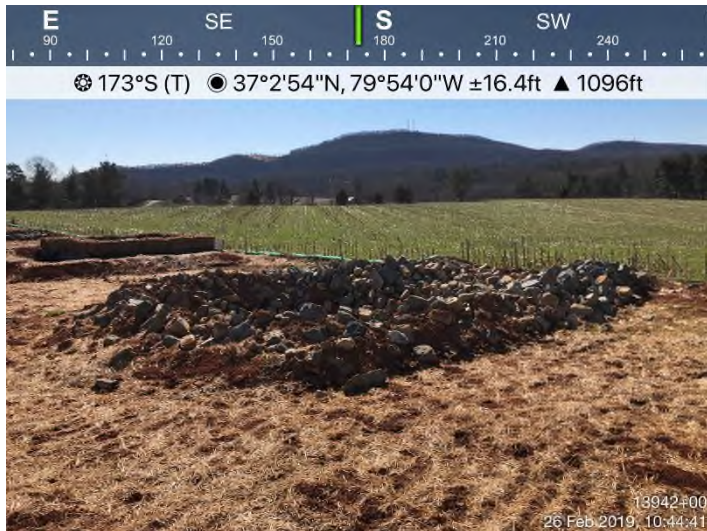
Fig. 1: STA 13942+00 – No diversion for CWD.

**Recommended Corrective Action:** Maintain and install all controls per the approved plan and specs.

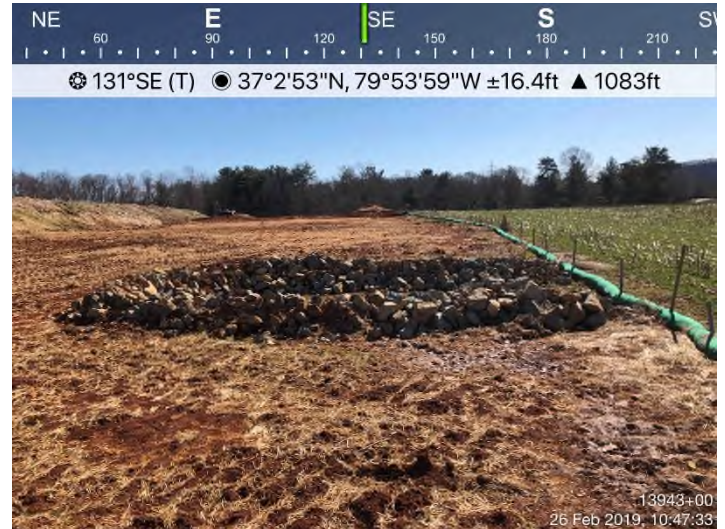
Fig. 2: STA 13943+00 – No diversion for CWD.

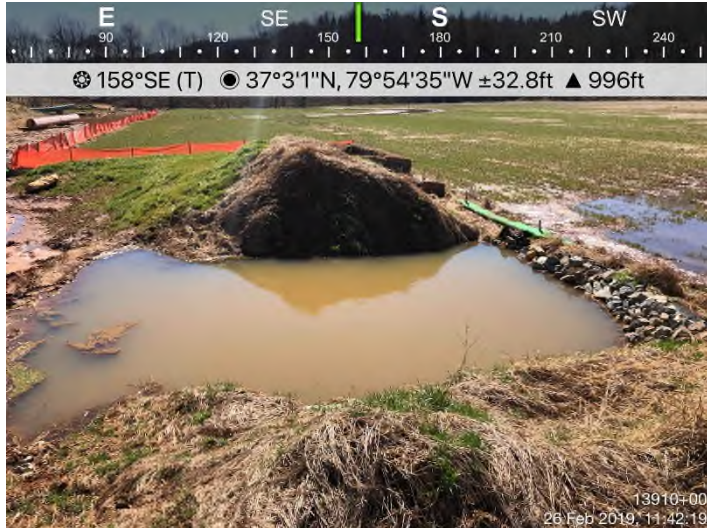
Fig. 3: STA 13910+00 – CWD unable to drain.

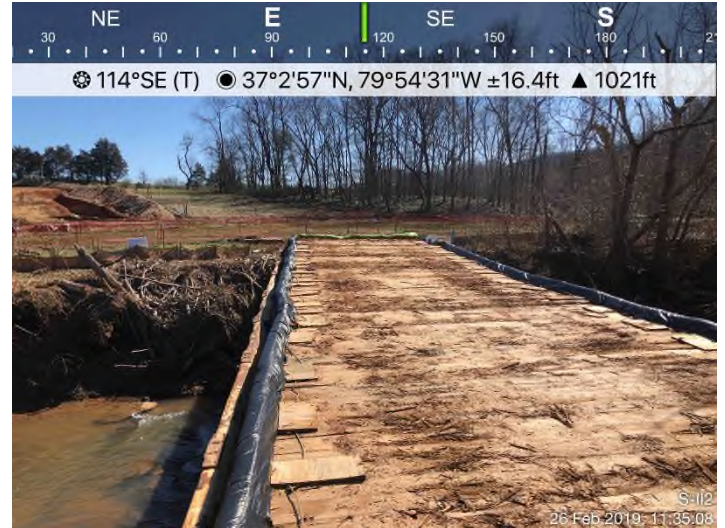
Fig. 4: S-II2 – Controls in place.

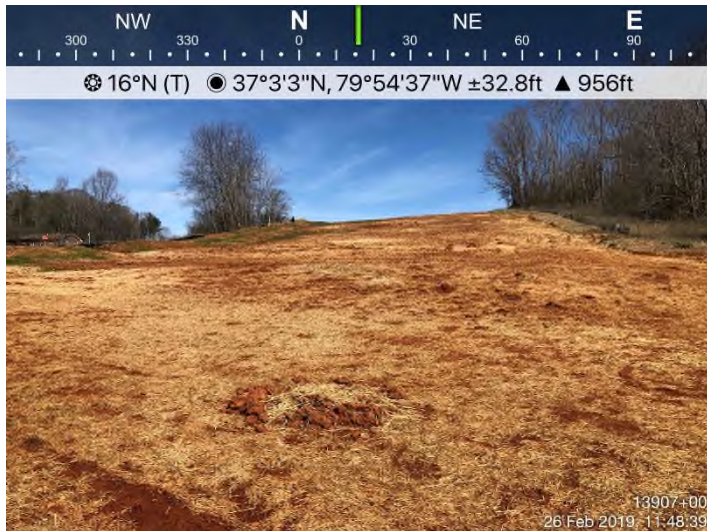
Fig. 5: **STA 13907+00** – Area stabilized. Controls in place.

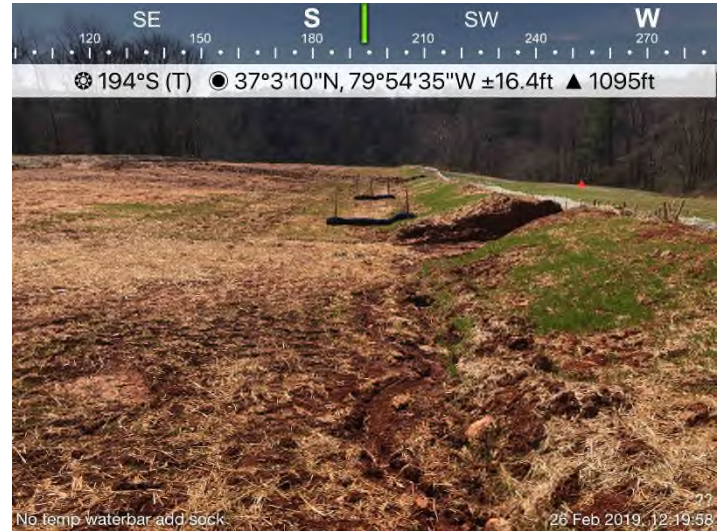
Fig. 6: **STA 13901+00** – CFS waterbar needed.

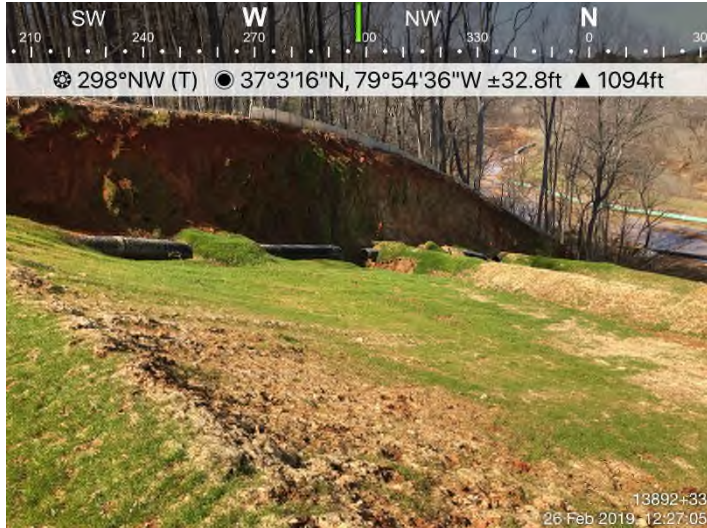
Fig. 7: **STA 13892+33** – Area stabilized. Controls in place.

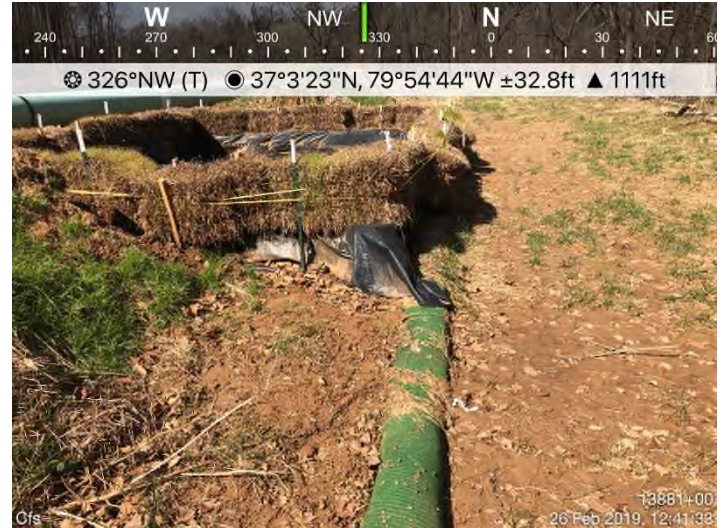
Fig. 8: **STA 13881+00** – CFS needs maintenance.

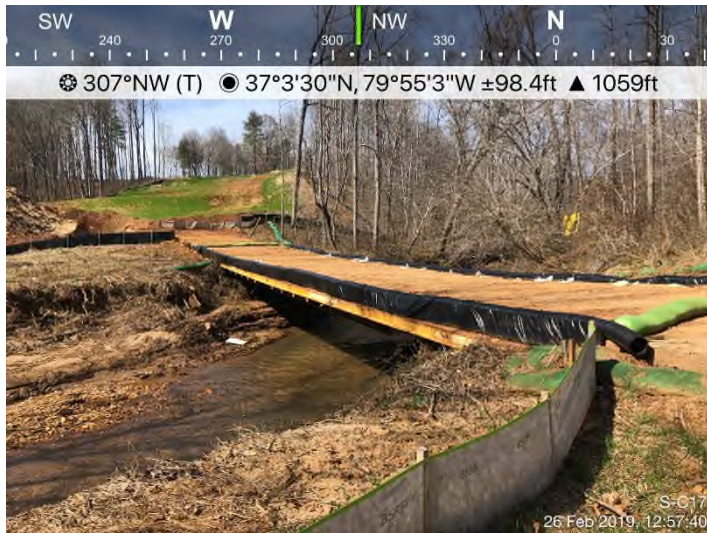
Fig. 9: **S-C17** – Controls in place.

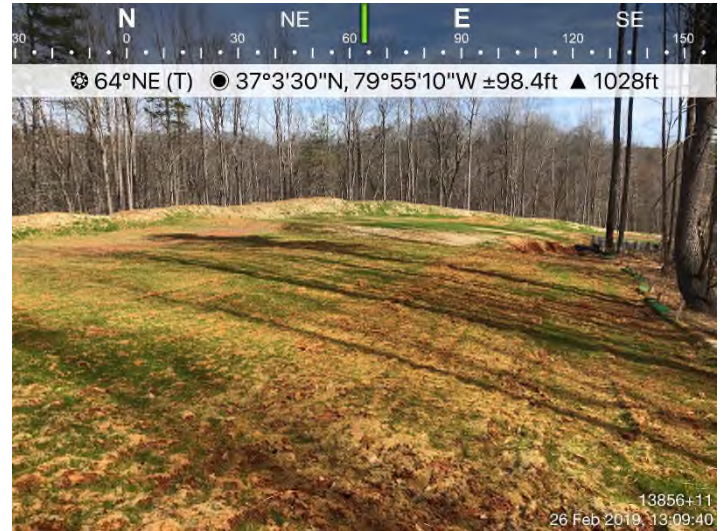
Fig. 10: **STA 13856+11** – Area stabilized. Controls in place.
