## FIELD INSPECTION

| <b>Project Name:</b> | Mountain Valley Pipeline | <b>Inspector:</b> | Marshall Willis |
| <b>Inspection Date:</b> | Friday, February 22, 2019 | <b>Project Contact:</b> | Brian Clauto |

# FIELD INSPECTION PHOTO LOG

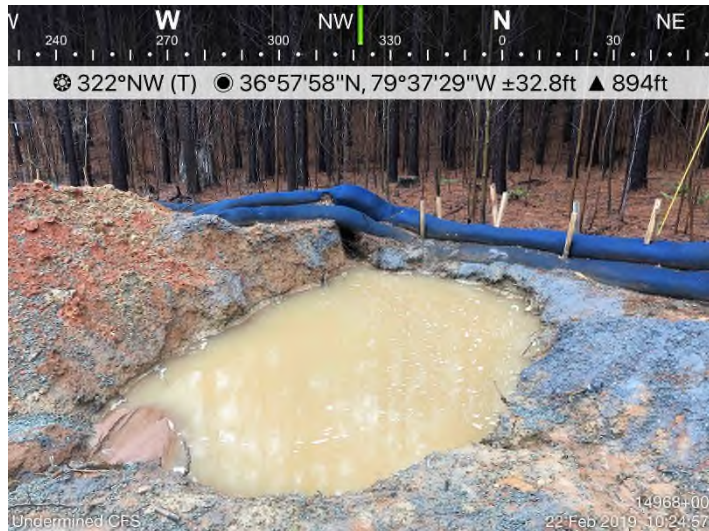
Fig. 1: STA 14968+00 – Undermined CFS.

**Recommended Corrective Action:** Maintain and install all controls per the approved plan and specs.

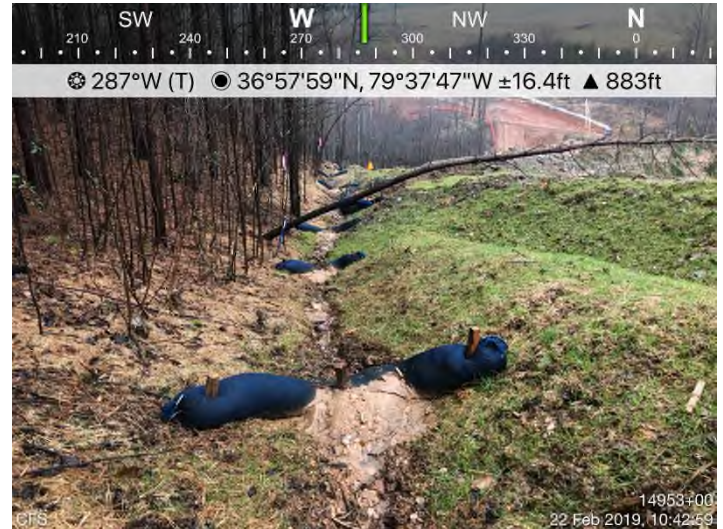
Fig. 2: STA 14953+00 – CFS full.

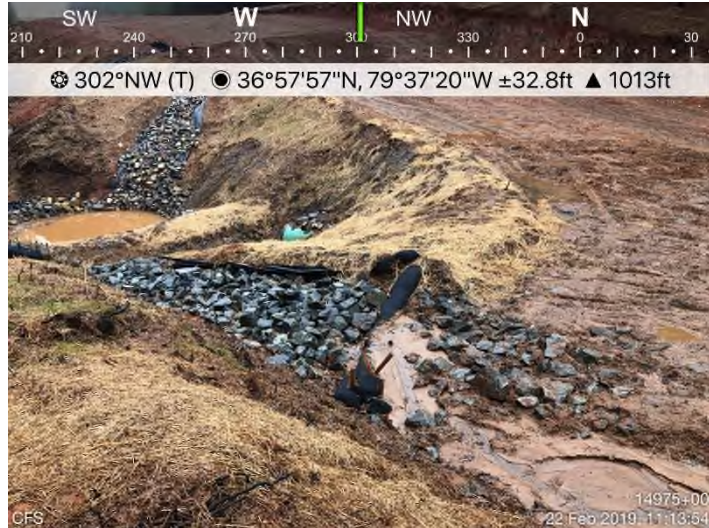
Fig. 3: STA 14975+00 – CFS full.

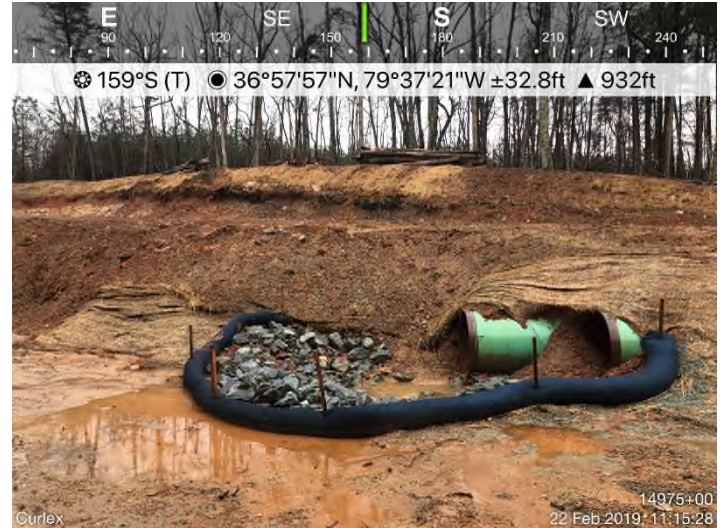
Fig. 4: STA 14975+00 – Erosion fabric maintenance.

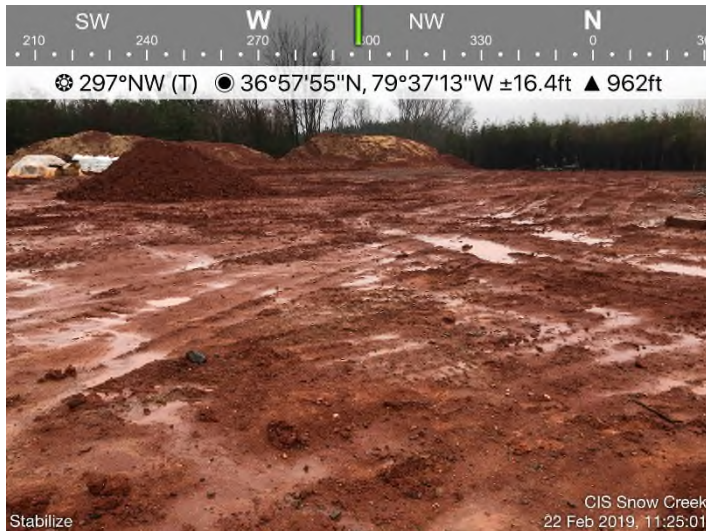
Fig. 5: **STA 14979+85** – Inadequate stabilization.

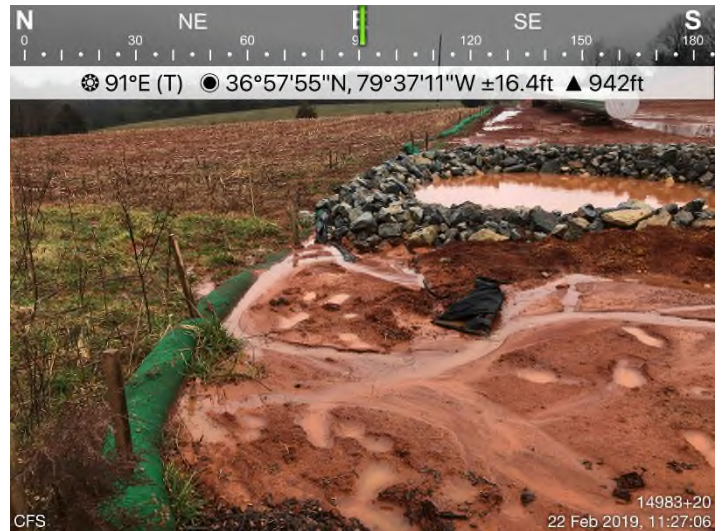
Fig. 6: **STA 114983+20**– CFS full.

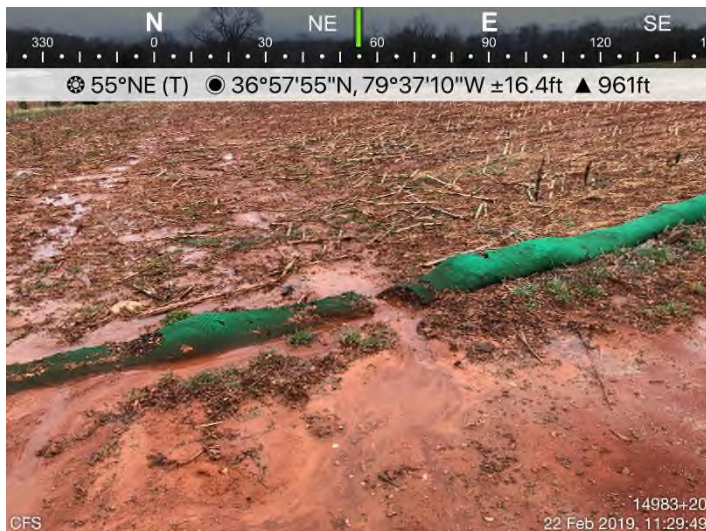
Fig. 7: **STA 14983+20** – CFS maintenance needed.

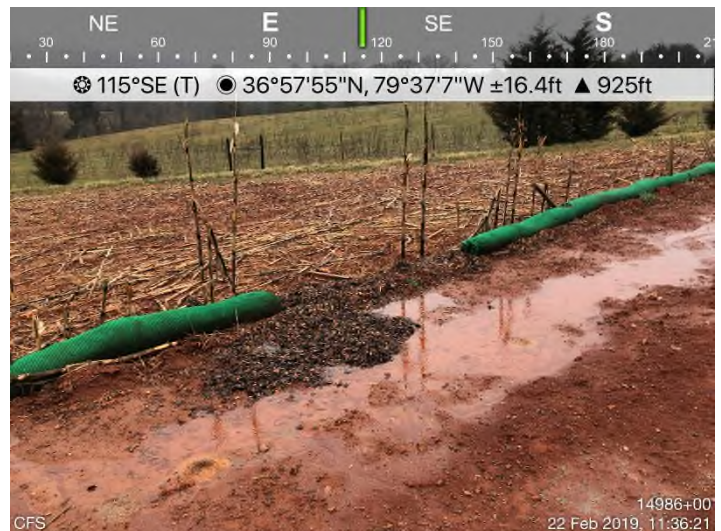
Fig. 8: **STA 14986+00**– CFS maintenance needed.
