## FIELD INSPECTION

| Project Name: | Mountain Valley Pipeline | Inspector: | Marshall Willis |
| Inspection Date: | Thursday, February 21, 2019 | Project Contact: | Brian Clauto |
| Spread H:<br>Franklin County | STA 13315+32 – 13273+02<br>STA 13344+00 – 13403+28 | Weather (Wet/Dry/Rain): | Wet |

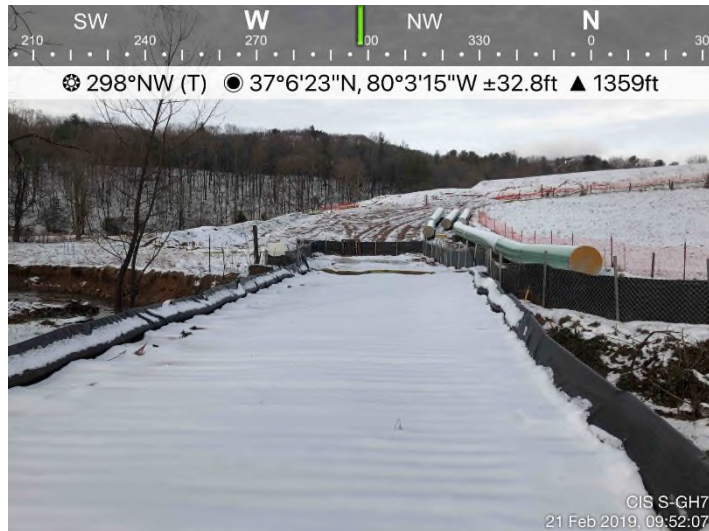
Fig. 1: **CIS S-GH7** – Controls in place.

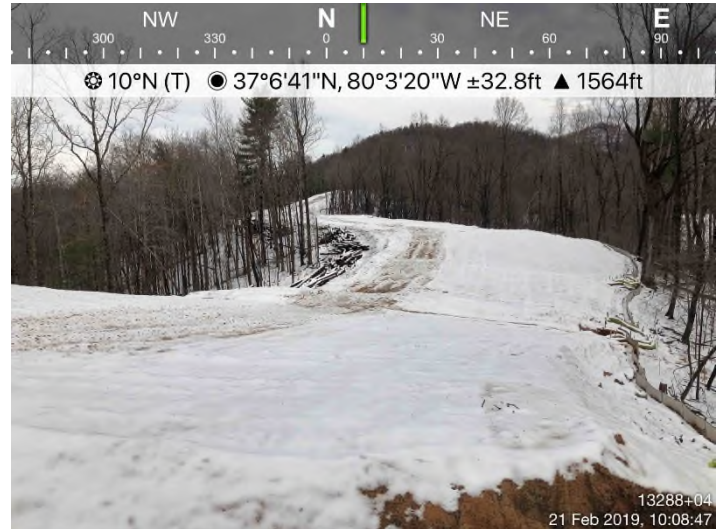
Fig. 2: **STA 13288+04** – Area stabilized.

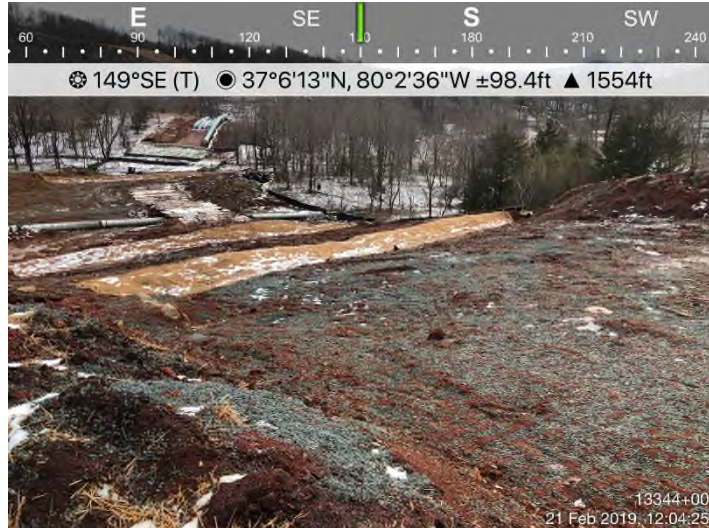
Fig. 3: **STA 13344+25** – Area stabilized.

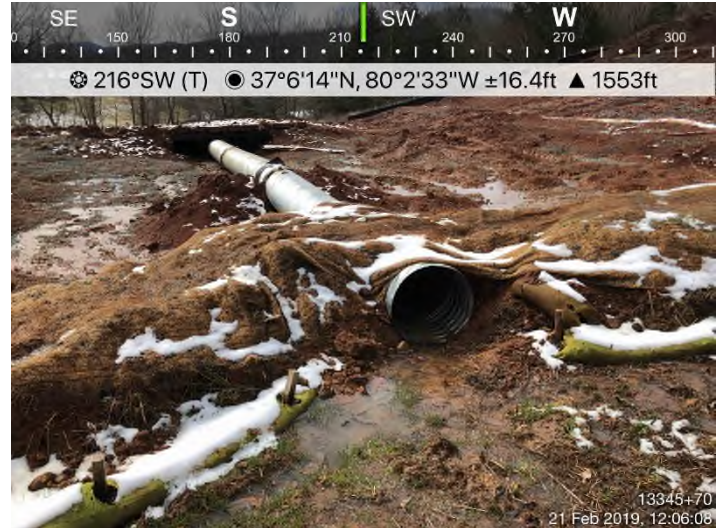
- Streams / wetlands inspected included: S-GH7, S-RR8, S-RR9 and S-RR11.
- CWD does not have inlet protection at STA 13345+70.
- CWD does not have inlet protection at CIS S-RR8.

Fig. 4: **STA 13345+70** – Inlet protection needed.

**Recommended Corrective Action:** Maintain and install all controls per the approved plan and specs.

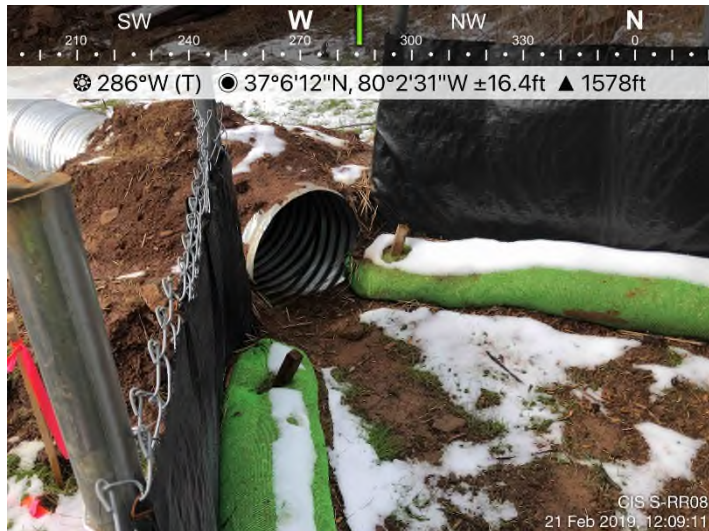
Fig. 5: **CIS S-RR8** – Inlet protection needed.

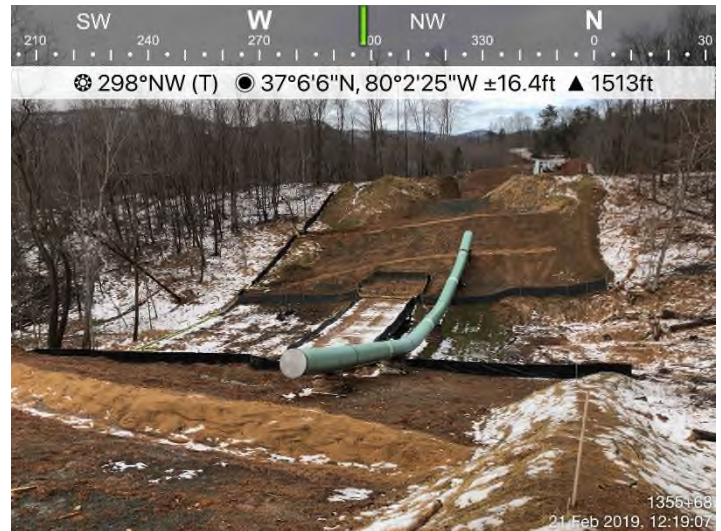
Fig. 6: **STA 13355+68** – Area stabilized.

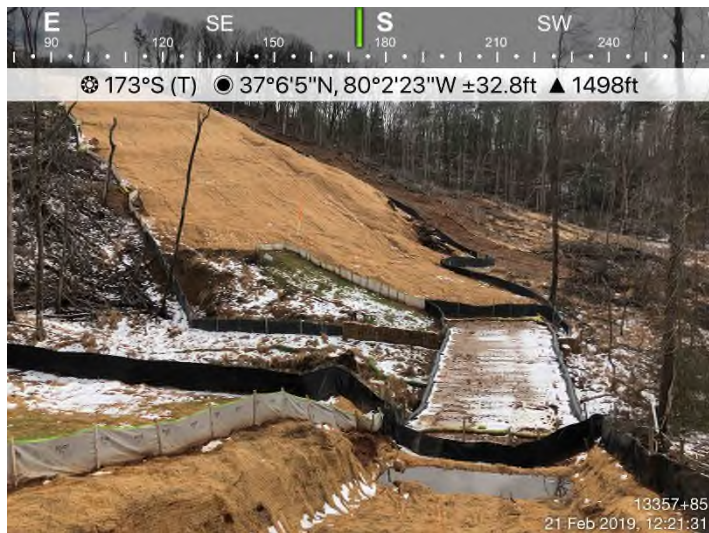
Fig. 7: **STA 13357+85** – S-R11 controls in place. Area stabilized.

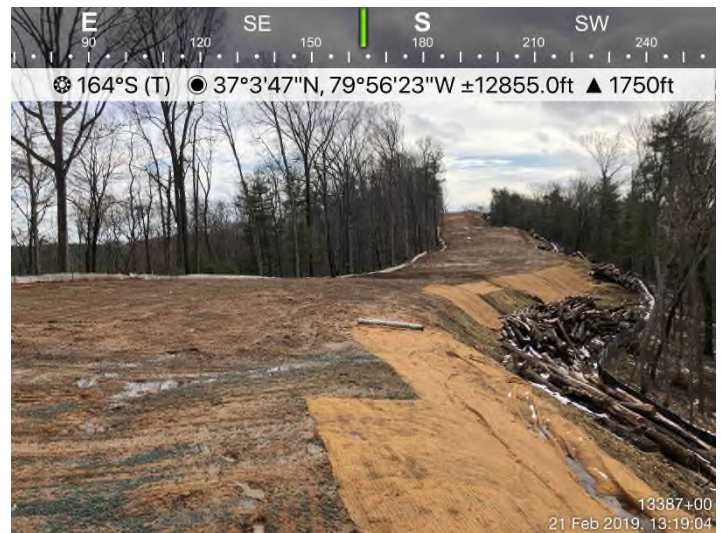
Fig. 8: **STA 13387+00** – Area stabilized.
