## FIELD INSPECTION

| <b>Project Name:</b> | <b>Mountain Valley Pipeline</b> | <b>Inspector:</b> | <b>Marshall Willis</b> |
| <b>Inspection Date:</b> | <b>Tuesday, February 19, 2019</b> | <b>Project Contact:</b> | <b>Brian Clauto</b> |
| <b>Spread I:<br/>Franklin County</b> | <b>STA 14062+17 – 14042+83<br/>STA 14272+24 – 14274+00<br/>STA 14129+00 – 14171+75</b> | <b>Weather (Wet/Dry/Rain):</b> | <b>Dry</b> |

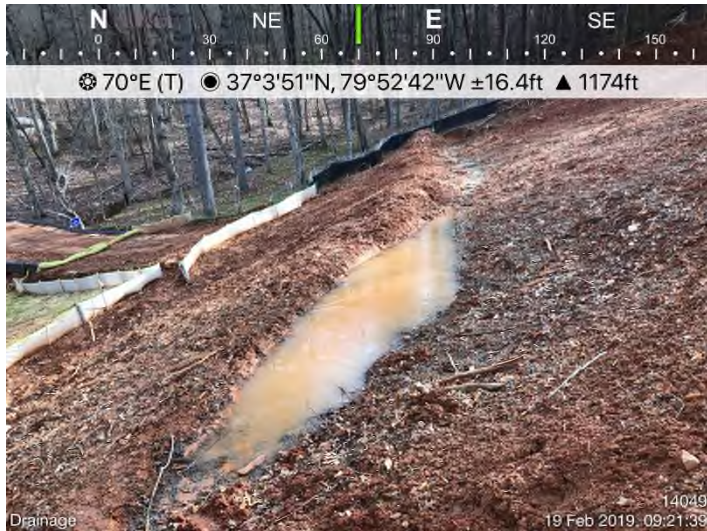
Fig. 1: **STA 14049+30** – Waterbar does not have positive drainage.

**Recommended Corrective Action:** Maintain and install all controls per the approved plan and specs.

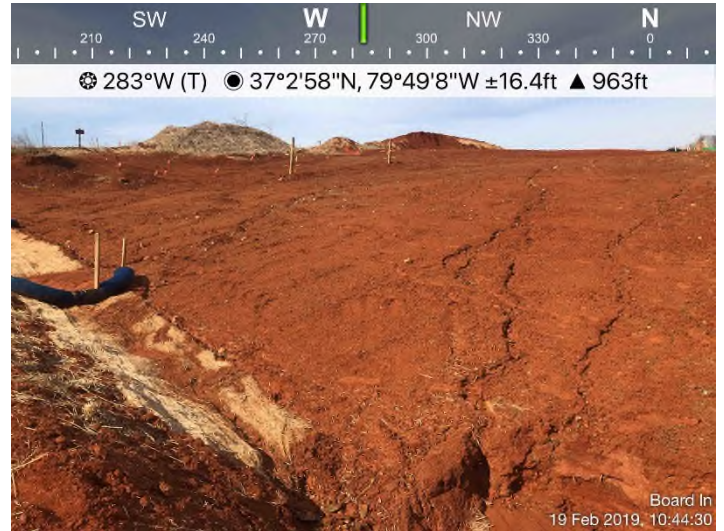
Fig. 2: **STA 14272+24** – Stabilization needed.

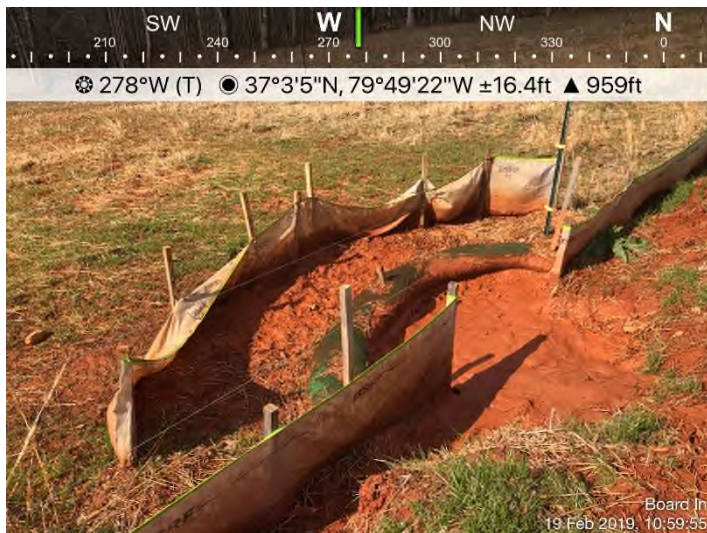
Fig. 3: **STA 14273+25** – Maintain P1.

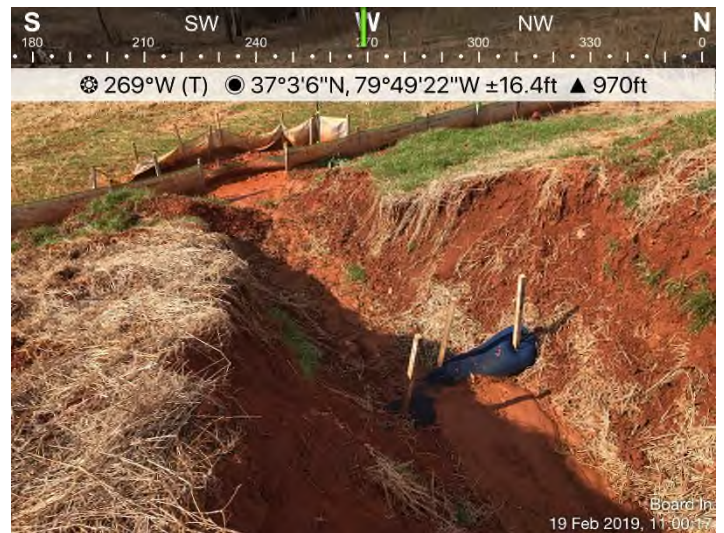
Fig. 4: **STA 14273+25** – Clean out CFS.

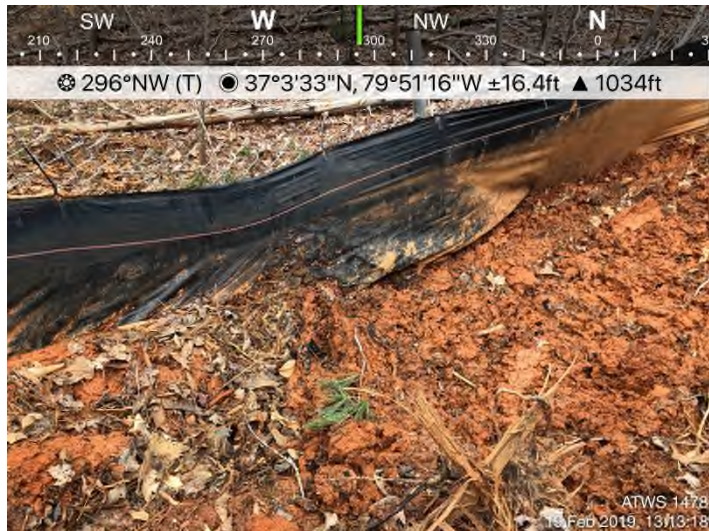
Fig. 5: **ATWS 1478** – Repair SSF.

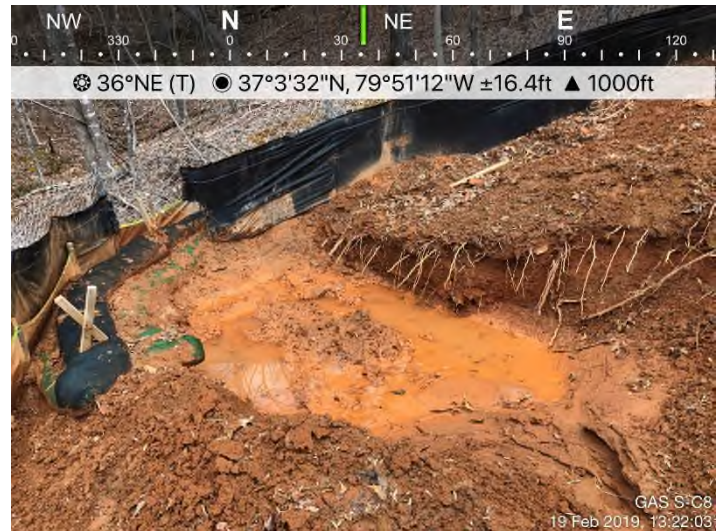
Fig. 6: **GAS S-C8** – Sump full.

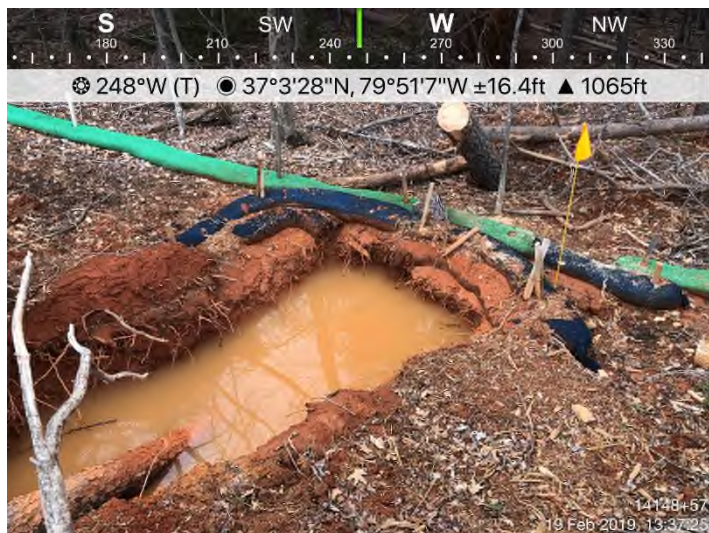
Fig. 7: **STA 14148+57** – Maintain CFS.

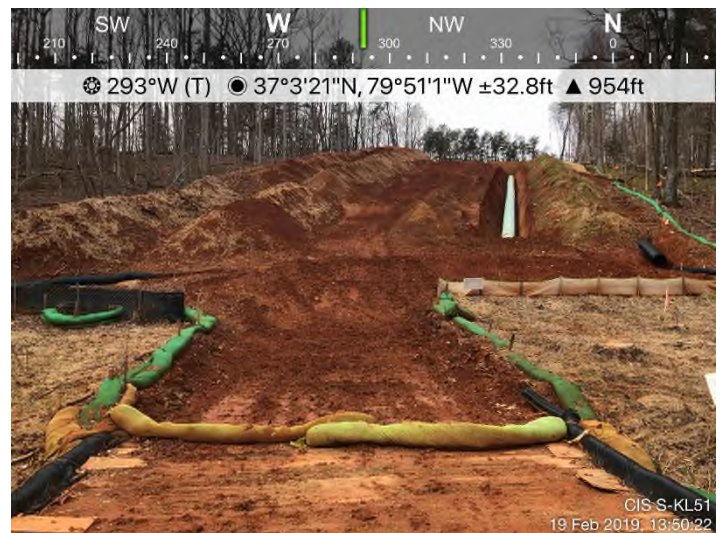
Fig. 8: **CIS S-KL51** – Stabilize areas adjacent to resource.
