## FIELD INSPECTION

| <b>Project Name:</b> | Mountain Valley Pipeline | <b>Inspector:</b> | Matthew Grant |
| <b>Inspection Date:</b> | Wednesday, January 30, 2019 | <b>Project Contact:</b> | Brian Clauto |
| <b>Spread:</b> Franklin County MP 282<br>St14915+00-14900+00<br>Pittsylvania County MP 290 St15350-15338, MP 293<br>St15494+80-15458 | Spread I | <b>Weather (Wet/Dry/Rain):</b> | Dry |

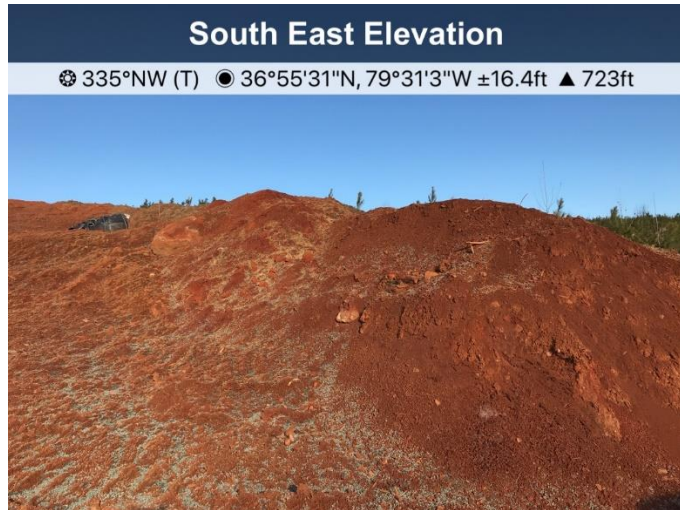
- Fig. 1 Stockpile near St#15344+00 requires additional stabilization

**Recommended Corrective Action:** Maintain and install all controls per the approved plan and specs.

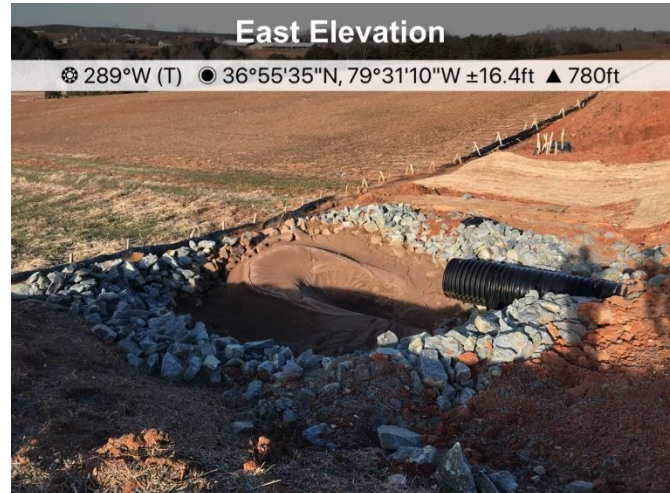
- Fig. 2 Plunge pool requires maintenance at St#15338+50

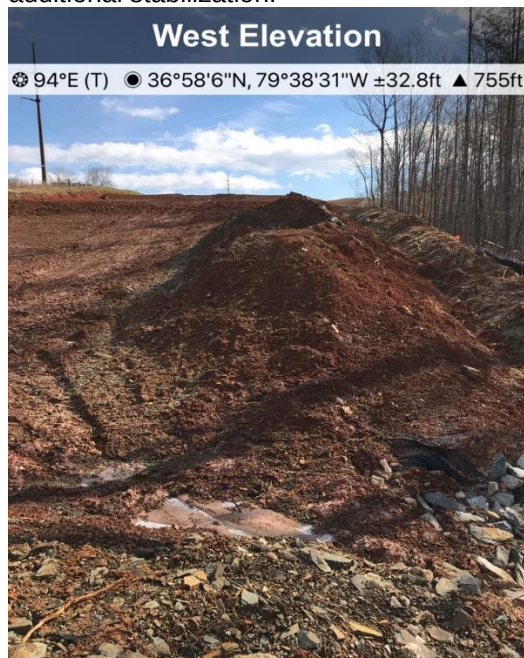
- Fig. 3 ROW and stockpiles near St#14915+00 require additional stabilization.

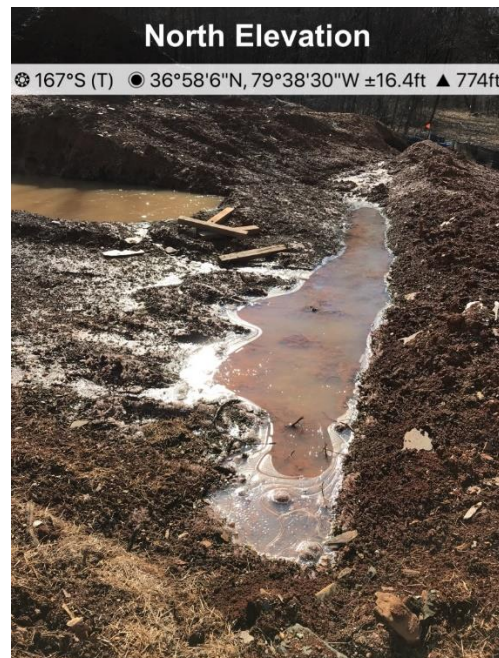
- Fig. 4 Waterbar requires maintenance at St#14916+00.

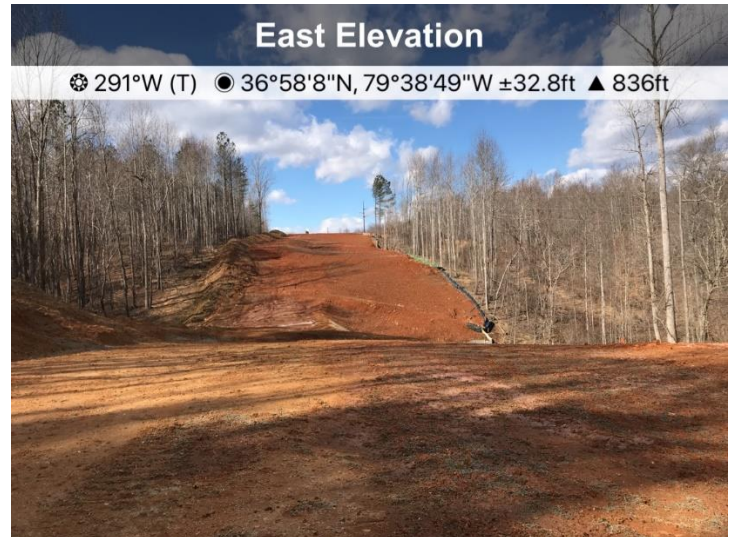
- Fig 6 Waterbars exceed 5% between 14902+00 and 14906+00.

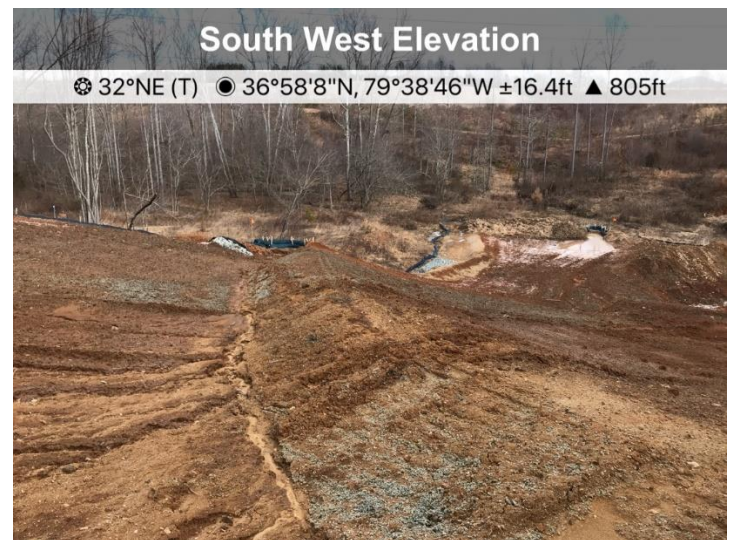
- Fig. 8 Waterbars exceed 5% between 14902+00 and 14906+00.
