FIELD INSPECTION

Project Name:	Mountain Valley Pipeline	Inspector:	Matthew Grant
Inspection Date:	Tuesday, January 22, 2019	Project Contact:	Brian Clauto
Spread: Montgomery County MP234-235	Spread H	Weather (Wet/Dry/Rain):	Dry
STAGE OF CONSTRUCTION: (Check all that apply)			
Clearing	Rough Grading	Trench Excavation	Pipe Assembly, Testing & Installation
Backfilling and Grade	e Restoration	& Stabilization	Other: dormant
		Yes No N/A	
	d and implemented in accordance with the nt control plan and stormwater manageme		
	ures properly maintained in effective oper nce with good engineering practices and, turer specifications?		
3 Areas of offsite sedi	ment deposition were observed?		
Comments:			
■ MP 234 St#12381+00 CFS and P1 silt fence is torn.			
Recommended Corrective Action : Maintain all controls per the approved plan and annual standards and specs.			
Deadline: _Within 24hr notification			
The recommended corrective constitute non-compliance and ensuring compliance on the above the control of the co	action deadline date applies to all conditions no d/or corrective actions are not completed by the pove project.	oted on this report unless otherwis e deadline, other enforcement acti

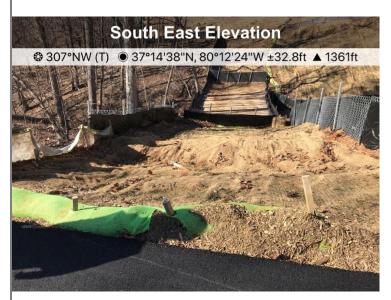
Fig. 1 MP 234 St#12381+00 CFS and P1 silt fence is torn.

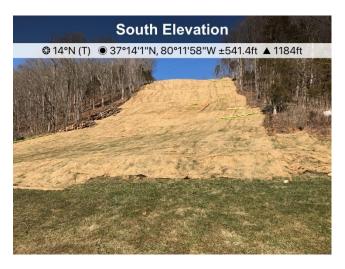
Fig. 3 At St#12420+44 matting has been installed
