## FIELD INSPECTION

| <b>Project Name:</b> | Mountain Valley Pipeline | <b>Inspector:</b> | Matthew Grant |
| <b>Inspection Date:</b> | Wednesday, February 27, 2019 | <b>Project Contact:</b> | Brian Clauto |
| <b>Spread: Roanoke County<br/>AR 287 Green Hollow Drive</b> | Spread H | <b>Weather (Wet/Dry/Rain):</b> | Dry |

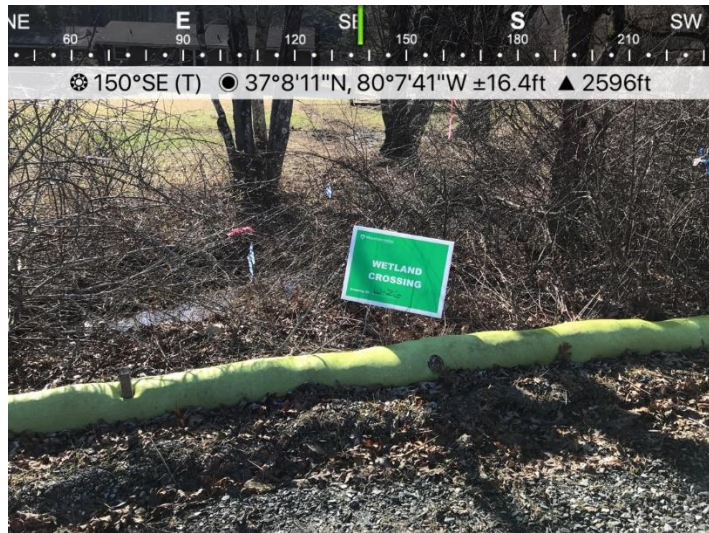
- Fig. 1. Wetland W-Z6 controls were in place and functioning at the time of inspection.

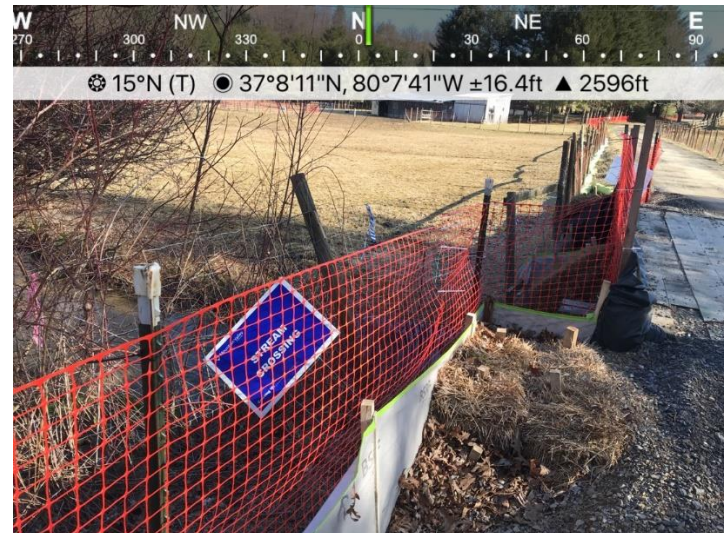
- Fig. 2. At designated stream S-Z16 erosion controls were in place and functioning at the time of inspection

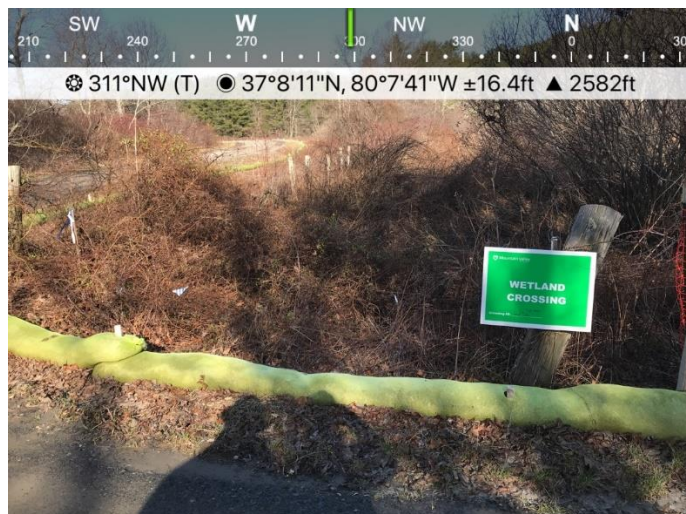
- Fig. 3. Wetland W-Z7 erosion controls were in place and functioning at the time of the inspection.

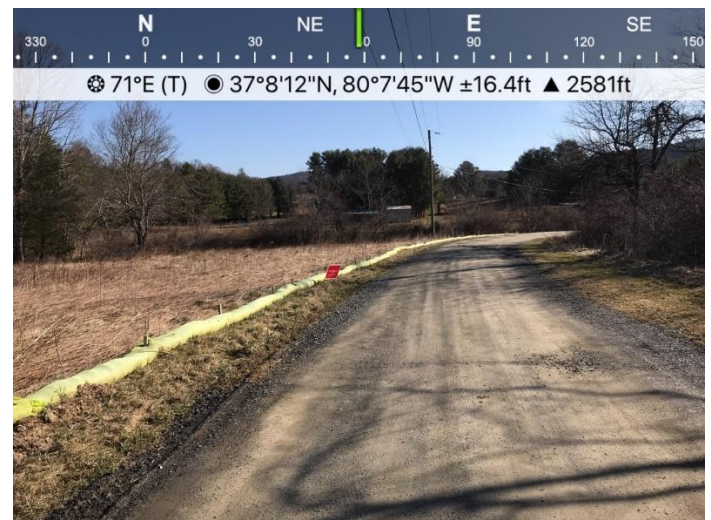
- Fig. 4. Access Rd 287 Green Hollow Drive, erosion controls were in place and functioning at the time of the inspection.
