## FIELD INSPECTION REPORT

| <b>Project Name:</b> | Mountain Valley Pipeline | <b>Inspector:</b> | Matthew Grant |
| <b>Inspection Date:</b> | Wednesday, March 4, 2020 | <b>Project Contact:</b> | Brian Clauto, |
| <b>Spread H:</b><br>Montgomery | MP 227.4-226.9<br>AR 268.01<br>ATWS 474, 474A | <b>Weather:</b> | Dry |

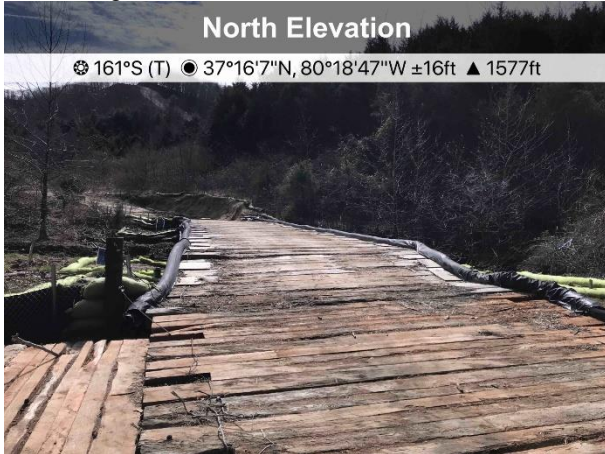
- Figure 1: Along AR 268.01 ECD's are in place at designated crossing S-G36.

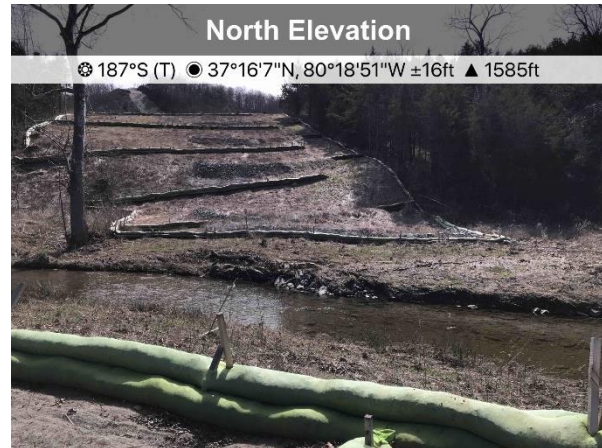
- Figure 2: On ROW at designated crossing S-G36, ECD's are in place and is stabilized with vegetation.

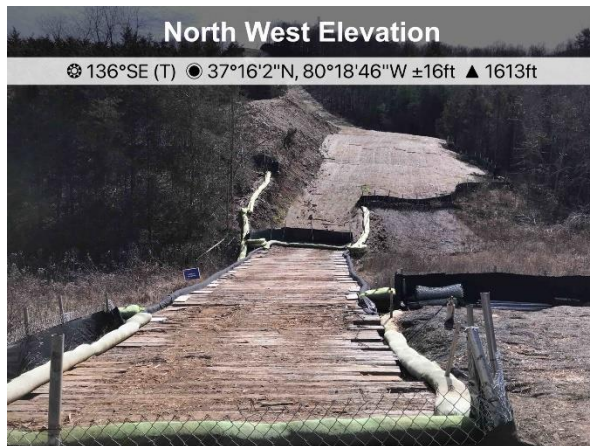
- Figure 3: At designated crossing S-G38 ECD's are in place.

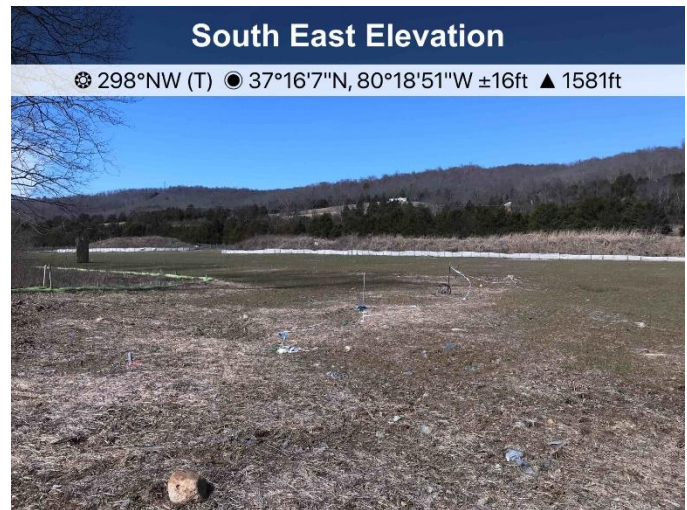
- Figure 4: ATWS 474 remains dormant and stabilized.
