## FIELD INSPECTION REPORT

| <b>Project Name:</b> | Mountain Valley Pipeline | <b>Inspector:</b> | Matthew Grant |
| <b>Spread I:<br/>Pittsylvania</b> | MP 291.1-293<br>ATWS 493, 548, 549, 494 | <b>Weather:</b> | Dry |

## FIELD INSPECTION PHOTO LOG

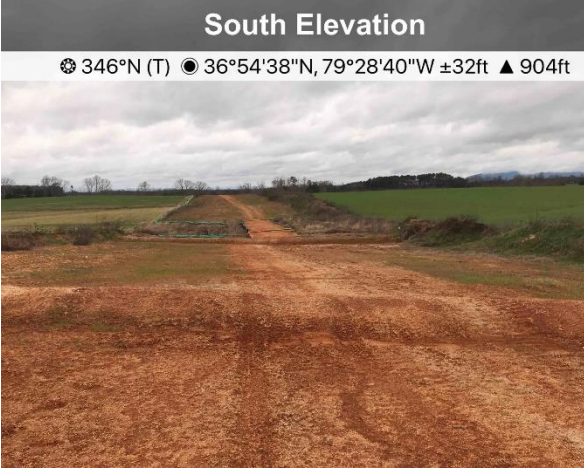
| <p>▪ <u>Figure 1:</u> Near MP293 ECD's are in place.</p> | <p>▪ <u>Figure 2:</u> Near MP292.3, the ROW is vegetated and CFS is in place.</p> |

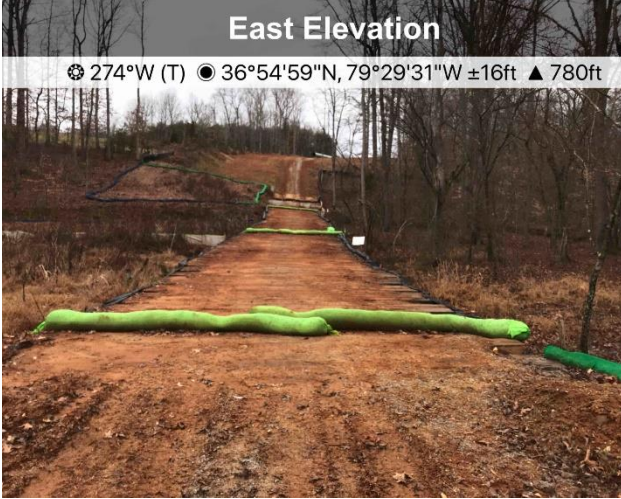
| <p>▪ <u>Figure 3:</u> At designated crossing S-G4, ECD's are in place</p> | <p>- <u>Figure 4:</u> Near MP291.1, ECD's are in place.</p> |
