COMPLAINT INVESTIGATION REPORT

Project Name:	Mountain Valley Pipeline	Inspector:	Marshall Willis
Inspection Date:	Wednesday, March 3, 2021	Project Contact:	Brian Clauto, Cory Chalmers
Spread I: Franklin County Pittsylvania County	STA 14993+00 – 15063+85 MVP-FR-324	Weather:	Wet

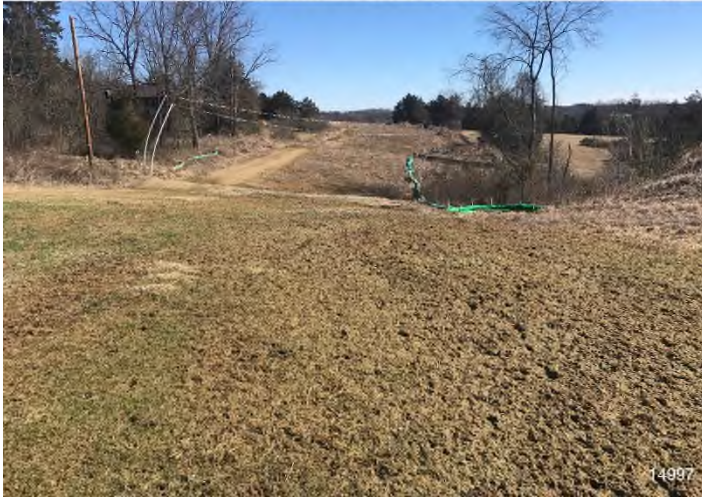
Figure 1: STA 14997+00 – Controls in place and functioning properly. Area stabilized with straw and hydro-mulch fiber matrix. No erosion evident.

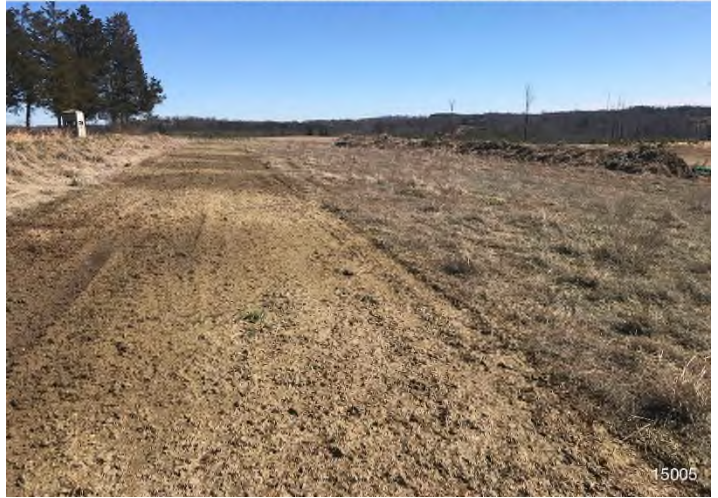
Figure 2: STA 15005+00 – Controls in place and functioning properly. Area stabilized with straw and hydro-mulch fiber matrix. No erosion evident.

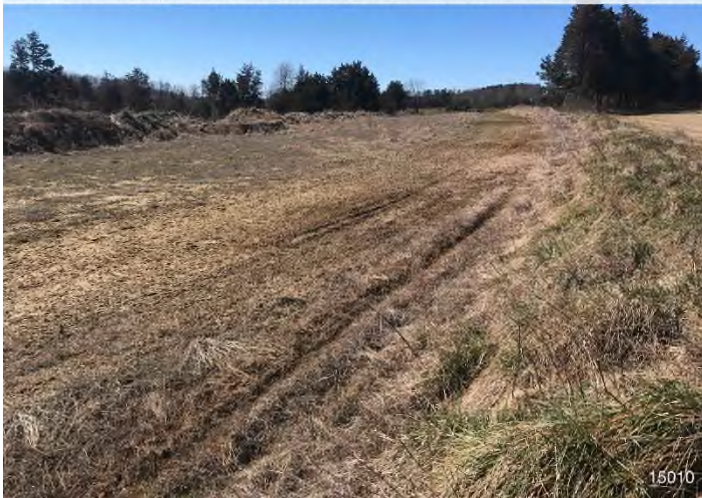
Figure 3: STA 15010+00 – Controls in place and functioning properly. Area stabilized with straw and hydro-mulch fiber matrix. No erosion evident.

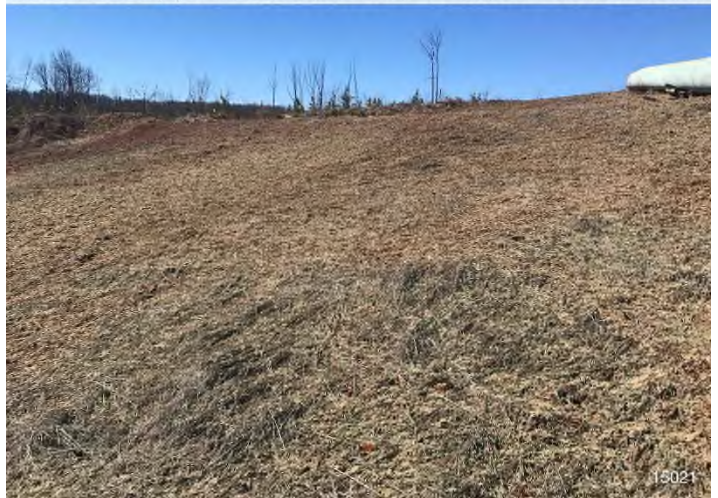
Figure 4: STA 15021+00 – Controls in place and functioning properly. Area stabilized with straw and hydro-mulch fiber matrix. No erosion evident.

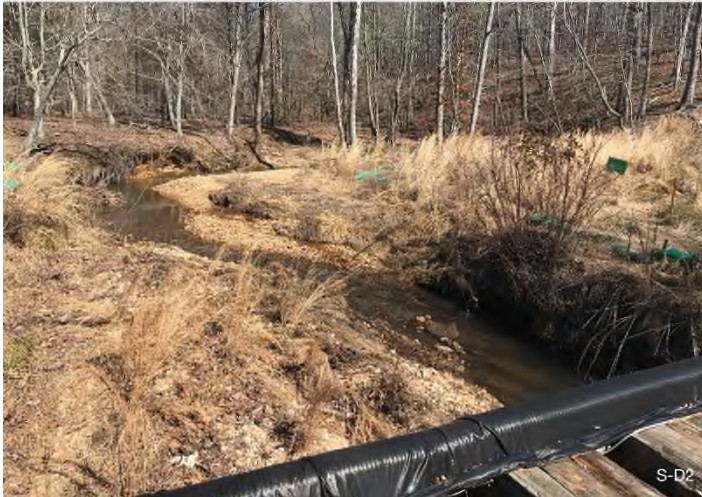
Figure 5: Stream S-D2 – Controls in place and functioning properly around Stream S-D2.

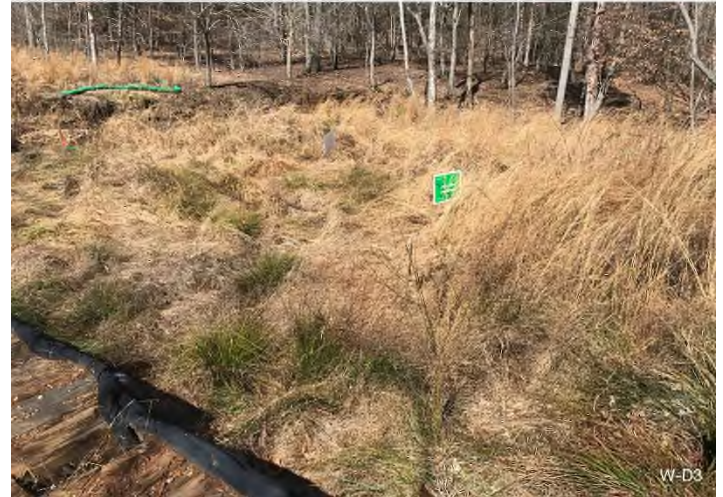
Figure 6: Wetland W-D3 – Controls in place and functioning properly around Wetland W-D3.

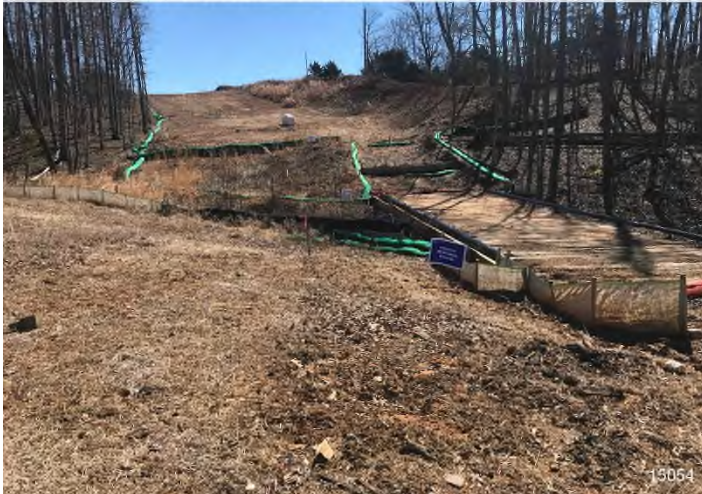
Figure 7: STA 15054+00 – Controls in place and functioning properly. Area stabilized with straw and erosion matting. No erosion evident.

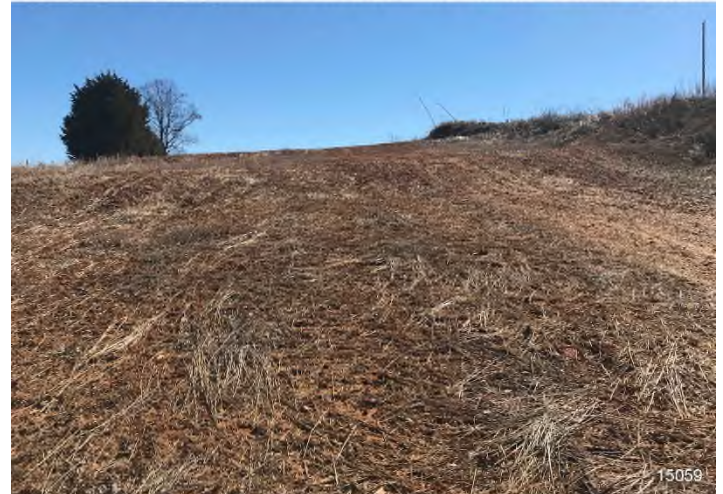
Figure 8: STA 15059+00 – Controls in place and functioning properly. Area stabilized with straw and erosion matting. No erosion evident.
