## FIELD INSPECTION REPORT

Project Name:	Mountain Valley Pipeline	Inspector:	Marshall Willis
Inspection Date:	Monday, March 1, 2021	Project Contact:	Brian Clauto, Cory Chalmers
Spread H: Montgomery County	STA 12298+39 – 12371+23 MVP-MN-276.03	Weather:	Rainy

## FIELD INSPECTION PHOTO LOG

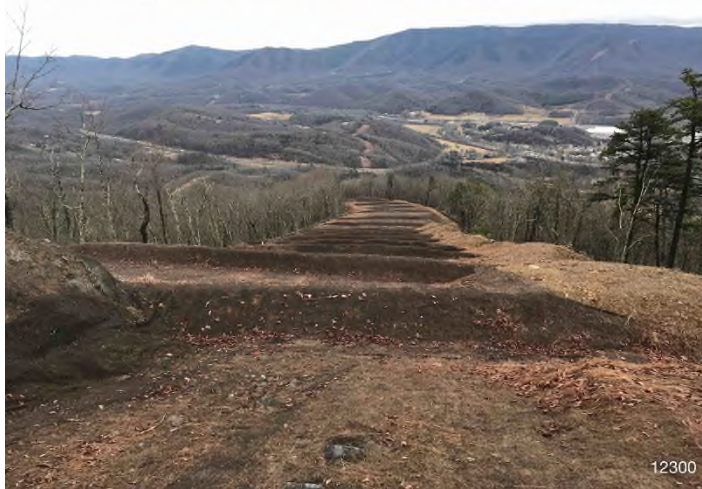
**Figure 1: STA 12330+00** – Controls in place and functioning properly. Area stabilized with erosion control matting.

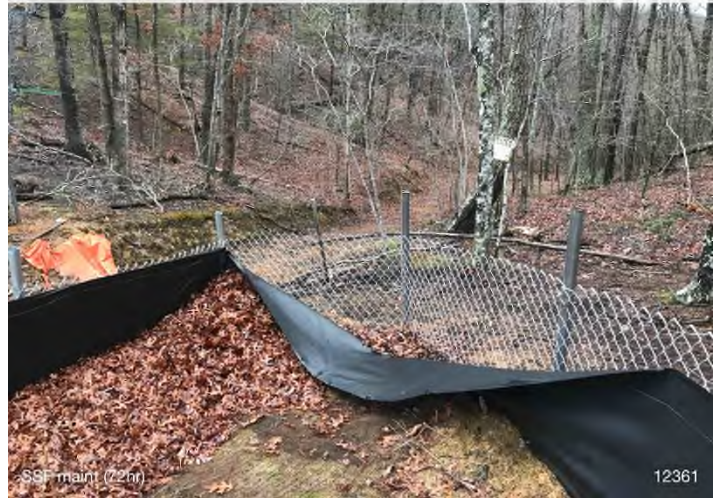
- STA 12338+50: Trash/construction debris deposited into controls.
- STA 12352+00: Trash/construction debris blowing off ROW.
- STA 12361+00: SSF maintenance required.

**Figure 2: STA 12361+00** – SSF maintenance required.

**Recommended Corrective Action:** Maintain and install all controls per the approved PSS&S. Provide good "housekeeping" measures to prevent trash and debris from impacting ESC controls or blowing off ROW.

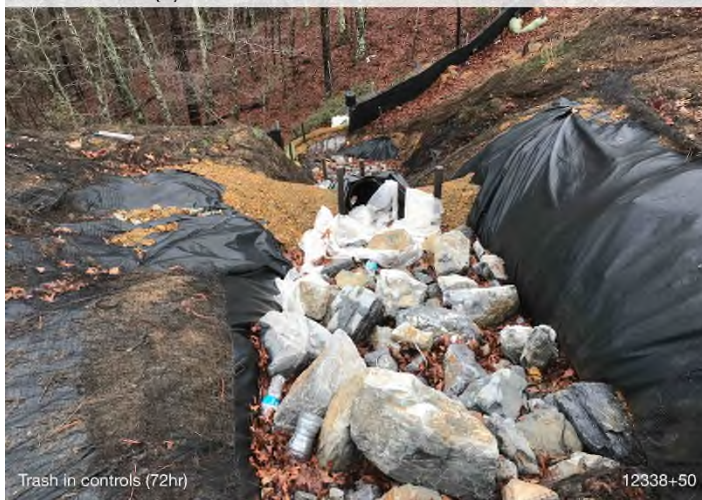
**Figure 3: STA 12338+50** – Trash and construction debris deposited in controls.

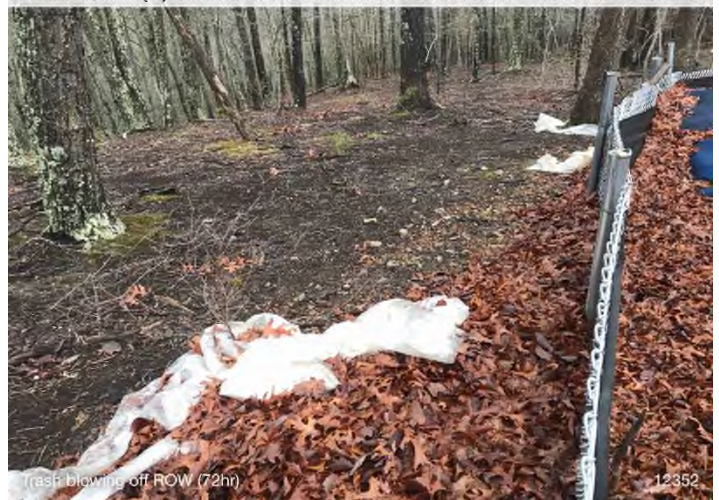
**Figure 4: STA 12352+00** – Construction debris deposited off ROW.
