FIELD INSPECTION REPORT

Project Name:	Mountain Valley Pipeline	Inspector:	Matthew Grant
Inspection Date:	Tuesday, March 30, 2021	Project Contact:	Brian Clauto
Spread G: Giles	ST11150+00-11120+00 ATWS 1367 AR-GI 249.01	Weather:	Dry

FIELD INSPECTION PHOTO LOG

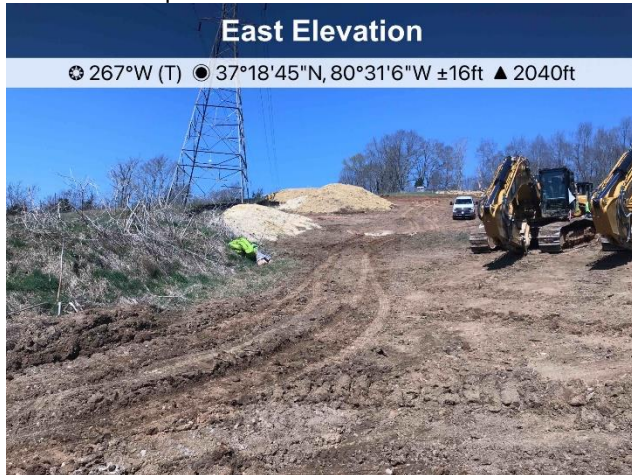
- Figure 1: Near St 11150+00, grading activities were ongoing and ECD's were in place.

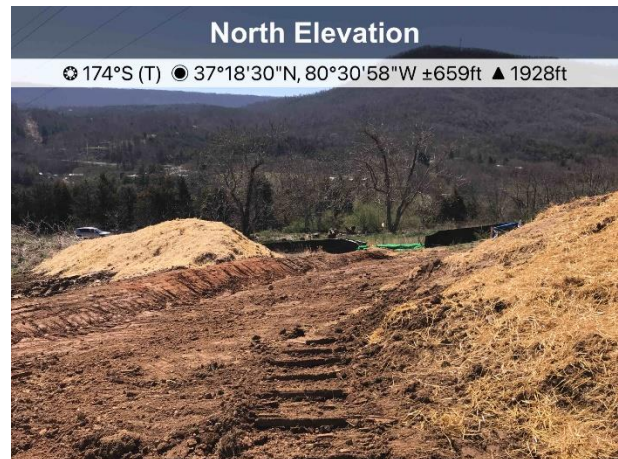
- Figure 2: Near St 1114800 stockpiles have been stabilized and ECD's have been installed.

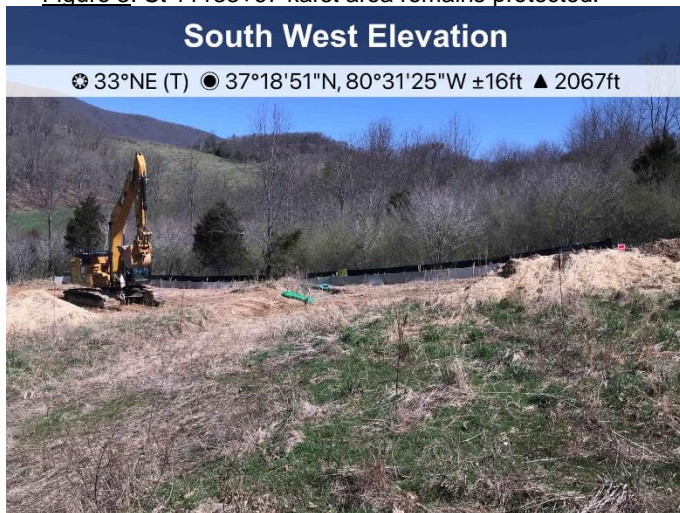
- Figure 3: St 11133+67 karst area remains protected.

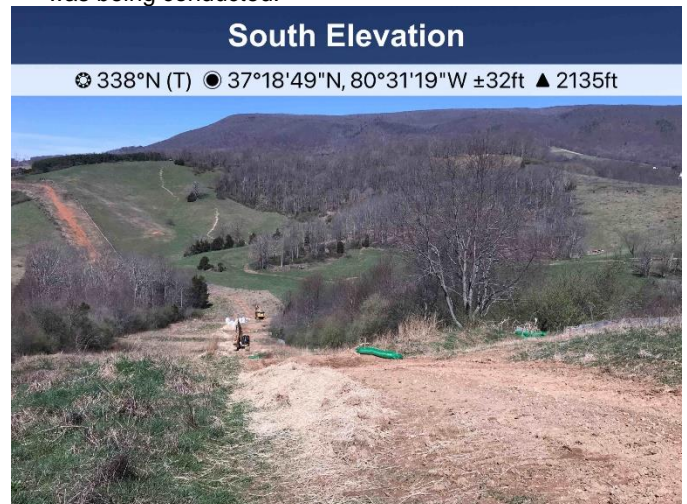
- Figure 4: Near St 11138+00, ROW travel lane maintenance was being conducted.
