## FIELD INSPECTION REPORT

<b>Project Name:</b>	Mountain Valley Pipeline	<b>Inspector:</b>	Marshall Willis
<b>Inspection Date:</b>	Friday, March 26, 2021	<b>Project Contact:</b>	Brian Clauto, Cory Chalmers
<b>Spread I: Franklin County</b>	STA 13541+66 – 13575+42 STA 13995+00 – 14000+00 MVP-FR-303.01	<b>Weather:</b>	Wet

## FIELD INSPECTION PHOTO LOG

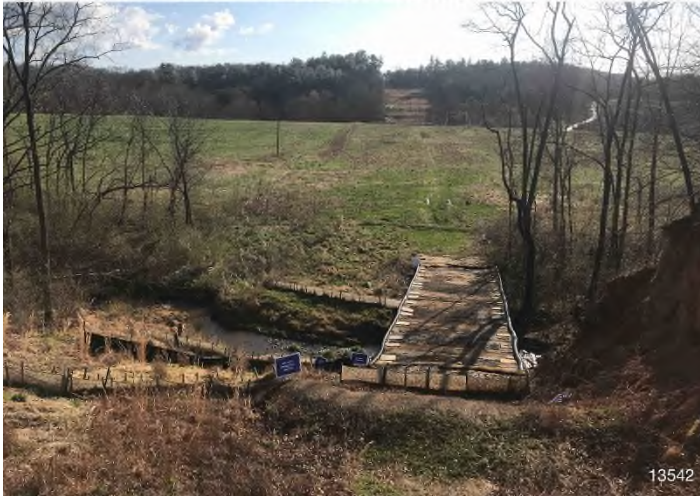
13542

**Figure 1: STA 13542+00** – Controls in place and functioning properly.

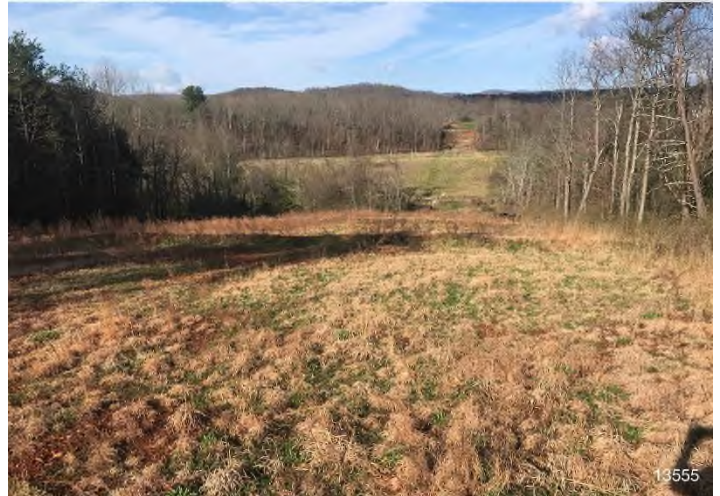
13555

**Figure 2: STA 13555+00** – Controls in place and functioning properly.

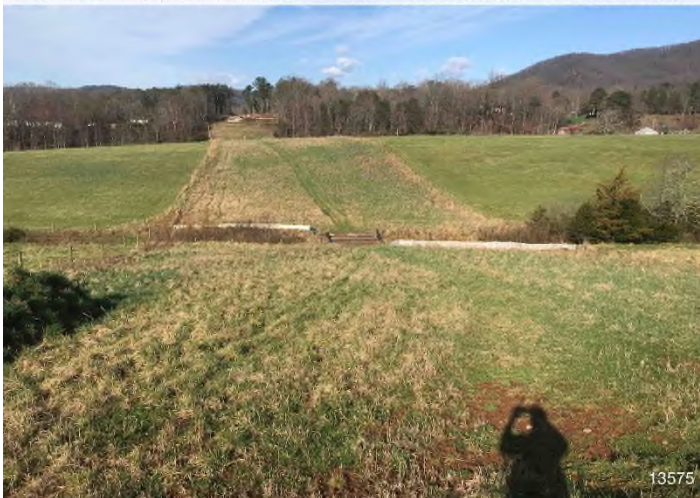
13575

**Figure 3: STA 13575+00** – Controls in place and functioning properly.

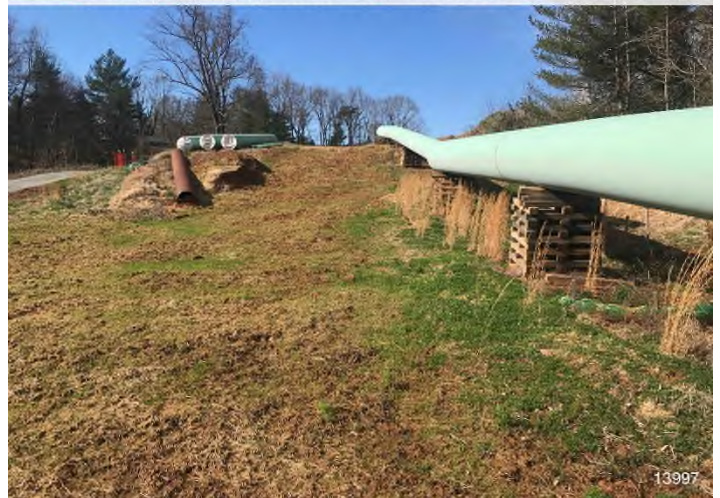
13997

**Figure 4: STA 13997+00** – Controls in place and functioning properly. Area stabilized with straw and Earth-Guard Edge.
