FIELD INSPECTION REPORT

Project Name:	Mountain Valley Pipeline	Inspector:	Marshall Willis
Inspection Date:	Wednesday, March 24, 2021	Project Contact:	Brian Clauto, Cory Chalmers
Spread H: Franklin County	STA 12994+02 – 13063+00 MVP-FR-290	Weather:	Wet

FIELD INSPECTION PHOTO LOG

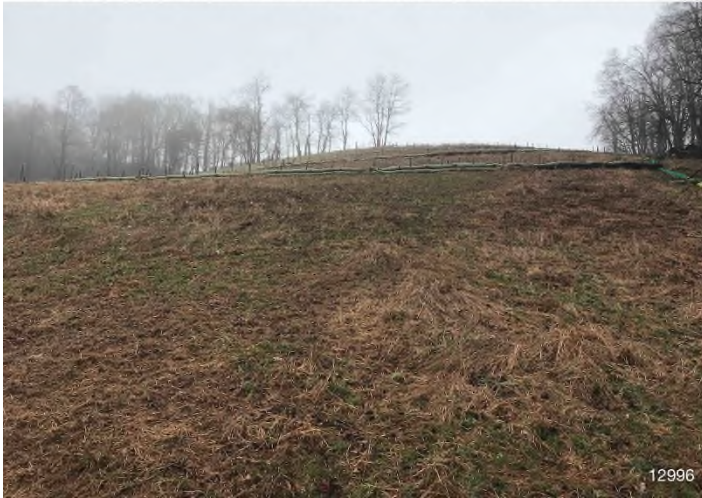
Figure 1: STA 12996+00 – Controls in place and functioning properly.
BRG: 106°E (T) LAT: 37.130701 LON: -80.130706 ±541ft ALT: 2640ft

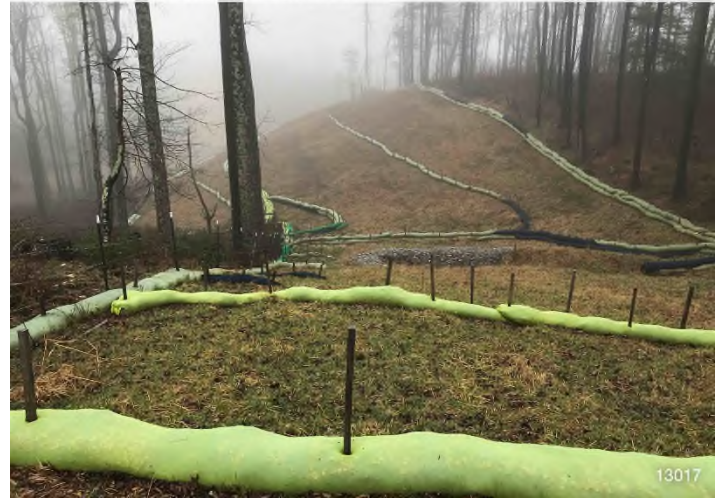
Figure 2: STA 13017+00 – Controls in place and functioning properly.
BRG: 101°E (T) LAT: 37.125474 LON: -80.122712 ±164ft ALT: 3019ft

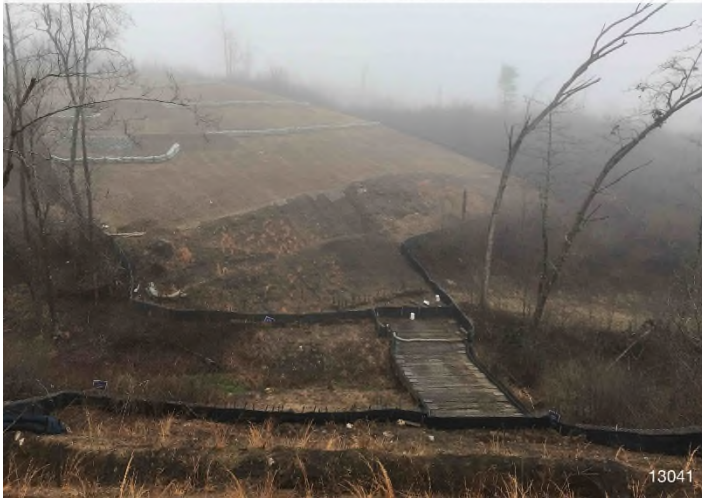
Figure 3: STA 13041+00 – Controls in place and functioning properly.
BRG: 133°SE (T) LAT: 37.115051 LON: -80.077529 ±16421ft ALT: 2763ft

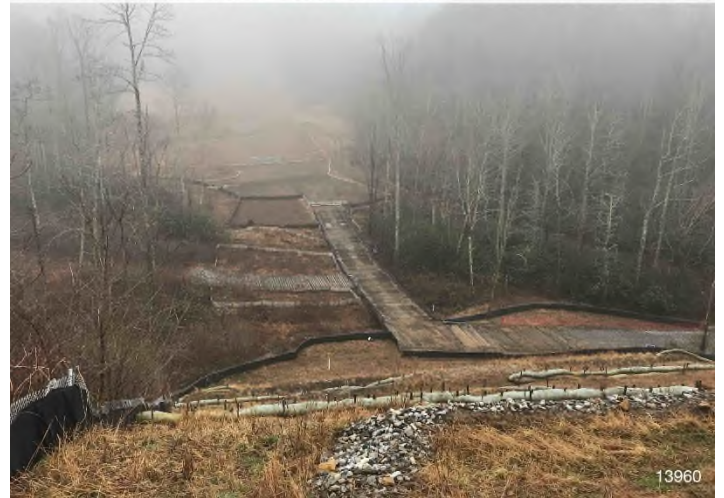
Figure 4: STA 13060+00 – Controls in place and functioning properly.
BRG: 119°SE (T) LAT: 37.125336 LON: -80.112661 ±24158ft ALT: 2712ft
