## FIELD INSPECTION REPORT

| Project Name: | Mountain Valley Pipeline | Inspector: | Marshall Willis |
| Spread H:<br>Franklin County | STA 13316+13 – 13260+00 | Weather: | Dry |

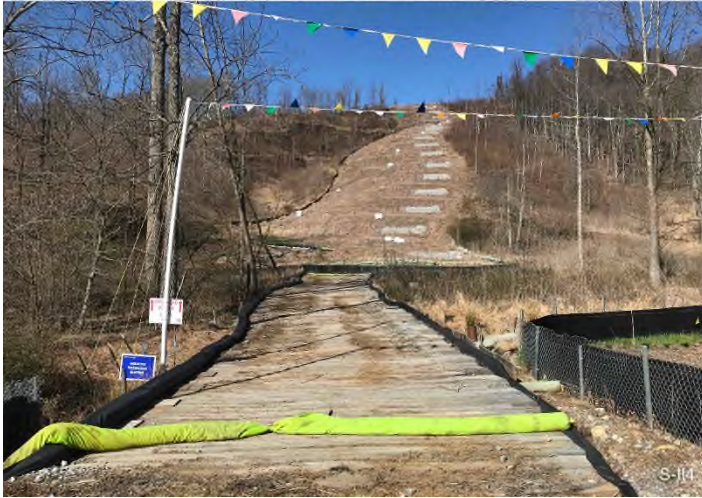
**Figure 1: Stream S-II4** – Controls in place and functioning properly around stream S-II4 crossing.

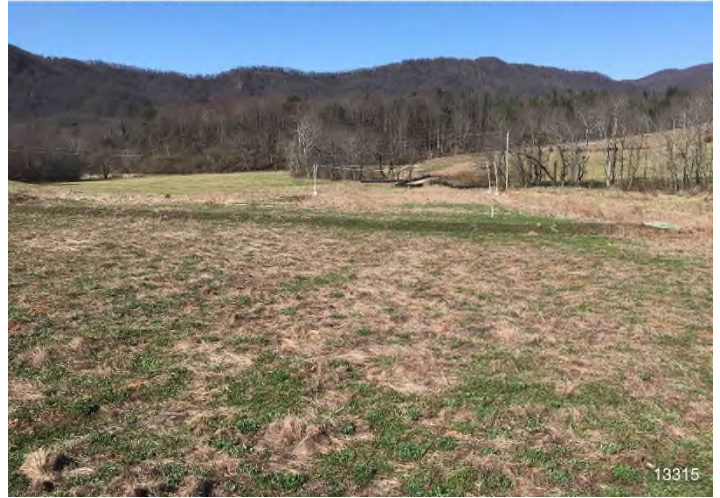
**Figure 2: STA 13315+00** – Controls in place and functioning properly.

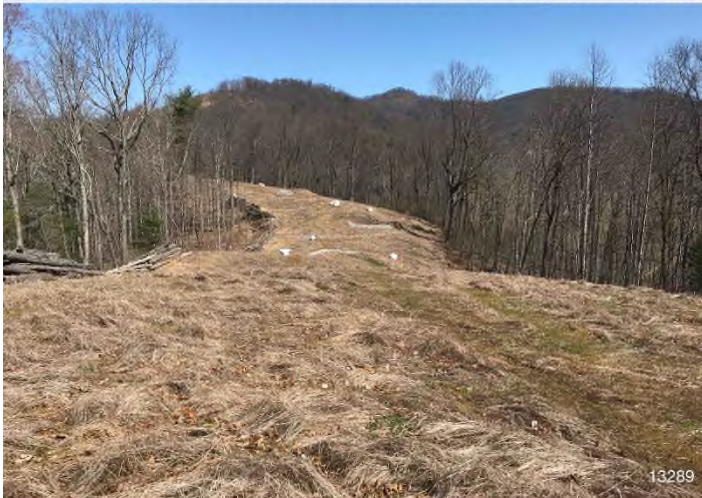
**Figure 3: STA 13289+00** – Controls in place and functioning properly.

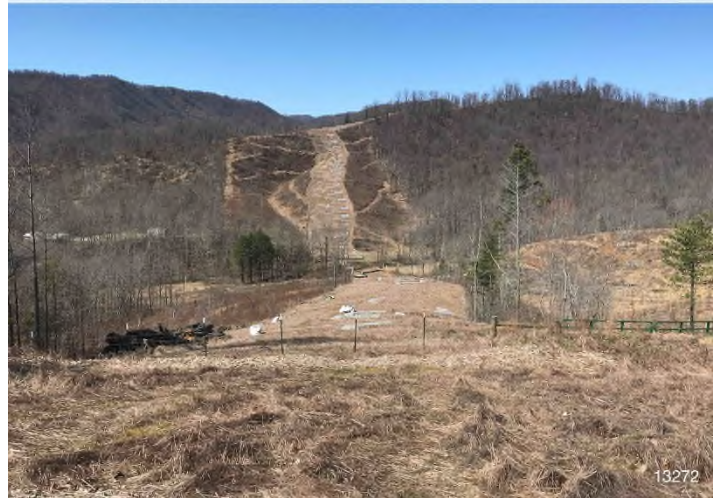
**Figure 4: STA 13273+00** – Controls in place and functioning properly.
