## FIELD INSPECTION REPORT

| <b>Project Name:</b> | Mountain Valley Pipeline | <b>Inspector:</b> | Marshall Willis |
| <b>Spread I:<br/>Franklin County</b> | STA 14845+68 – 14928+52 | <b>Weather:</b> | Wet |

## FIELD INSPECTION PHOTO LOG

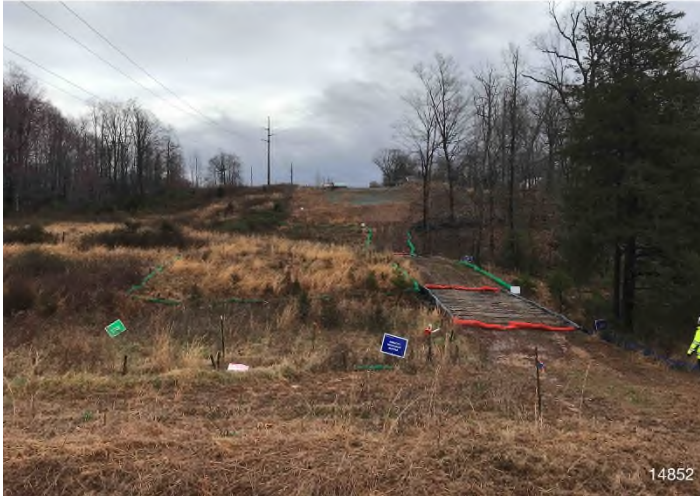
**Figure 1: STA 14852+00** – Controls in place and functioning properly. Area stabilized with straw and Earth-Guard.

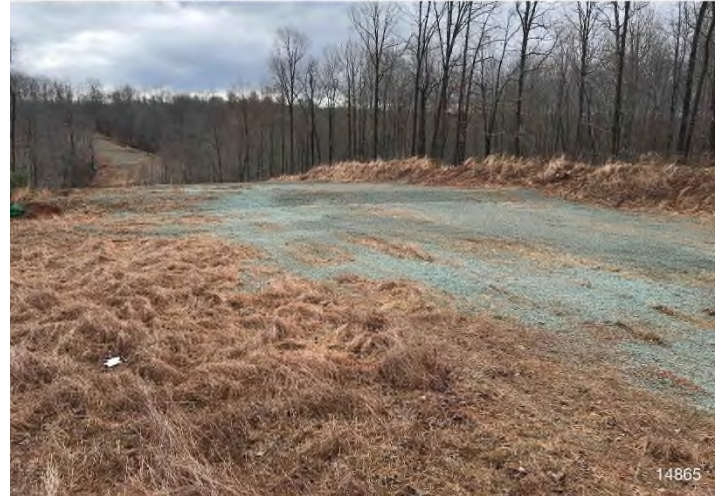
**Figure 2: STA 14865+00** – Controls in place and functioning properly. Area stabilized with straw and Earth-Guard.

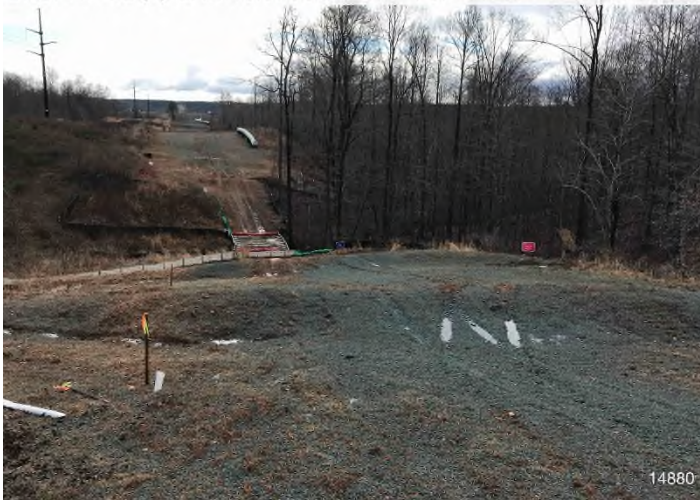
**Figure 3: STA 14880+00** – Controls in place and functioning properly. Area stabilized with straw and Earth-Guard.

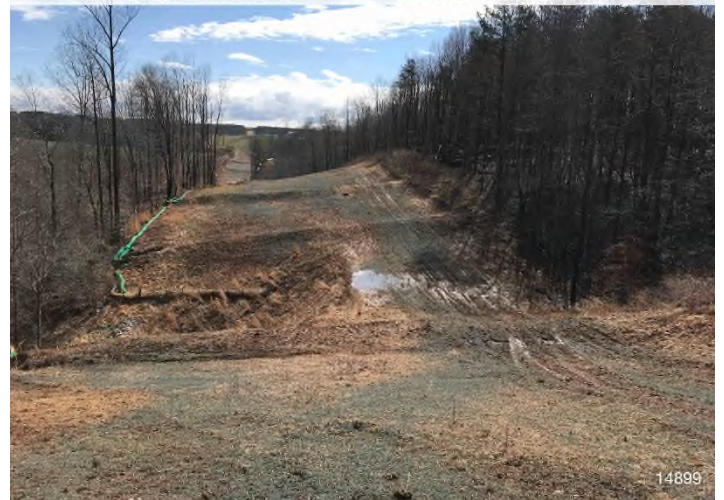
**Figure 4: STA 14899+00** – Controls in place and functioning properly. Area stabilized with straw and Earth-Guard.
