## FIELD INSPECTION REPORT

| <b>Project Name:</b> | Mountain Valley Pipeline | <b>Inspector:</b> | Marshall Willis |
| <b>Spread H:<br/>Montgomery County</b> | STA 12071+80 – 12190+95<br>MVP-MN-270<br>MVP-MN-274 | <b>Weather:</b> | Dry |

## FIELD INSPECTION PHOTO LOG

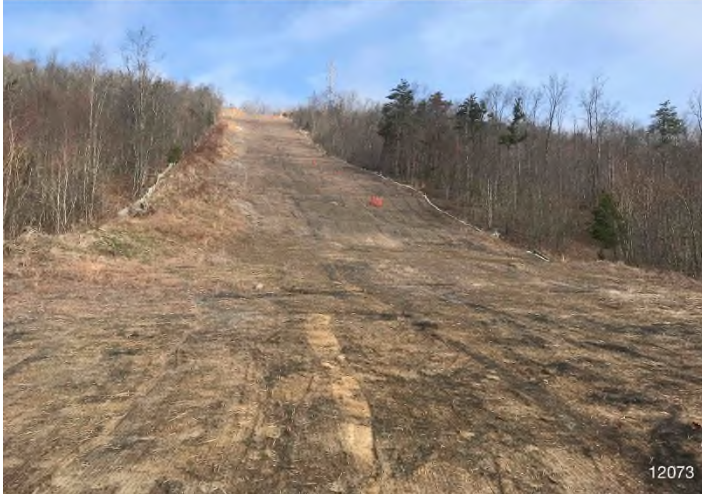
**Figure 1: STA 12073+00** – Controls in place and functioning properly. Area stabilized with erosion control matting and straw.  
BRG: 357°N (T) LAT: 37.230819 LON: -80.260627 ±7205ft ALT: 1297ft

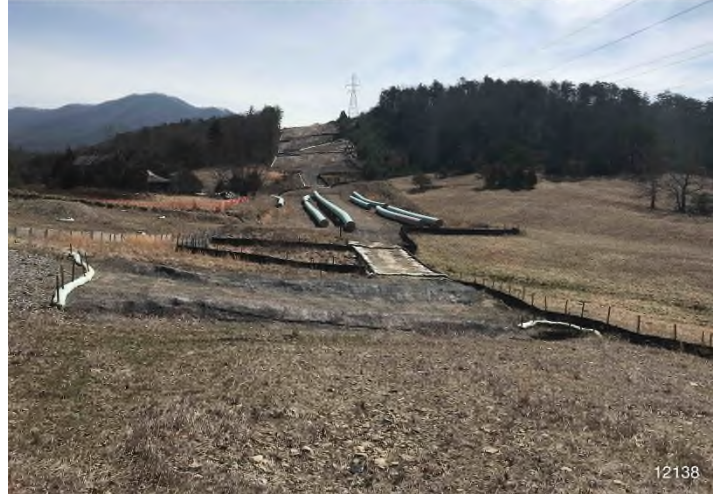
**Figure 2: STA 12138+00** – Controls in place and functioning properly. Area stabilized with erosion control matting and straw.  
BRG: 102°E (T) LAT: 37.256126 LON: -80.276270 ±16ft ALT: 1420ft

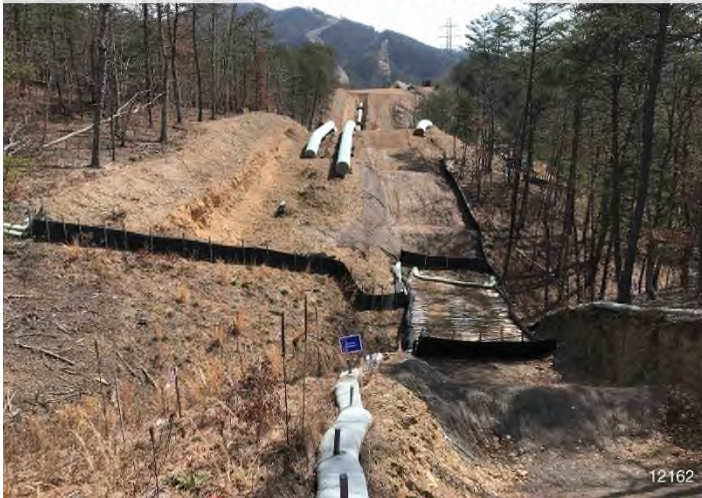
**Figure 3: STA 12162+00** – Controls in place and functioning properly. Area stabilized with erosion control matting and straw.  
BRG: 98°E (T) LAT: 37.250842 LON: -80.267059 ±3051ft ALT: 1447ft

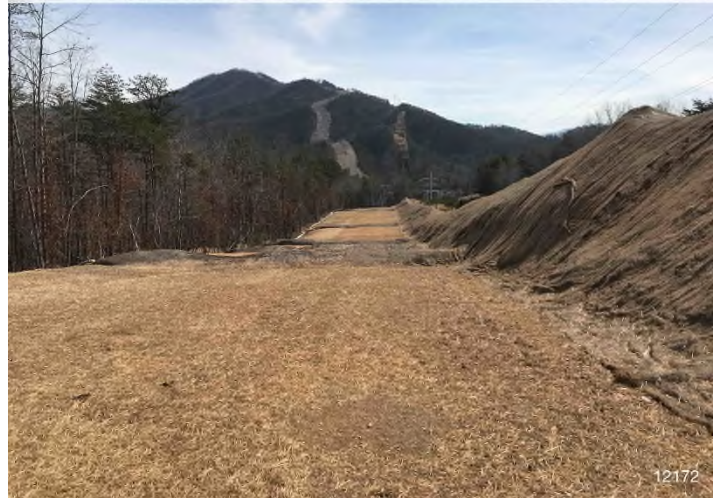
**Figure 4: STA 12172+00** – Controls in place and functioning properly. Area stabilized with erosion control matting and straw.  
BRG: 99°E (T) LAT: 37.231655 LON: -80.260382 ±7205ft ALT: 1420ft
