## FIELD INSPECTION REPORT

Project Name:	Mountain Valley Pipeline	Inspector:	Marshall Willis
Inspection Date:	Tuesday, March 16, 2021	Project Contact:	Brian Clauto, Cory Chalmers
Spread I: Franklin County	STA 14441+00 – 14524+76 MVP-FR-315	Weather:	Wet

## FIELD INSPECTION PHOTO LOG

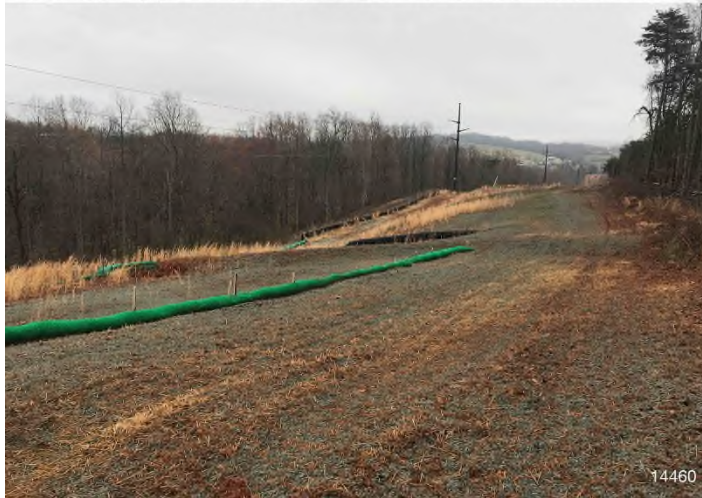
**Figure 1: STA 14460+00** – Controls in place and functioning properly. Area stabilized with straw and Earth-Guard.

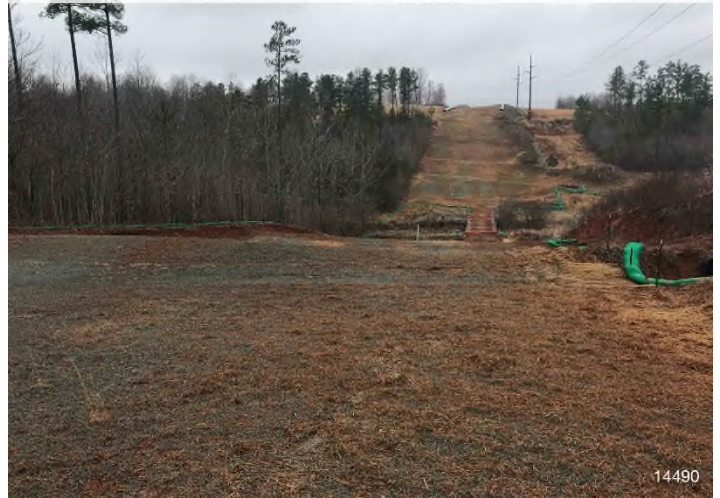
**Figure 2: STA 14490+00** – Controls in place and functioning properly. Area stabilized with straw and Earth-Guard.

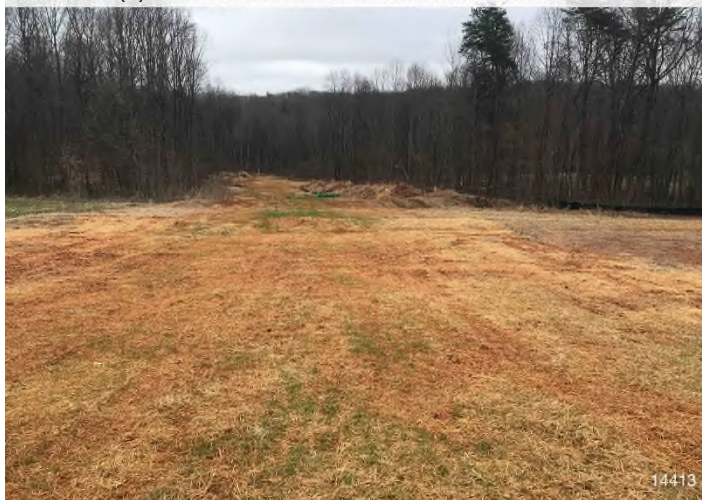
**Figure 3: STA 14413+00** – Controls in place and functioning properly. Area stabilized with straw and Earth-Guard.

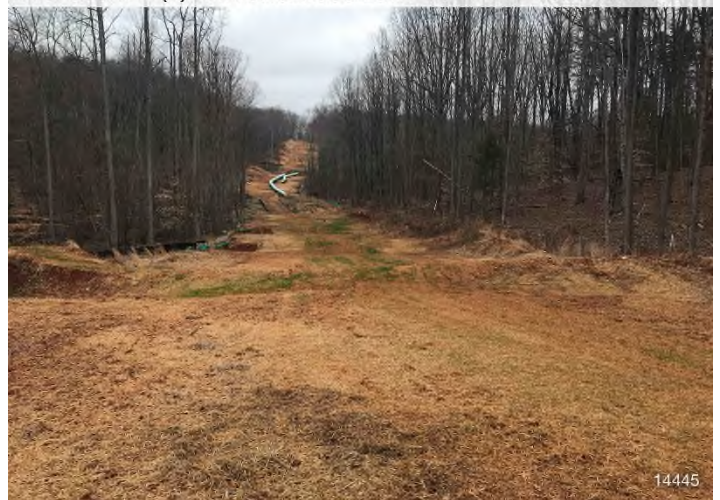
**Figure 4: STA 14445+00** – Controls in place and functioning properly. Area stabilized with straw and Earth-Guard.
