## FIELD INSPECTION REPORT

| <b>Project Name:</b> | Mountain Valley Pipeline | <b>Inspector:</b> | Marshall Willis |
| <b>Spread H:<br/>Roanoke County</b> | STA 12942+90 – 12982+00<br>MVP-RO-287<br>MVP-RO-288 | <b>Weather:</b> | Dry |

## FIELD INSPECTION PHOTO LOG

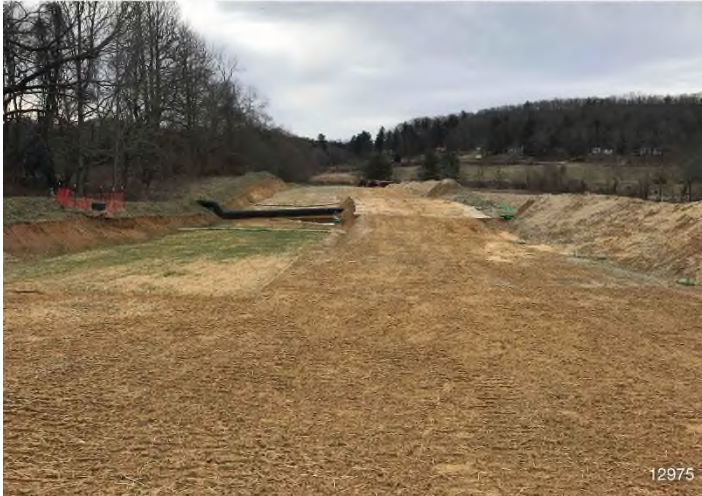
**Figure 1: STA 12975+00** – Controls in place and functioning properly. Area stabilized with hydro-mulch and straw.  
BRG: 142°SE (T) LAT: 37.130313 LON: -80.136784 ±16ft ALT: 2680ft

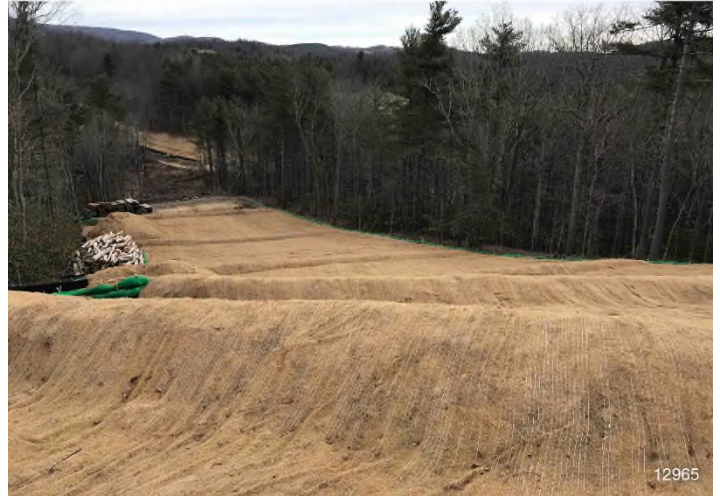
**Figure 2: STA 12965+00** – Controls in place and functioning properly. Area stabilized with erosion control matting.  
BRG: 14°N (T) LAT: 37.132431 LON: -80.137334 ±98ft ALT: 2758ft

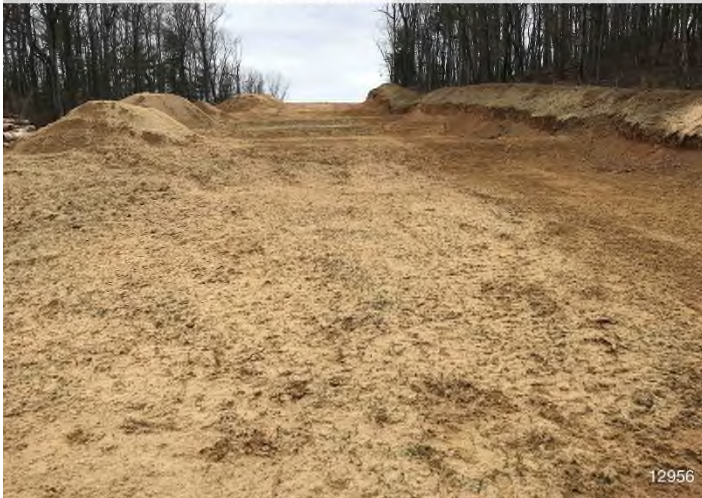
**Figure 3: STA 12956+00** – Controls in place and functioning properly. Area stabilized with hydro-mulch and straw.  
BRG: 333°NW (T) LAT: 37.134928 LON: -80.137904 ±16ft ALT: 2648ft

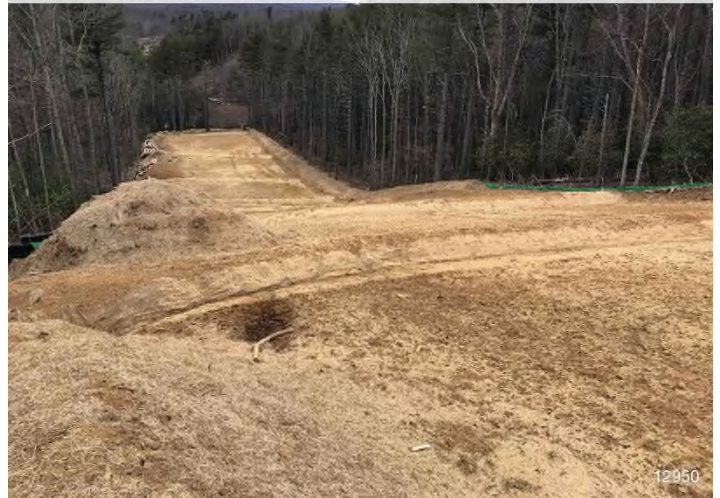
**Figure 4: STA 12950+00** – Controls in place and functioning properly. Area stabilized with hydro-mulch and straw.  
BRG: 358°N (T) LAT: 37.146534 LON: -80.124510 ±7851ft ALT: 2640ft
