FIELD INSPECTION REPORT

Project Name:	Mountain Valley Pipeline	Inspector:	Marshall Willis
Inspection Date:	Friday, March 12, 2021	Project Contact:	Brian Clauto, Cory Chalmers
Spread I: Franklin County	STA 14171+36 – 14209+75	Weather:	Dry

FIELD INSPECTION PHOTO LOG

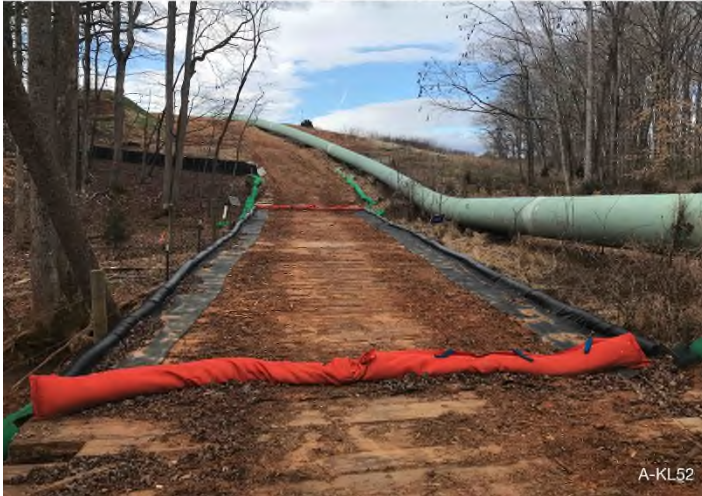
Figure 1: Stream S-KL52 – Controls in place and functioning properly. Area stabilized with straw and hydro-mulch.

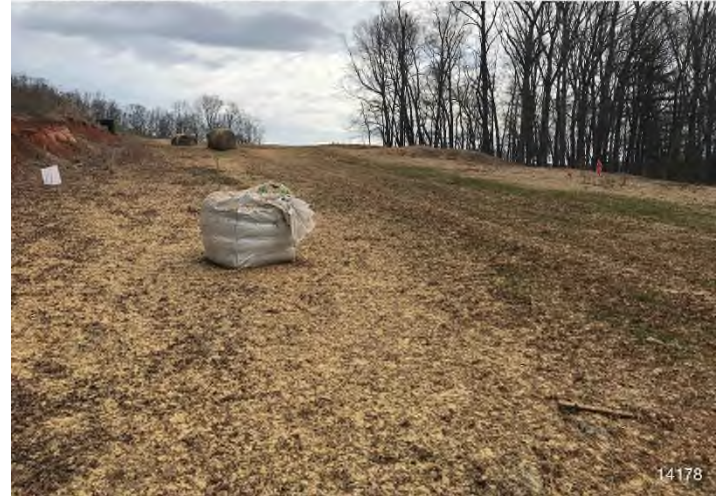
Figure 2: STA 14178+00 – Controls in place and functioning properly. Area stabilized with straw and hydro-mulch.

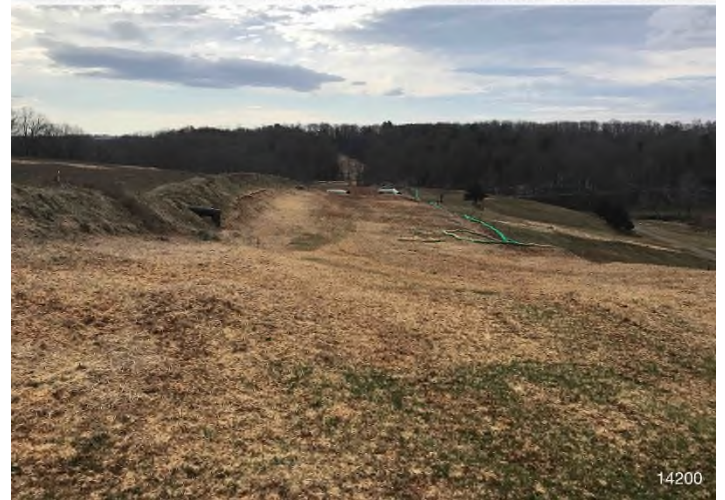
Figure 4: STA 14200+00 – Controls in place and functioning properly. Area stabilized with straw and hydro-mulch.
