## FIELD INSPECTION REPORT

<b>Project Name:</b>	Mountain Valley Pipeline	<b>Inspector:</b>	Marshall Willis
<b>Inspection Date:</b>	Wednesday, March 10, 2021	<b>Project Contact:</b>	Brian Clauto, Cory Chalmers
<b>Spread I: Franklin County Pittsylvania County</b>	STA 15480+67 – 15447+00 STA 14233+12 – 14250+00 MVP-MLV-AR-32	<b>Weather:</b>	Dry

## FIELD INSPECTION PHOTO LOG

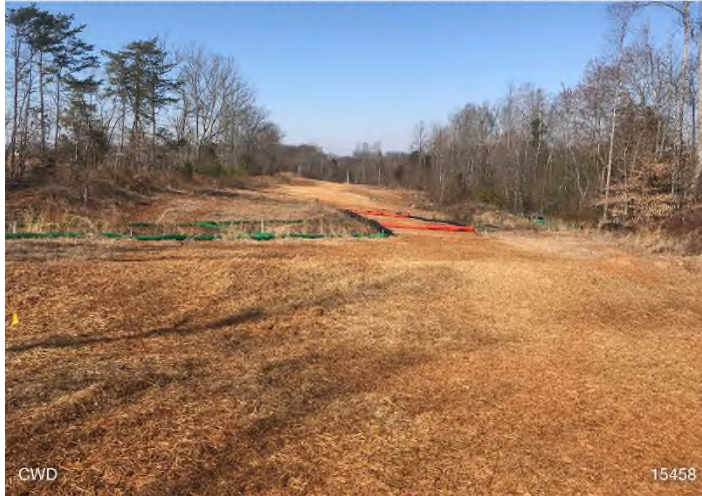
**Figure 1: STA 15458+00** – Controls in place and functioning properly. Area stabilized with straw.

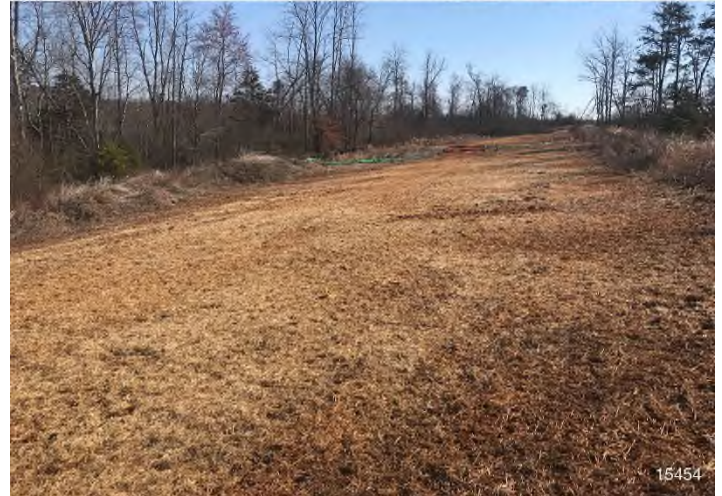
**Figure 2: STA 15454+00** – Controls in place and functioning properly. Area stabilized with straw.

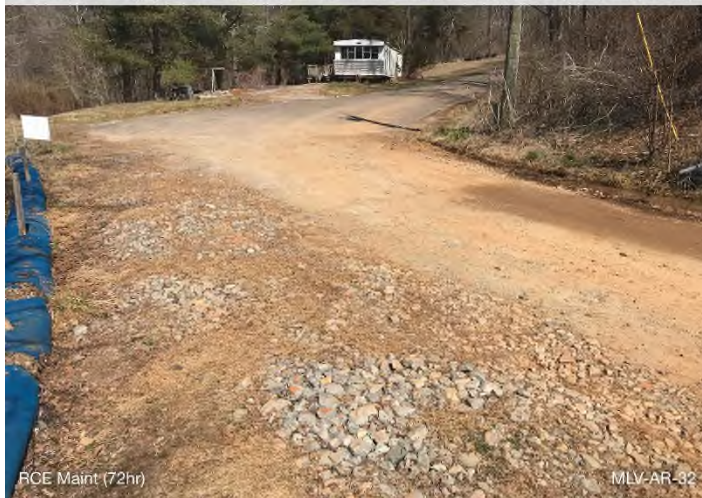
**Figure 3: MLV-AR-32** – RCE maintenance needed.

- STA 14235+00: Re-stabilize staging area.
- MVP-MLV-AR-32: RCE maintenance needed.

**Recommended Corrective Action:** Maintain and install all controls per the approved PSS&S.

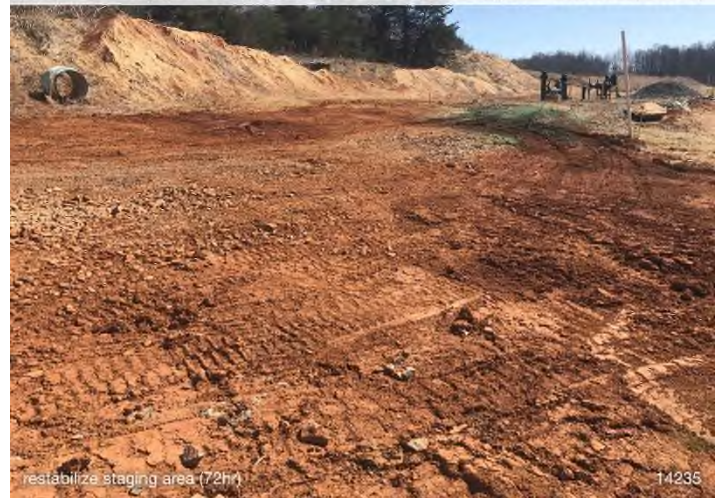
**Figure 4: STA 14235+00** – Re-stabilization of staging area needed.
