## FIELD INSPECTION REPORT

| Project Name: | Mountain Valley Pipeline | Inspector: | Marshall Willis |
| Spread H:<br>Montgomery County | STA 12445+19 – 12544+06 | Weather: | Dry |

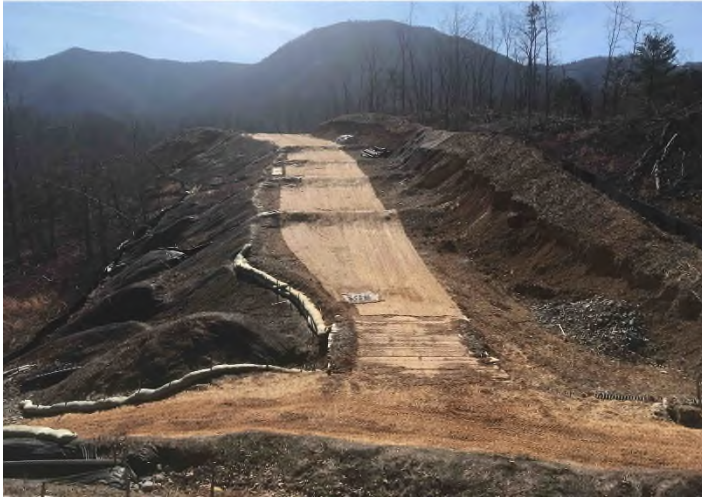
**Figure 1: STA 12530+00** – Controls in place and functioning properly. Area stabilized with erosion control matting.

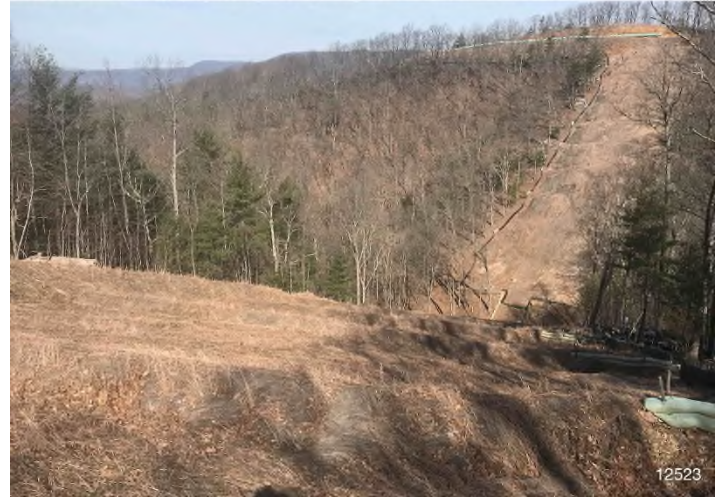
**Figure 2: STA 12523+00** – Controls in place and functioning properly. Area stabilized with erosion control matting.

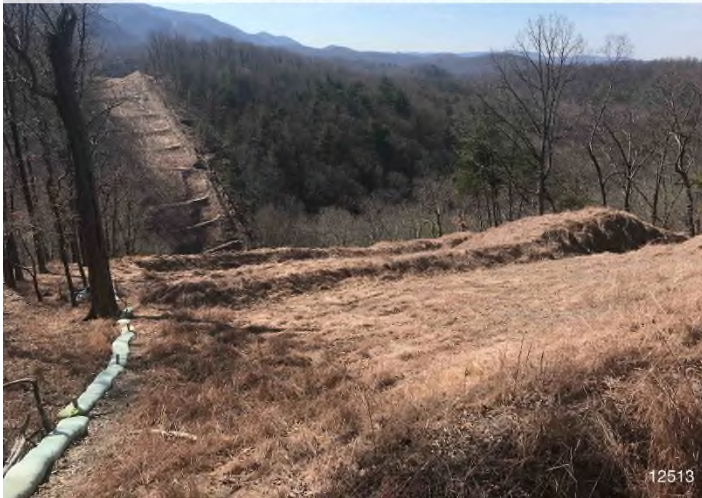
**Figure 3: STA 12513+00** – Controls in place and functioning properly. Area stabilized with erosion control matting.

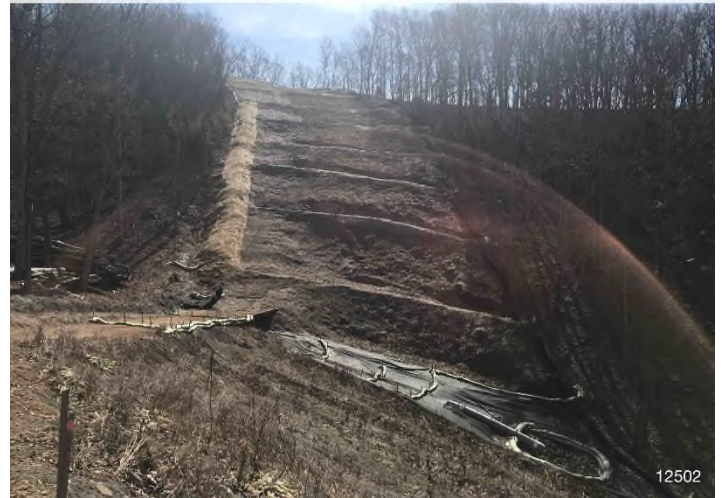
**Figure 4: STA 12502+00** – Controls in place and functioning properly. Area stabilized with erosion control matting.
