FIELD INSPECTION REPORT

Project Name:	Mountain Valley Pipeline	Inspector:	Marshall Willis
Inspection Date:	Wednesday, April 7, 2021	Project Contact:	Brian Clauto, Cory Chalmers
Spread I: Franklin County	STA 14311+57 – 14454+22	Weather:	Dry

FIELD INSPECTION PHOTO LOG

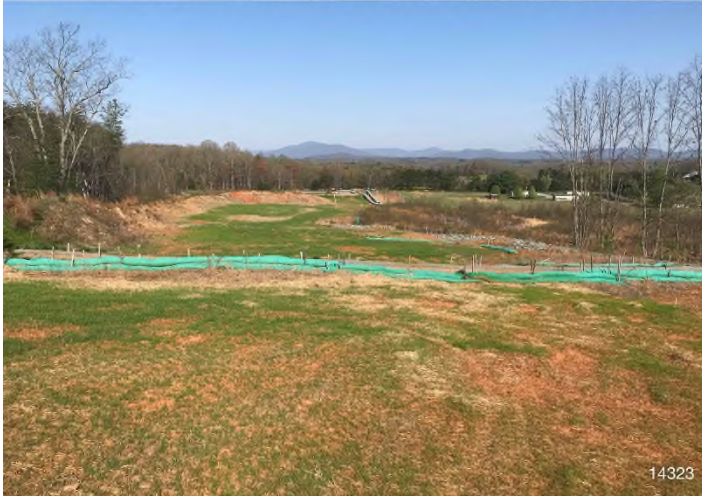
Figure 1: STA 14323+00 – Controls in place and functioning properly.
BRG: 294°NW (T) LAT: 37.041499 LON: -79.806493 ±16ft ALT: 1131ft

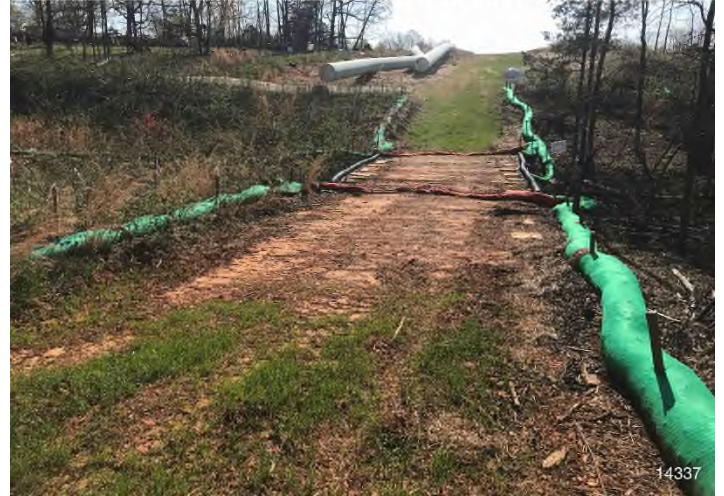
Figure 2: STA 14337+00 – Controls in place and functioning properly.
BRG: 70°E (T) LAT: 37.037968 LON: -79.804488 ±32ft ALT: 1135ft

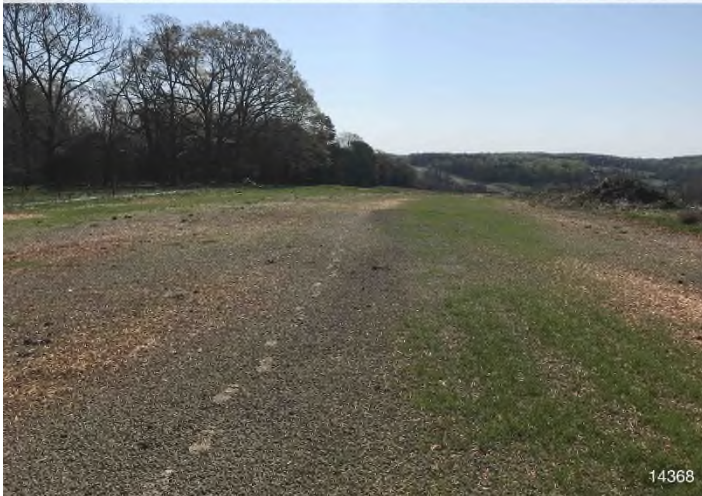
Figure 3: STA 14368+00 – Controls in place and functioning properly.
BRG: 113°SE (T) LAT: 37.062048 LON: -79.809757 ±13133ft ALT: 1141ft

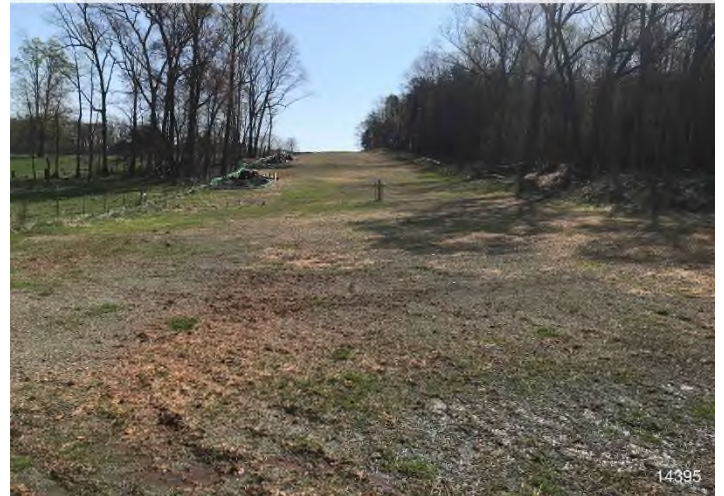
Figure 4: STA 14395+00 – Controls in place and functioning properly.
BRG: 110°E (T) LAT: 37.031667 LON: -79.788239 ±14544ft ALT: 969ft
