FIELD INSPECTION REPORT

Project Name:	Mountain Valley Pipeline	Inspector:	Marshall Willis
Inspection Date:	Monday, March 29, 2021	Project Contact:	Brian Clauto, Cory Chalmers
Spread I: Pittsylvania County	STA 15853+73 – 16000+00 MVP-PI-340	Weather:	Wet

FIELD INSPECTION PHOTO LOG

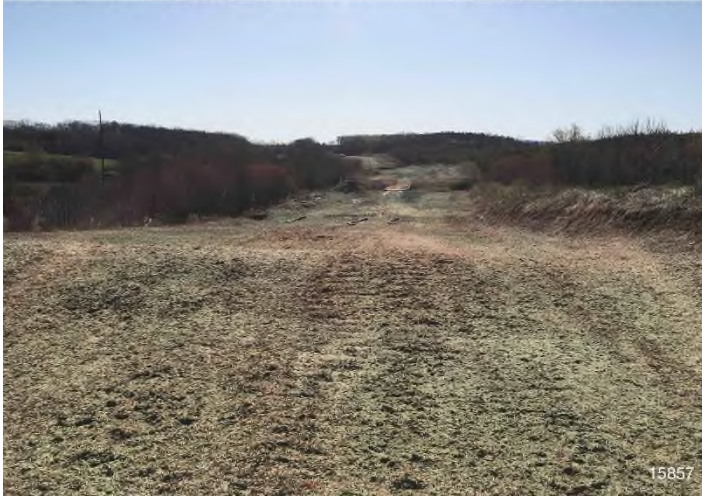
Figure 1: STA 15857+00 – Controls in place and functioning properly. Area stabilized with straw and hydro-mulch.
BRG: 116°SE (T) LAT: 36.851358 LON: -79.384242 ±32ft ALT: 739ft

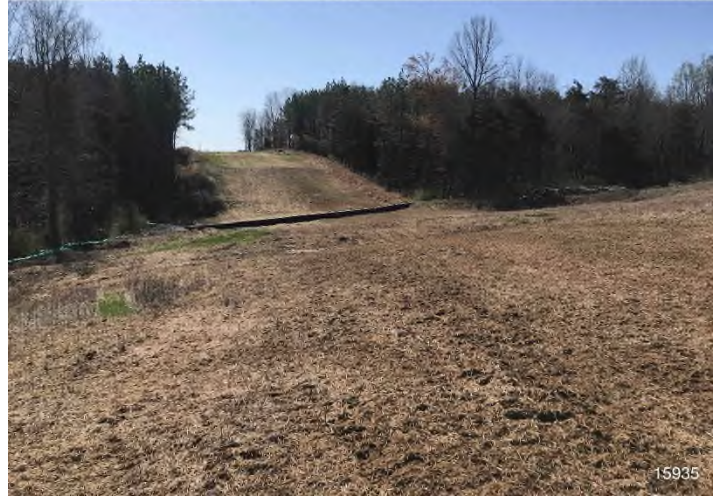
Figure 2: STA 15935+00 – Controls in place and functioning properly. Area stabilized with straw and hydro-mulch.
BRG: 167°S (T) LAT: 36.814334 LON: -79.356787 ±24673ft ALT: 638ft

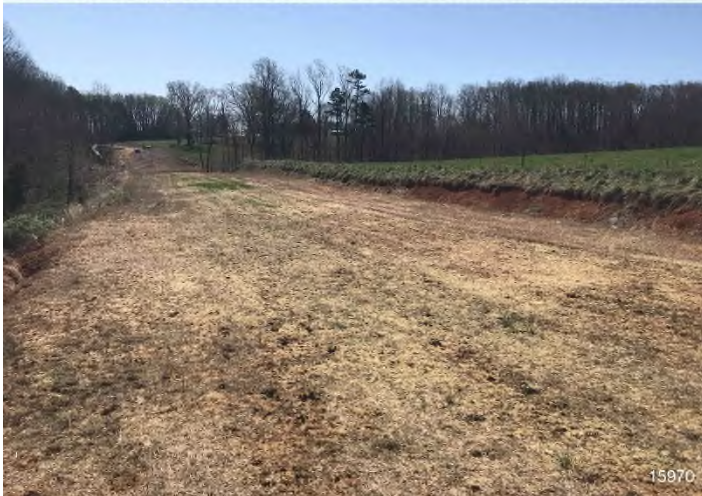
Figure 3: STA 15970+00 – Controls in place and functioning properly. Area stabilized with straw and hydro-mulch.
BRG: 156°SE (T) LAT: 36.831479 LON: -79.358222 ±98ft ALT: 622ft

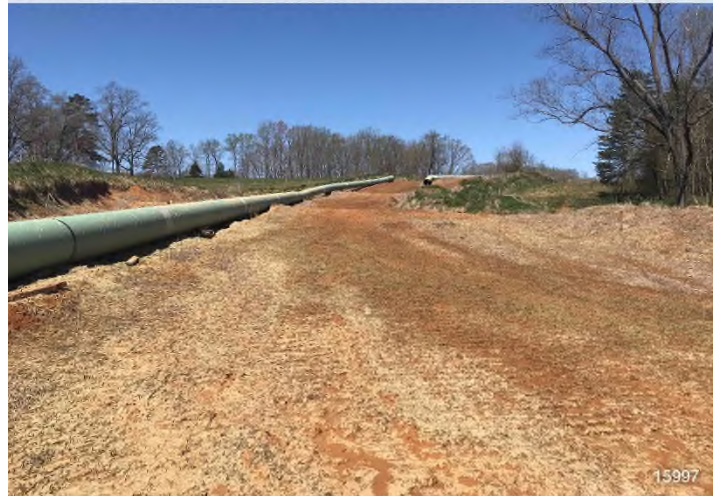
Figure 4: STA 15997+00 – Controls in place and functioning properly. Area stabilized with straw and hydro-mulch.
BRG: 263°W (T) LAT: 36.827102 LON: -79.351302 ±16ft ALT: 606ft
