## FIELD INSPECTION REPORT

| Project Name: | Mountain Valley Pipeline | Inspector: | Marshall Willis |
| Spread I:<br>Franklin County | STA 14454+22 – 14546+75<br>MVP-FR-317.01 | Weather: | Dry |

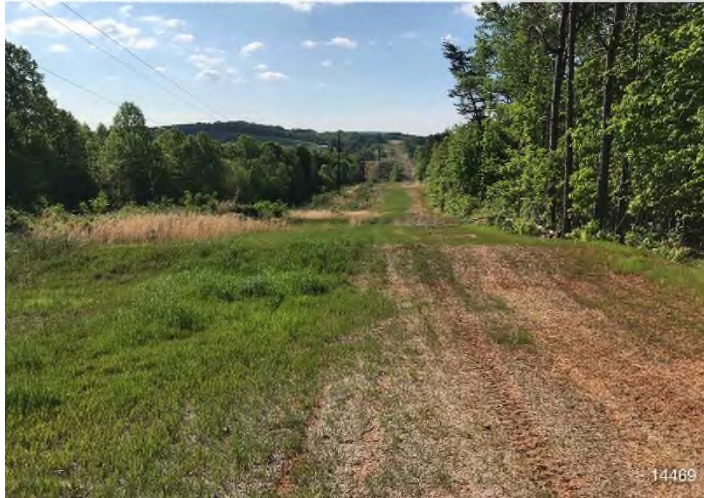
**Figure 1: STA 14469+00** – Controls in place and functioning properly.

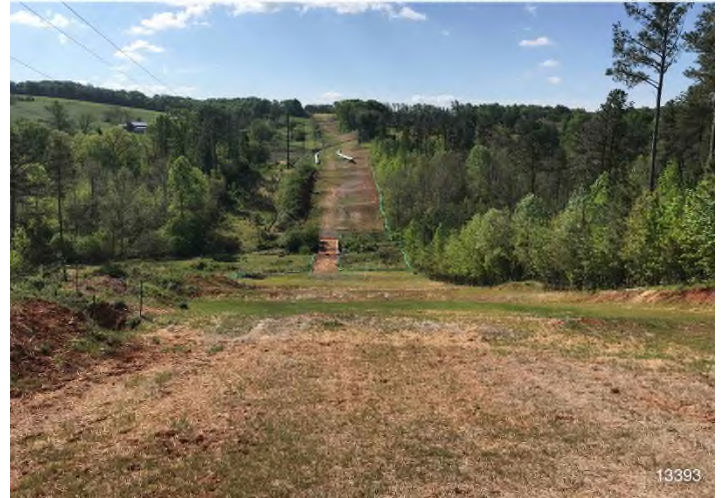
**Figure 2: STA 14493+00** – Controls in place and functioning properly.

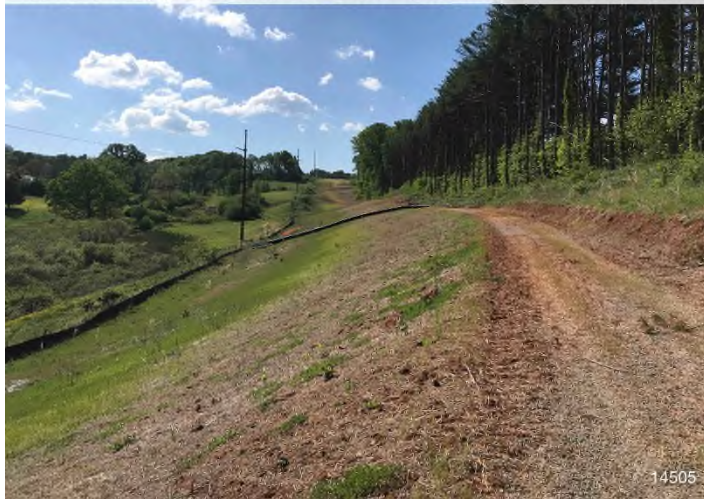
**Figure 3: STA 14505+00** – Controls in place and functioning properly.

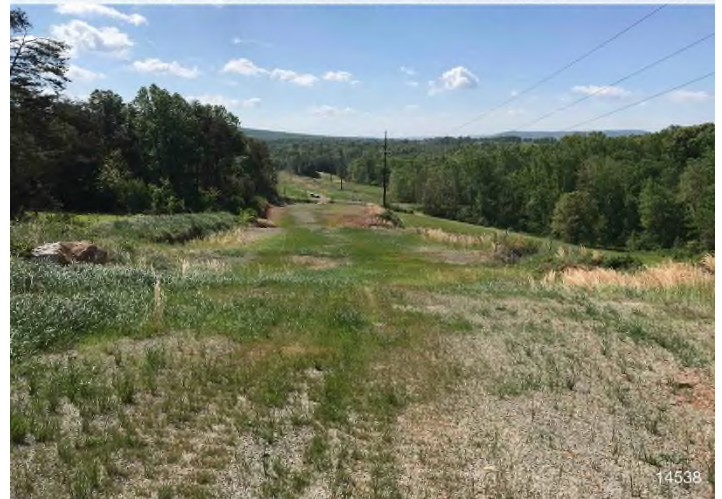
**Figure 4: STA 14538+00** – Controls in place and functioning properly.
