FIELD INSPECTION REPORT

Project Name:	Mountain Valley Pipeline	Inspector:	Marshall Willis
Inspection Date:	Thursday, April 29, 2021	Project Contact:	Brian Clauto, Cory Chalmers
Spread H: Franklin County	STA 13342+67 – 13415+51	Weather:	Dry

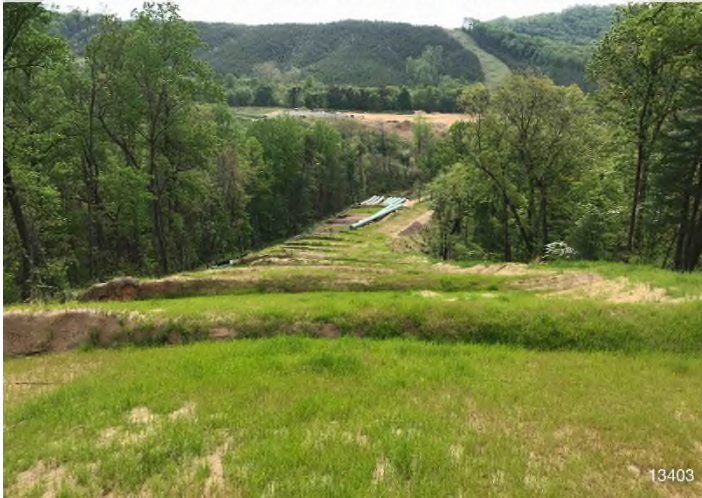
Figure 1: STA 13403+00 – Controls in place and functioning properly.

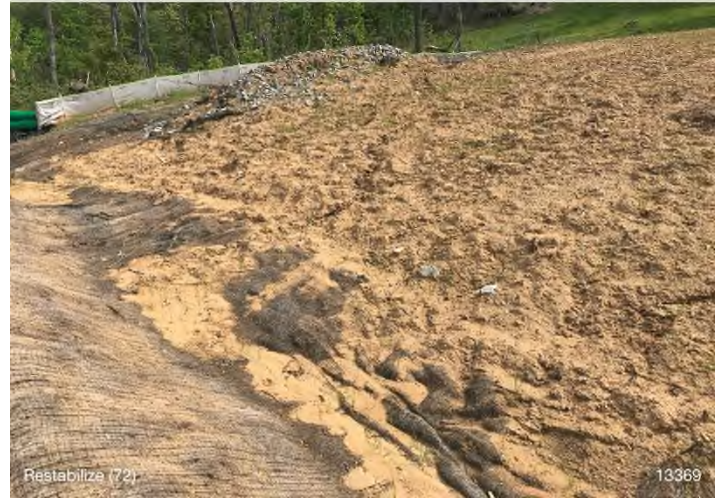
Figure 2: STA 13369+00 – Re-stabilization needed.

- STA 13369+00: Re-stabilize area.

Recommended Corrective Action: Maintain and install all controls per the approved PSS&S.

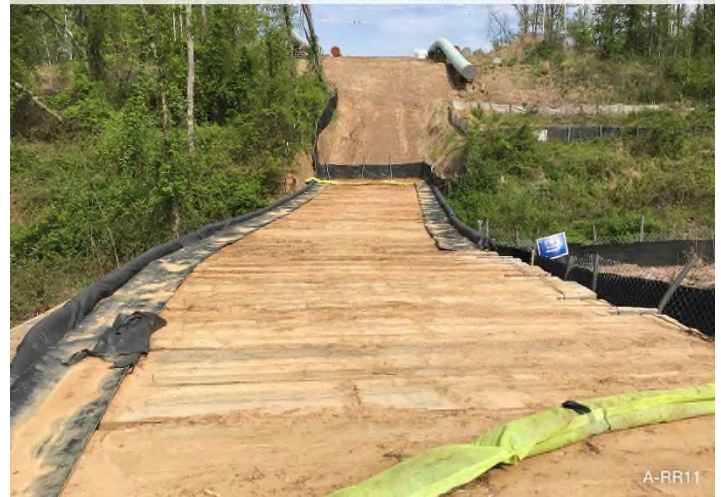
Figure 4: Stream S-RR11 – Controls in place and functioning properly.
